Assessing and classifying the condition and values of waterways in the Ipswich LGA

ICC EnviroForum 2015

Kaye Cavanagh and Steve Skull

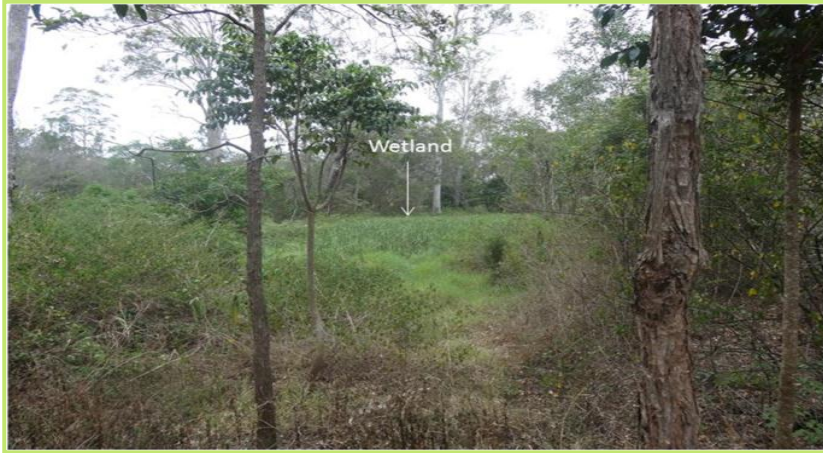
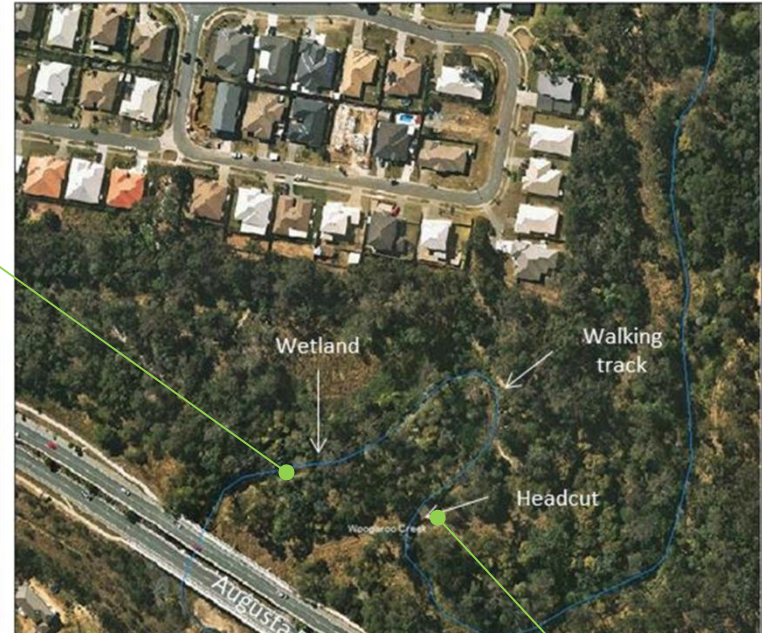
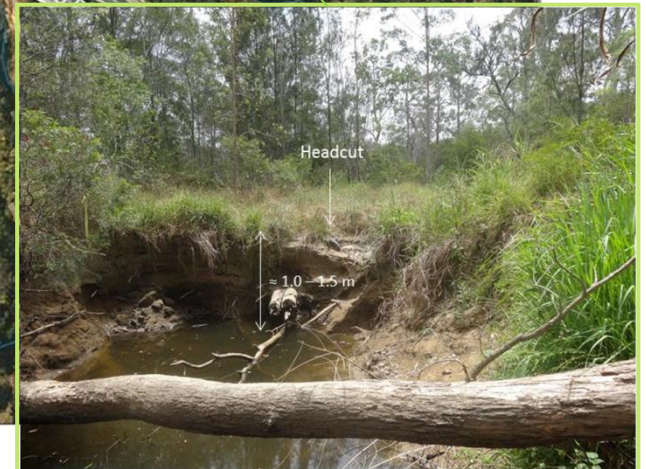
Management implications - Woogaroo Creek

- A headcut just downstream of Augusta Parkway.
- Significant urbanisation has occurred in the catchment upstream of this location
- The headcut is 1.0-1.5m high and is now 100m downstream from a remnant wetland
- A council path also abuts the channel between the wetland and headcut
- The wetland is understood to be an important fish breeding habitat
