Figure 18. Location and overall priority rank of the top 50 barriers to fish passage in the GB region.

Discussion

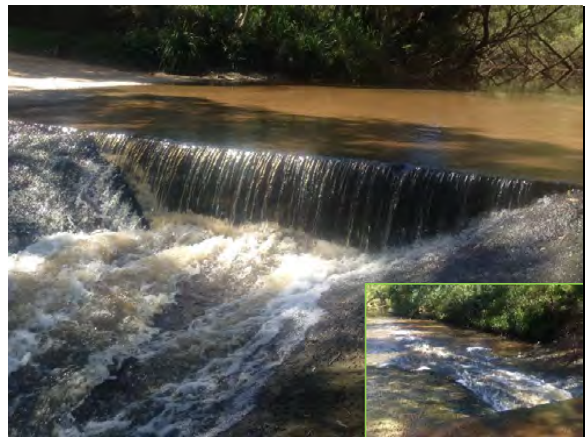
Overall Priority	3	
LGA/LGA Priority	GCCC & LCC	1* & 1*
Barrier ID	10352	
Stream Name	Albert River	
Location	-27.800196°	153.169262°
Barrier Type	Redundant Weir	
Barrier Name	Luscombe Weir	
Fishway Type Needed	Removal	
Approx. Cost of Fishway	\$1.3 million

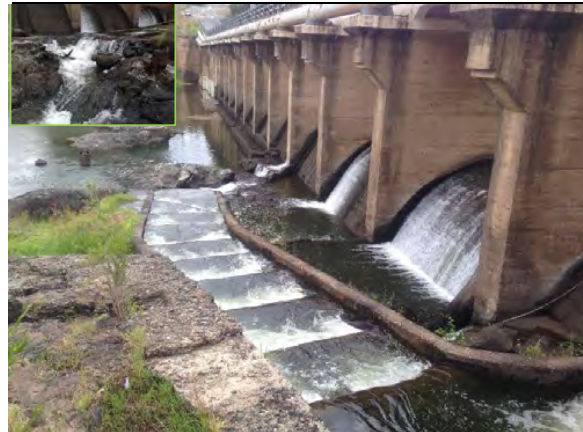
Overall Priority	3	
LGA/LGA Priority	BCC	1
Barrier ID	12850	
Stream Name	Brisbane River	
Location	-27.537293°	152.797935°
Barrier Type	Weir	
Barrier Name	Mt Crosby Weir	
Fishway Type Needed	Concrete Cone	
Approx. Cost of Fishway	\$800 k - \$1 .1 million

Overall, the top three highest priority ranked barriers in the GB region were (1) Caboolture River Barrage, (2) Elimbah Creek Tidal Causeway, and equal third, Luscombe Weir on the Albert River and Mt. Crosby Weir on the Brisbane River. The reason these barriers scored so highly in the prioritisation process, along with many other barriers ranked in the top 50, was due to a combination of critical criteria these barriers met in terms of potential for fish community impacts. Generally these barriers were on high ordered streams, situated on, or in close proximity to the estuary, had minimal to no barriers downstream and blocked access to large areas of available habitat upstream. This combination of factors meant that these barriers, and barriers with similar traits, present the biggest overall impacts to fish community condition and overall aquatic ecosystem health, and thus, ranked highest in priority for remediation works.

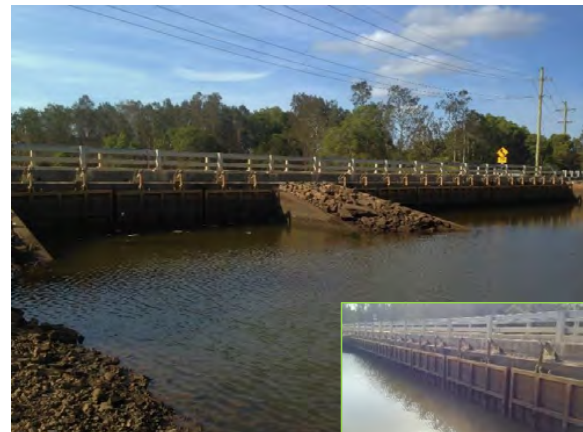
Overall Priority	5	
LGA/LGA Priority	GCCC & LCC	3 & 2
Barrier ID	10351	
Stream Name	Albert River	
Location	-27.775037°	153.186256°
Barrier Type	Tidal Pipe Causeway	
Barrier Name	Stanmore Road	
Fishway Type Needed	Bridge/Culverts	R.Ramp/Cone
Approx. Cost of Fishway	\$100-\$300 k	\$50-\$90 k

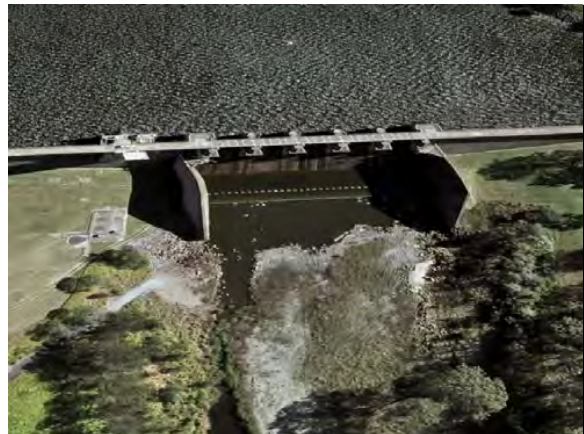
Overall Priority	11	
LGA/LGA Priority	MBRC	4
Barrier ID	2279	
Stream Name	North Pine River	
Location	-27.263543°	152.937002°
Barrier Type	Dam	
Barrier Name	North Pine Dam	
Fishway Type Needed	Fish Lift	
Approx. Cost of Fishway	\$1 - 2 million

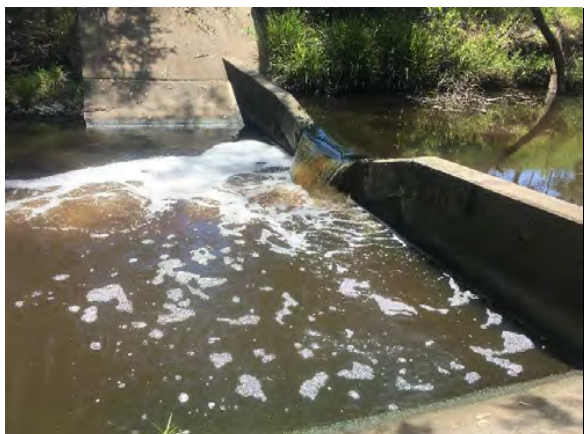
Overall Priority	12	
LGA/LGA Priority	ICC	1
Barrier ID	8231	
Stream Name	Warrill Creek	
Location	-27.659011°	152.698957°
Barrier Type	DNRM V-notch Gauging Weir	
Barrier Name	DNRM Weir	
Fishway Type Needed	Cone (1st ridge) &/or R.Ramp	
Approx. Cost of Fishway	\$70 - \$100 k

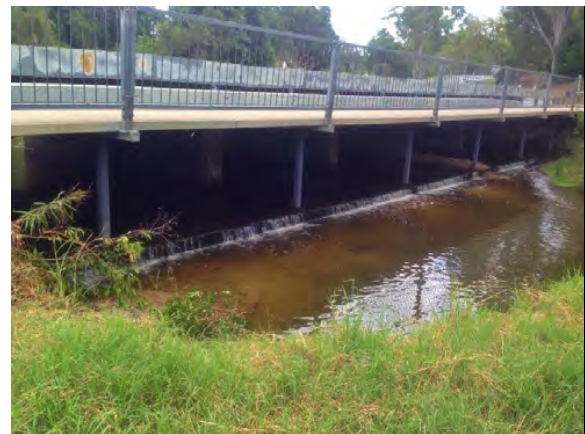
Overall Priority	15	
LGA/LGA Priority	RCC	2
Barrier ID	4876	
Stream Name	Hilliards Creek	
Location	-27.511266°	153.246640°
Barrier Type	Causeway (pedestrian)	
Barrier Name	Fellmonger Park	
Fishway Type Needed	New Culverts + Rock Ramp	
Approx. Cost of Fishway	\$60 - \$100 k

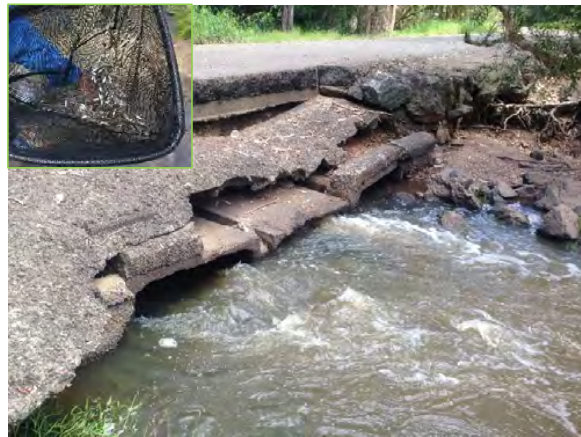
Overall Priority	18	
LGA/LGA Priority	GCCC	5
Barrier ID	13911	
Stream Name	Hotham Creek	
Location	-27.799051°	153.307883°
Barrier Type	Tidal Causeway	
Barrier Name	Sugar Cane Crossing	
Fishway Type Needed	Removal/Rock Ramp	
Approx. Cost of Fishway	\$30 - \$40 k

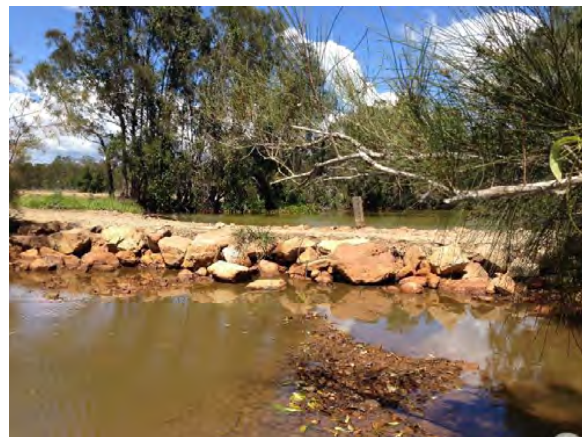
Overall Priority	18	
LGA/LGA Priority	MBRC	6
Barrier ID	10719	
Stream Name	King John Creek	
Location	-27.093888°	153.028851°
Barrier Type	Pipe Causeway	
Barrier Name	Estuary diverted	
Fishway Type Needed	Bed Level Xing &/or R.Ramp	
Approx. Cost of Fishway	\$15 - \$25 k

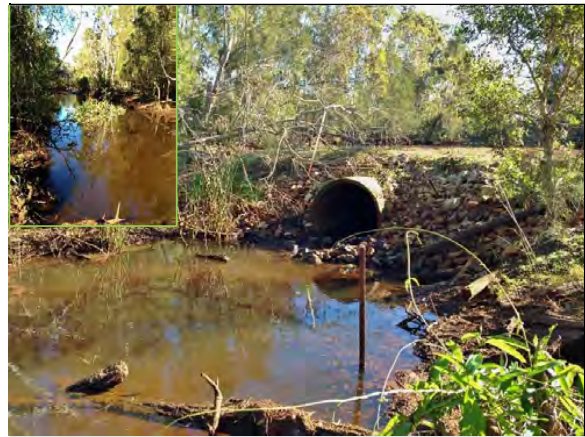
Overall Priority	20	
LGA/LGA Priority	GCCC	6
Barrier ID	5810	
Stream Name	Sandy Creek	
Location	-27.716465°	153.302614°
Barrier Type	New Tidal Floodgate	
Barrier Name	Loves Rd (main west arm)	
Fishway Type Needed	Fish Friendly Auto Tidal Gate	
Approx. Cost of Fishway	*\$25 - \$75 k

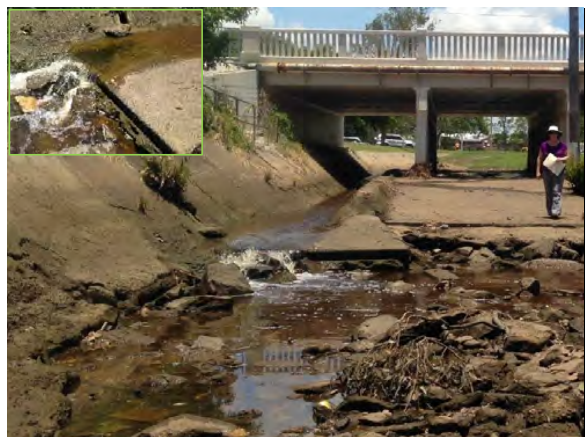
Overall Priority	20	
LGA/LGA Priority	BCC	3
Barrier ID	11864	
Stream Name	Norman Creek	
Location	-27.497907°	153.043011°
Barrier Type	Tidal Culvert Apron Drop ~300mm	
Barrier Name	Logan Road - Hanlon Park	
Fishway Type Needed	R.Ramp/Cone + horizontal baffles	
Approx. Cost of Fishway	\$20 - \$40 k

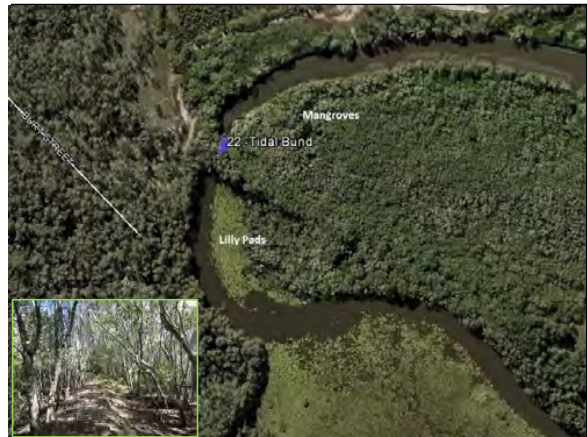
Overall Priority	22	
LGA/LGA Priority	MBRC	7
Barrier ID	13992	
Stream Name	King John Creek	
Location	-27.104366°	153.025763°
Barrier Type	Tidal Pipe Causeway	
Barrier Name	Tidal causeway adj FHA	
Fishway Type Needed	Removal/Bed level Crossing	
Approx. Cost of Fishway	\$5 - \$25 k

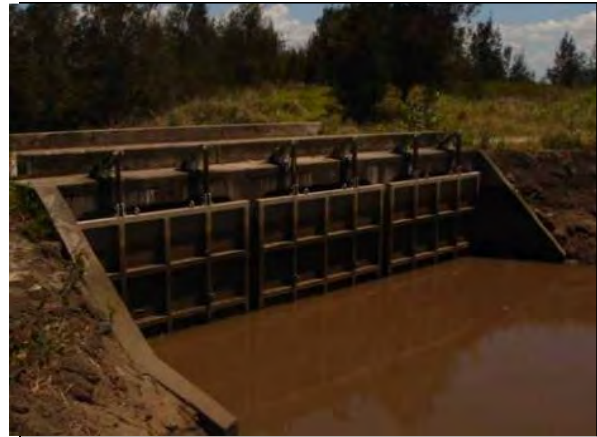
Overall Priority	22	
LGA/LGA Priority	GCCC	7
Barrier ID	5807	
Stream Name	Sandy Creek East	
Location	-27.719208°	153.309700°
Barrier Type	Tidal Floodgate	
Barrier Name	School Rd	
Fishway Type Needed	Fish Friendly Auto Tidal Gate	
Approx. Cost of Fishway	*\$25 - \$75 k

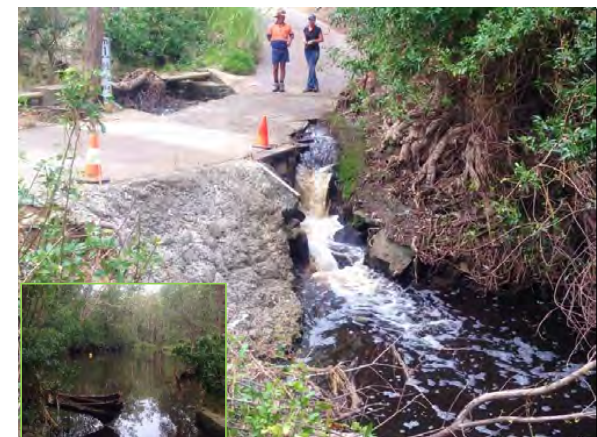
Overall Priority	26	
LGA/LGA Priority	BCC	4
Barrier ID	13996	
Stream Name	Cabbage Tree Creek	
Location	-27.334655°	153.043116°
Barrier Type	Rock Weir	
Barrier Name	Lemke Rd - adj AFL Club	
Fishway Type Needed	Removal/Rock Ramp	
Approx. Cost of Fishway	\$5 - \$10 k

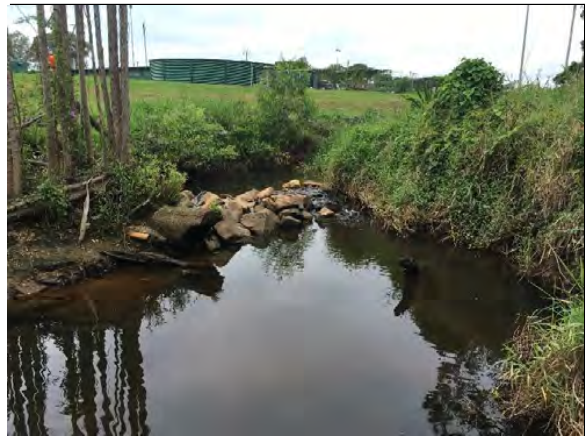
Overall Priority	26	
LGA/LGA Priority	LCC	4
Barrier ID	7083	
Stream Name	Quinze Creek	
Location	-27.755147°	153.115479°
Barrier Type	Causeway	
Barrier Name	D/S Waterford-Tamborine Rd	
Fishway Type Needed	Removal + Bd Level Xing/R.Ramp	
Approx. Cost of Fishway	\$25 - \$60 k

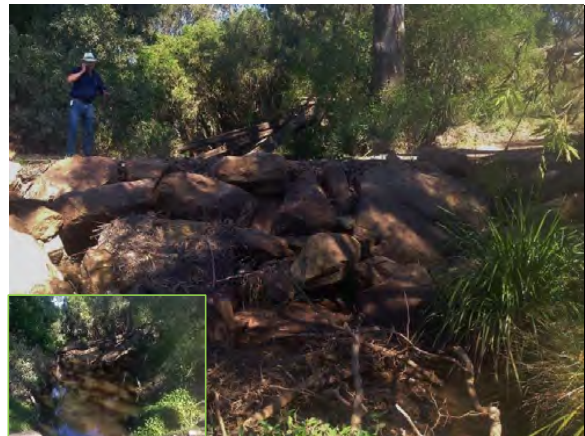
Overall Priority	26	
LGA/LGA Priority	MBRC	10
Barrier ID	13992	
Stream Name	North Pine River	
Location	-27.263190°	152.951383°
Barrier Type	Pipe Culvert Causeway	
Barrier Name	Opposite Old Petrie Town	
Fishway Type Needed	Bed Level Xing/New Culverts	
Approx. Cost of Fishway	\$20 - \$50 k

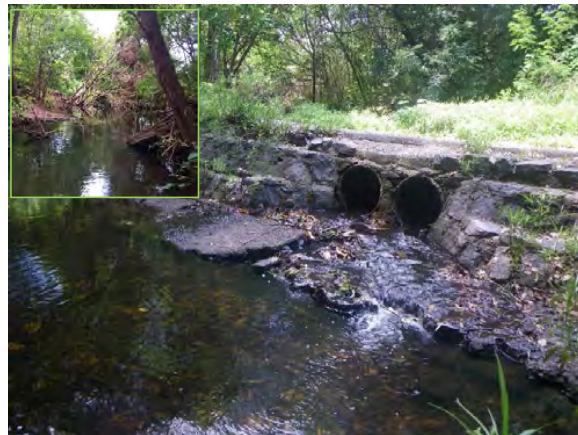
Overall Priority	32	
LGA/LGA Priority	LCC	5
Barrier ID	6387	
Stream Name	Scrubby Creek	
Location	-27.662613°	153.123738°
Barrier Type	Pipe Culvert Causeway	
Barrier Name	Gould Adams Prk - Kingston Rd	
Fishway Type Needed	Full-width Rock Ramp	
Approx. Cost of Fishway	\$60- \$100 k

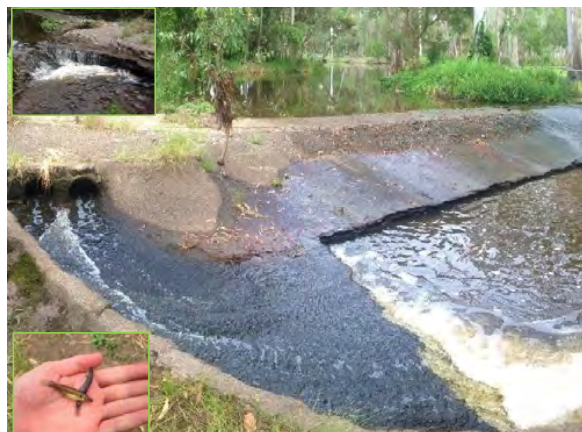
Overall Priority	32	
LGA/LGA Priority	MBRC	12
Barrier ID	2106	
Stream Name	Freshwater Creek	
Location	-27.668090°	153.119794°
Barrier Type	Earthen Bund	
Barrier Name	Upstream Hays Inlet FHA	
Fishway Type Needed	Removal/Rock Ramp	
Approx. Cost of Fishway	\$5 - \$30 k

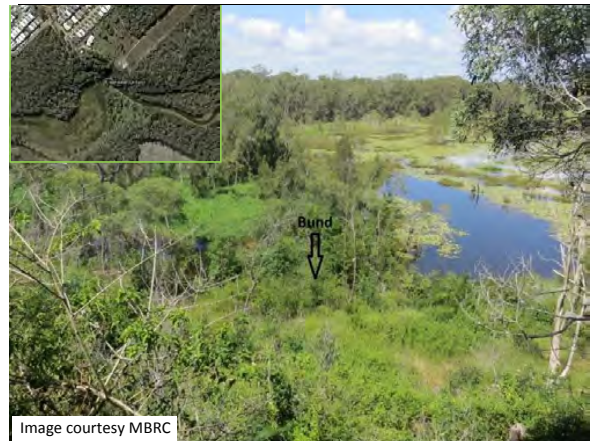
Overall Priority	32	
LGA/LGA Priority	LCC	5
Barrier ID	6388	
Stream Name	Scrubby Creek	
Location	-27.668090°	153.119794°
Barrier Type	Pipe Culvert Causeway	
Barrier Name	D/S Logan Motorway	
Fishway Type Needed	Removal/Bed Level Xing + R.Ramp	
Approx. Cost of Fishway	\$30 k - \$60 k

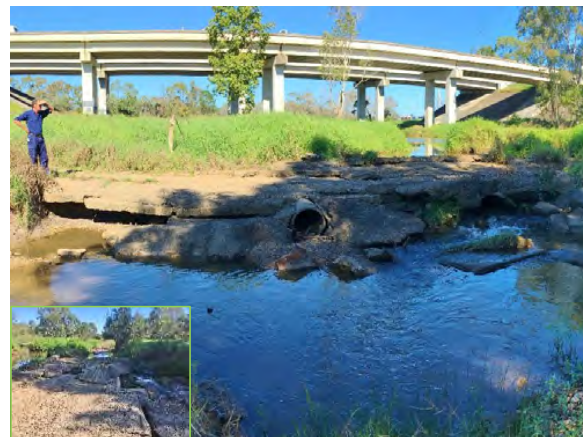
Overall Priority	32	
LGA/LGA Priority	ICC	4
Barrier ID	9649	
Stream Name	Bundamba Creek	
Location	-27.635605°	152.790513°
Barrier Type	Rock Weir	
Barrier Name	Worley Park	
Fishway Type Needed	Rock Ramp	
Approx. Cost of Fishway	\$5 - \$8 k

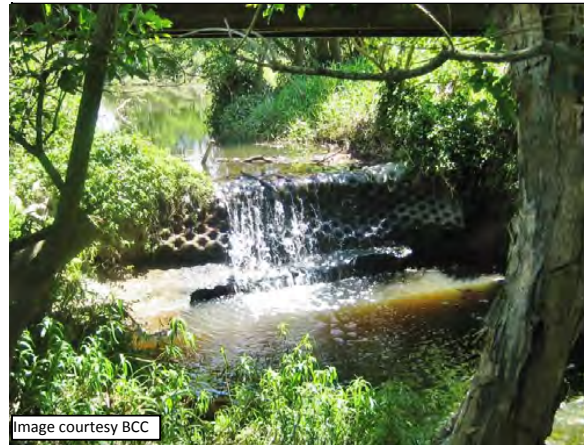
Overall Priority	37	
LGA/LGA Priority	ICC	8
Barrier ID	9748	
Stream Name	Bundamba Creek	
Location	-27.644044°	152.800083°
Barrier Type	Pipe Causeway	
Barrier Name	East Owen Street	
Fishway Type Needed	New Box Culverts &/or Rock Ramp	
Approx. Cost of Fishway	\$20 - \$90 k

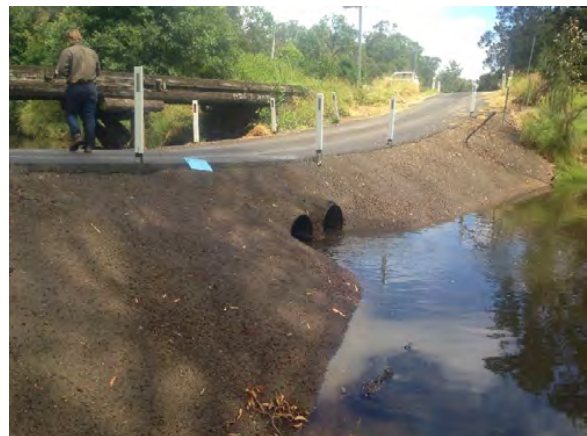
Overall Priority	37	
LGA/LGA Priority	GCCC	8
Barrier ID	5525	
Stream Name	Cabbage Tree Point Creek	
Location	-27.722999°	153.344490°
Barrier Type	Tidal Floodgate - Pipe	
Barrier Name	Cabbage Tree Point	
Fishway Type Needed	Fish Friendly Auto-tidal Gates	
Approx. Cost of Fishway	\$10 - \$15 k

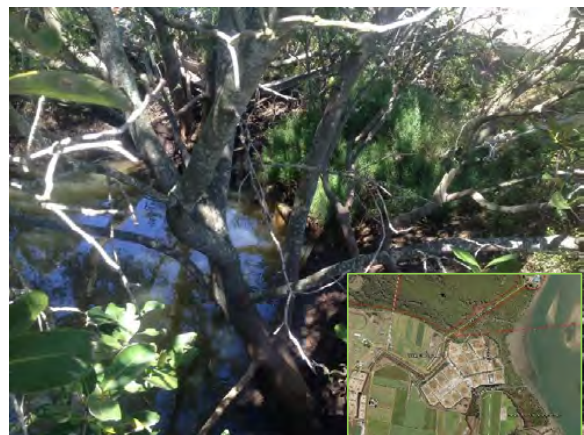
Overall Priority	40	
LG/LGA Priority	BCC	8
Barrier ID	343	
Stream Name	Zillmere Waterholes	
Location	-27.364832°	153.061926°
Barrier Type	Culvert Causeway	
Barrier Name	Sandgate Road	
Fishway Type Needed	Rock Ramp + Nib wall & Baffles	
Approx. Cost of Fishway	\$30 - \$50 k

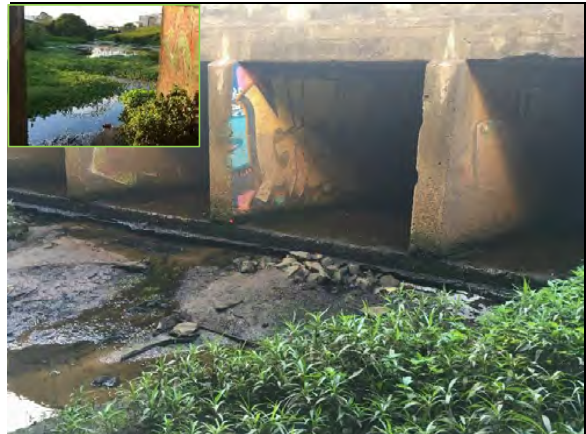
Overall Priority	40	
LG/LGA Priority	BCC	8
Barrier ID	13828	
Stream Name	Hemmant Creek	
Location	-27.451713°	153.125205°
Barrier Type	Tidal Floodgate	
Barrier Name	Hemmant Tingalpa Rd	
Fishway Type Needed	Fish Friendly Auto-tidal Gates	
Approx. Cost of Fishway	\$25 - \$35

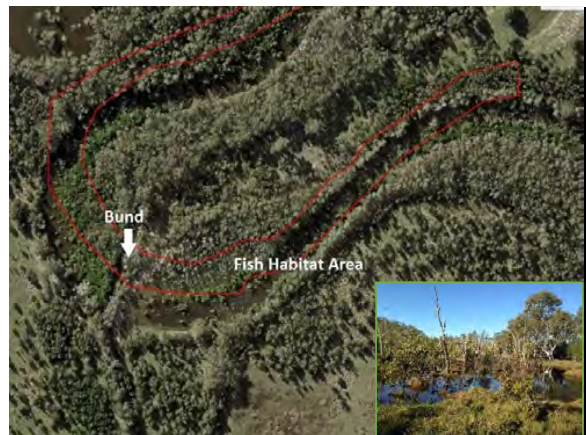
Overall Priority	40	
LG/LGA Priority	MBRC	13
Barrier ID	13940	
Stream Name	King John Creek	
Location	-27.102760°	153.025381°
Barrier Type	Earthen Bund	
Barrier Name	Deception Bay FHA	
Fishway Type Needed	Removal/Bed Level Crossing	
Approx. Cost of Fishway	\$5 - \$15 k

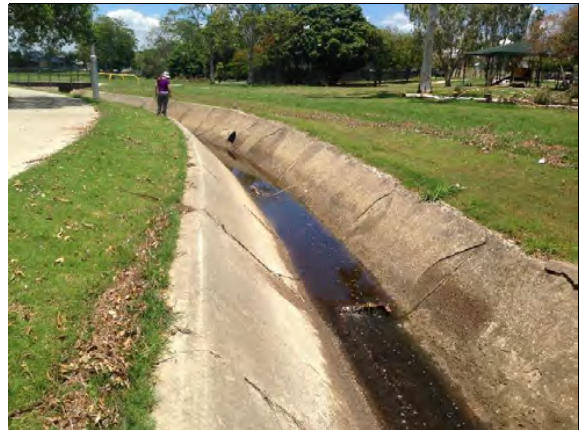
Overall Priority	44	
LGA/LGA Priority	BCC	11
Barrier ID	11647	
Stream Name	Bulimba Creek	
Location	-27.502643°	153.105451°
Barrier Type	Culvert Causeway	
Barrier Name	Opposite Carindale Shop. Cntr	
Fishway Type Needed	Rock Ramp	
Approx. Cost of Fishway	\$15 - \$25

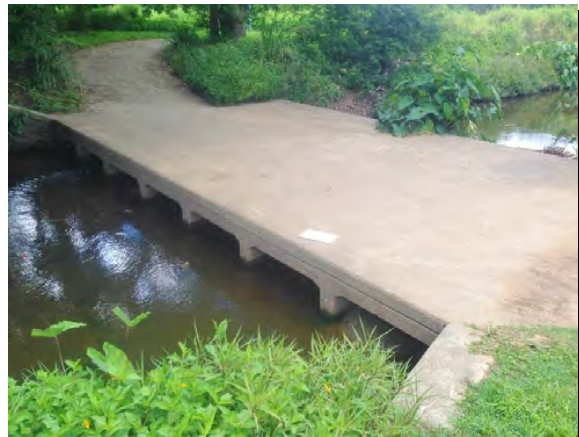
Overall Priority	44	
LGA/LGA Priority	BCC	11
Barrier ID	13943	
Stream Name	Blunder Creek	
Location	-27.571258°	152.987956°
Barrier Type	Causeway	
Barrier Name	Oxley Creek Junction	
Fishway Type Needed	Removal/Bed Level Xing	
Approx. Cost of Fishway	\$3 - \$5 k

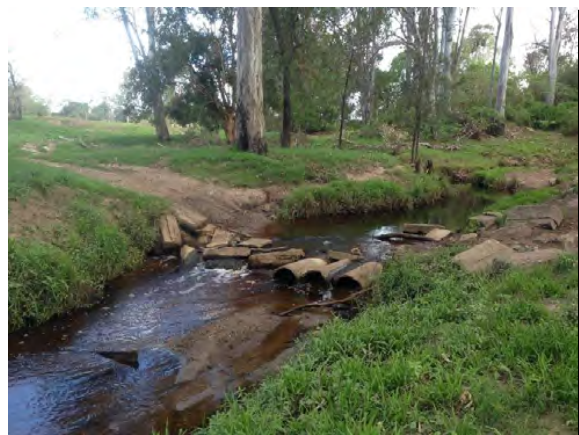
Overall Priority	44	
LGA/LGA Priority	BCC	11
Barrier ID	11648	
Stream Name	Bulimba Creek	
Location	-27.504079°	153.105604°
Barrier Type	Culvert Causeway	
Barrier Name	Opposite Carindale Shop. Cntr	
Fishway Type Needed	Removal	
Approx. Cost of Fishway	\$3 - \$5 k

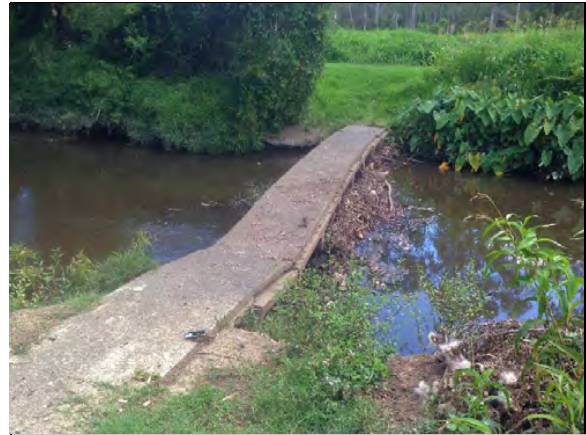
Overall Priority	47	
LGA/LGA Priority	ICC	9
Barrier ID	12970	
Stream Name	Woogaroo Creek	
Location	-27.622268°	152.908130°
Barrier Type	Rock Weir	
Barrier Name	Newman St Easement	
Fishway Type Needed	Rock Ramp	
Approx. Cost of Fishway	\$30 - \$50 k

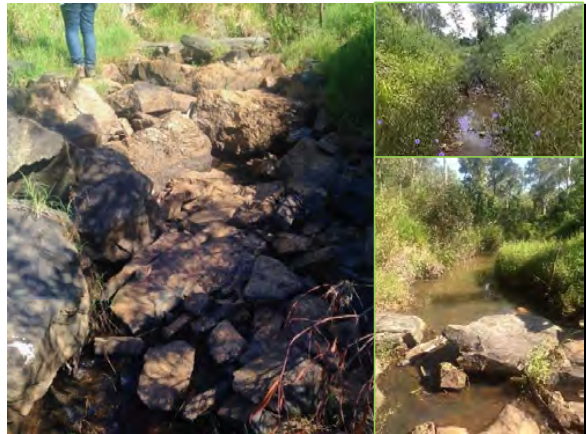
Overall Priority	47	
LGA/LGA Priority	MBRC	14
Barrier ID	1523	
Stream Name	South Pine River	
Location	-27.365176°	152.877745°
Barrier Type	Culvert Causeway	
Barrier Name	Cannington Crt - Samford	
Fishway Type Needed	Rock Ramp + Baffles/Culverts	
Approx. Cost of Fishway	\$40 k - \$80 k

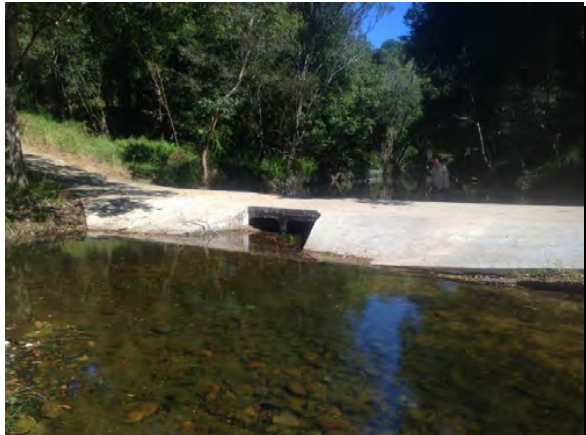
Overall Priority	47	
LGA/LGA Priority	BCC	14
Barrier ID	12461	
Stream Name	Moggill Creek	
Location	-27.504555°	152.930528°
Barrier Type	Pipe Causeway	
Barrier Name	Branton Street	
Fishway Type Needed	Removal/Rock Ramp	
Approx. Cost of Fishway	\$20 k - \$80 k

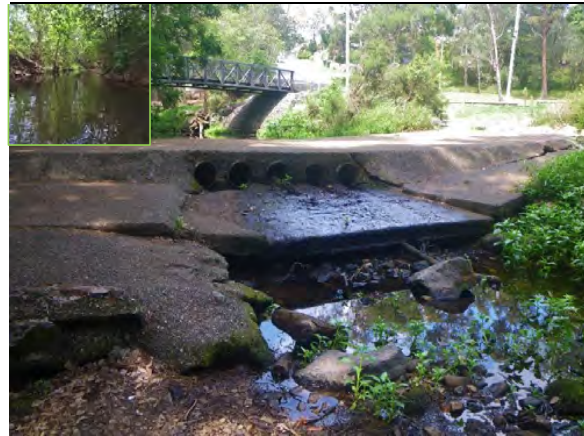
Overall Priority	47	
LGA/LGA Priority	MBRC	15
Barrier ID	11071	
Stream Name	Caboolture River	
Location	-27.109714°	152.885927°
Barrier Type	Culvert Causeway	
Barrier Name	Litherland Road	
Fishway Type Needed	Rock Ramp + Baffles	
Approx. Cost of Fishway	\$30 - \$50 k

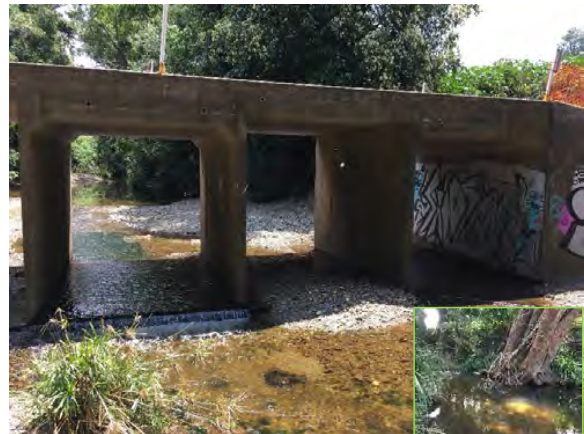
Overall Priority	47	
LGA/LGA Priority	LCC	14
Barrier ID	13407	
Stream Name	Scrubby Creek	
Location	-27.664953°	153.087981°
Barrier Type	Weir	
Barrier Name	Demeio Park	
Fishway Type Needed	Full-width Rock Ramp	
Approx. Cost of Fishway	\$50 k - \$80 k

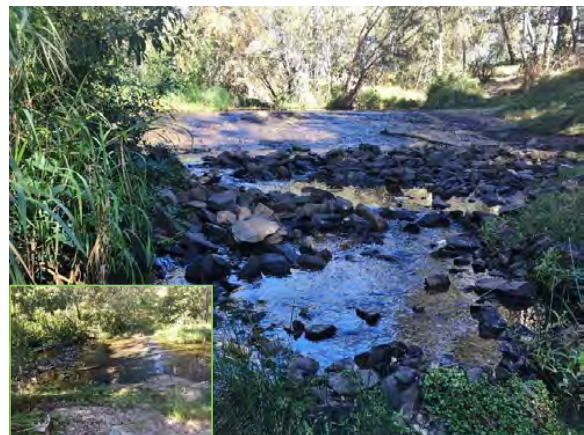
Overall Priority	47	
LGA/LGA Priority	MBRC	14
Barrier ID	3953	
Stream Name	Six Mile (Elimbah) Creek	
Location	-26.997845°	152.918202°
Barrier Type	Relic Causeway	
Barrier Name	Beerburum West State Forest	
Fishway Type Needed	Removal	
Approx. Cost of Fishway	\$4 - 8 k

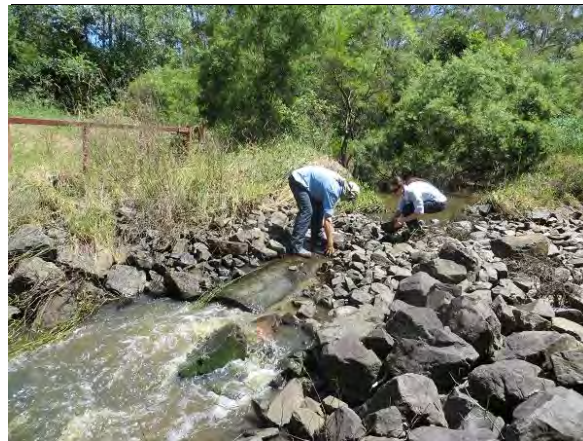
Overall Priority	47	
LGA/LGA Priority	GCCC	9
Barrier ID	7749	
Stream Name	Pimpama River	
Location	-27.790614°	153.269688°
Barrier Type	Pipe Causeway	
Barrier Name	Relic barrier in GC train corridor	
Fishway Type Needed	Removal	
Approx. Cost of Fishway	\$5 - \$15 k

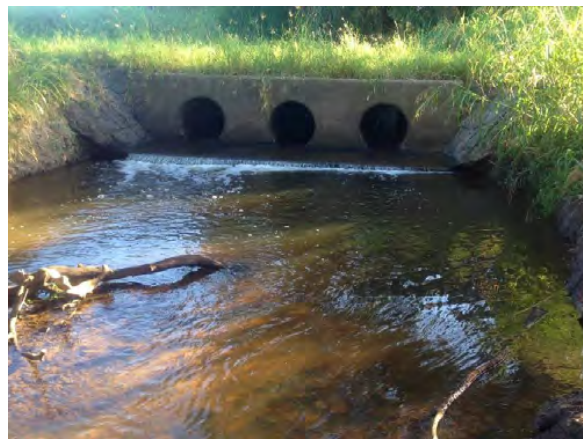
Overall Priority	47	
LGA/LGA Priority	MBRC	14
Barrier ID	2417	
Stream Name	Bells Creek	
Location	-27.252733°	153.092914°
Barrier Type	Culverts + Concrete lined drain	
Barrier Name	Bells Paddock Reserve	
Fishway Type Needed	Horizontal & Vertical Baffles	
Approx. Cost of Fishway	\$15 - \$50 k

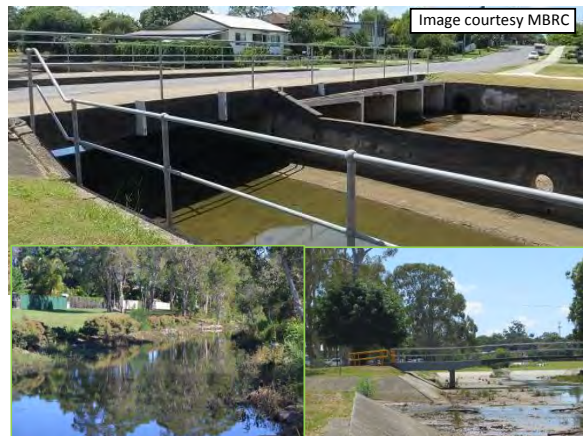
Overall Priority	47	
LGA/LGA Priority	RCC	4
Barrier ID	5071	
Stream Name	Eprapah Creek	
Location	-27.583315°	153.281349°
Barrier Type	Culvert Causeway	
Barrier Name	Redland Bay Road	
Fishway Type Needed	Culvert Baffles	
Approx. Cost of Fishway	\$15 - \$40 k

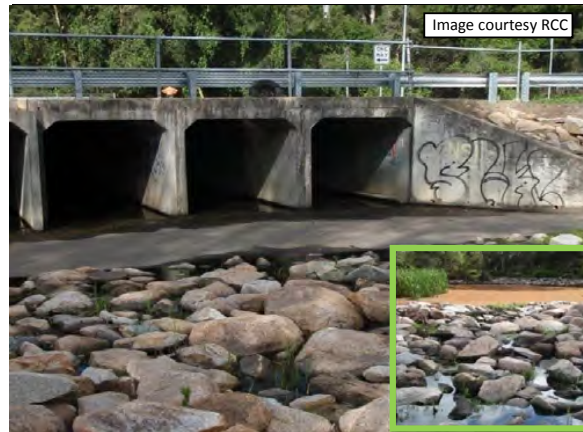
Overall Priority	56	
LGA/LGA Priority	ICC	10
Barrier ID	3953	
Stream Name	Six Mile Creek	
Location	-27.606753°	152.859900°
Barrier Type	Rock Weir	
Barrier Name	Urban Utilities Pipeline barrier	
Fishway Type Needed	Removal/Rock Ramp	
Approx. Cost of Fishway	\$10 - \$40 k

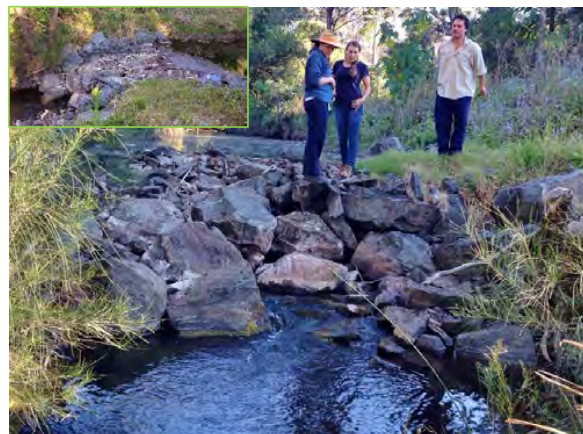
Overall Priority	56	
LGA/LGA Priority	MBRC	18
Barrier ID	1264	
Stream Name	Cedar Creek	
Location	-27.338880°	152.882218°
Barrier Type	Perched Culvert Causeway	
Barrier Name	Hanson Road	
Fishway Type Needed	New culverts/ Rock Ramp	
Approx. Cost of Fishway	\$40 - \$80 k

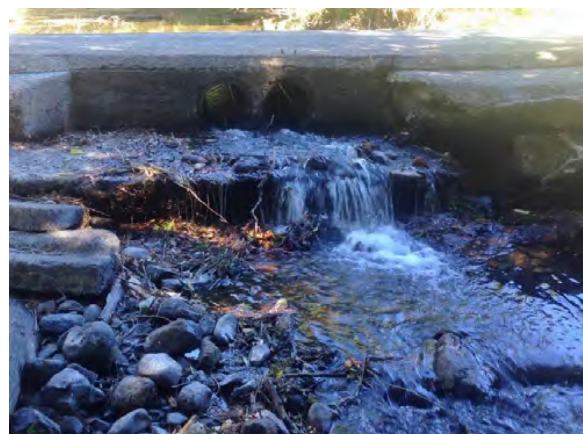
Overall Priority	56	
LGA/LGA Priority	LCC	15
Barrier ID	10540	
Stream Name	Oxley Creek	
Location	-27.728289°	152.948461°
Barrier Type	Perched Culvert Causeway	
Barrier Name	Roberts Road	
Fishway Type Needed	New culverts/Rock Ramp	
Approx. Cost of Fishway	\$40 - \$80 k

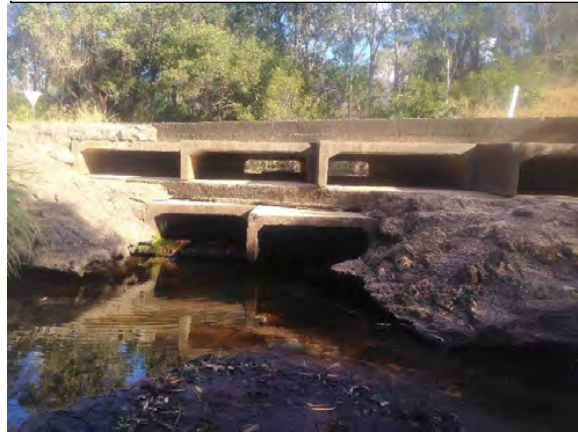
Overall Priority	56	
LGA/LGA Priority	RCC	5
Barrier ID	4850	
Stream Name	Tarradarrapin Creek	
Location	-27.490879°	153.220676°
Barrier Type	Culvert Apron Drop	
Barrier Name	Dorsal Drive	
Fishway Type Needed	Retro-fit Cone/Rock Ramp	
Approx. Cost of Fishway	\$50 - \$80 k

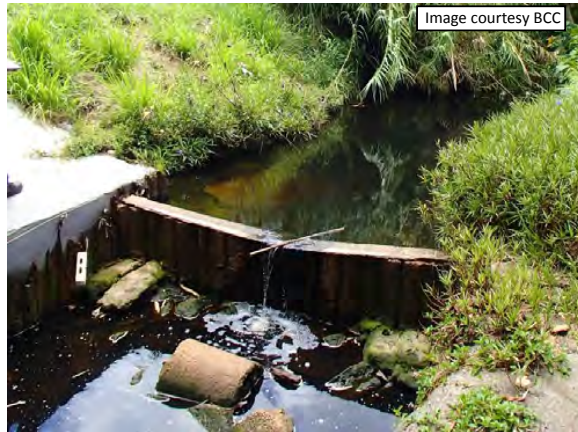
Overall Priority	56	
LGA/LGA Priority	BCC	15
Barrier ID	4256	
Stream Name	Wynnum Creek	
Location	-27.440850°	153.169327°
Barrier Type	Tidal Weir	
Barrier Name	Adjacent Tingal Rd	
Fishway Type Needed	Removal/Rock Ramp	
Approx. Cost of Fishway	\$4 - \$30 k

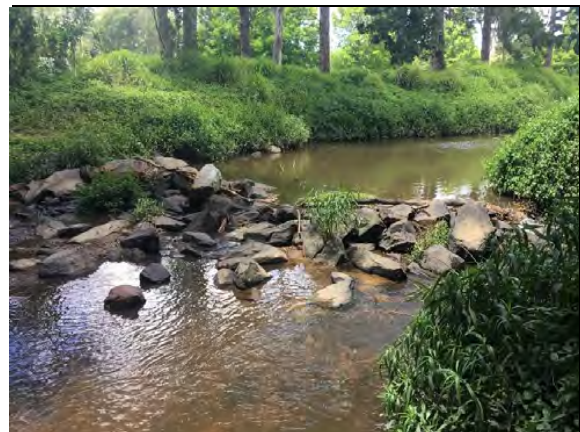
Overall Priority	56	
LGA/LGA Priority	GCCC	10
Barrier ID	7811	
Stream Name	Pimpama River	
Location	-27.787995°	153.268460°
Barrier Type	Culvert Causeway	
Barrier Name	Stewarts Road	
Fishway Type Needed	Rock Ramp + Baffles/Box Culverts	
Approx. Cost of Fishway	\$30 - \$70 k

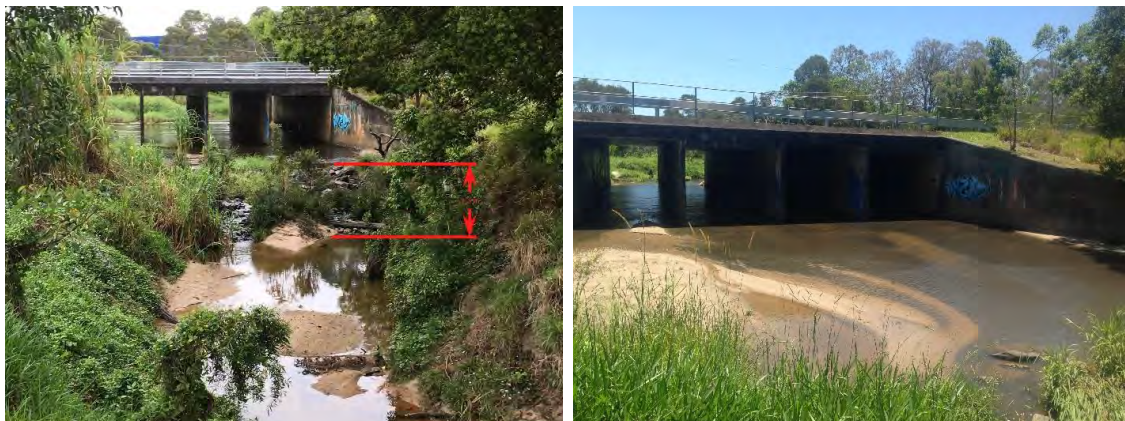
Barrier Ranking	36 th in the Greater Brisbane region
Barrier Type(s)	Surface drop, water depth and flow velocity
Total Surface Drop (head loss)	1.8 m, consisting of 0.5 m through culverts and 1.3 m off culvert apron
Best Remediation Method	Combination of nature-like partial-width rock-ramp and horizontal culvert baffle fishways
Length of Fishway	91 m
Number of Ridges	17 ridges in rock-ramp, 10 horizontal culvert baffle ridges
Drops Between Pools	80 mm for rock-ramp & 50 mm for the horizontal baffles
Slots (number & type)	4 slots, consisting 2 x high flow and 2 x low flow
Total Construction Time	3 weeks
Total Rock Used	783 t – predominantly consisting of large rock: 1.2 - 3 m (up to 11 t)
Total Overall Cost	\$ 124 000

Figure 20. Left; showing the 1.3 m surface drop barrier off the downstream face of the culvert apron. Right; showing stream flow spread out across all four box culverts creating a shallow water surface barrier along the entire 50 m length of the structure. During stream flow events the culverts also created a flow velocity barrier.

The remediation of the Paradise Road overpass barrier in Slacks Creek was undertaken in partnership between Logan City Council and Catchment Solutions. The Paradise Road overpass was ranked the 36th highest priority barrier in the GB region. A fish passage options assessment was undertaken to determine the most appropriate fish passage solution at this site. The investigation determined that a combination of two fishway designs would provide suitable fish passage; rock-ramp fishway to assist fish ascending the concrete culvert apron drop, and a series of horizontal concrete baffles retrofitted to the base of the culverts to assist fish passage through the 50 m long culverts (500 mm head loss).

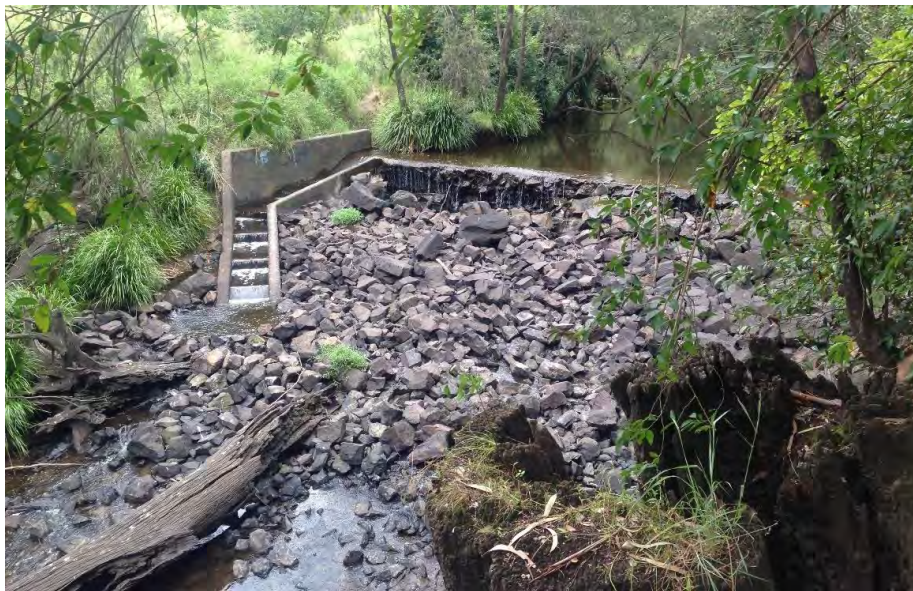
Barrier Ranking	7 th in Greater Brisbane region
Barrier Type(s)	Surface drop
Total Surface Drop	2.4 m
Best Remediation Method	1:33 Partial- width rock-ramp fishway + 1:15 full width
Length of Fishway	90 m
Number of Ridges	33
Drops Between Pools	75 mm
Total Construction Time	3 weeks
Total Rock Used	480 t
Total Overall Cost	\$ 96 000

Figure 23. Berrys Weir fish barrier before remediation works, with relic north- American style fish ladder visible down left side of weir

The remediation of Berrys Weir with rock-ramp fishway on the Bremer River was undertaken in partnership between Ipswich City Council and Catchment Solutions in 2016. Berrys Weir was the 7th highest priority ranked fish barrier in the Greater Brisbane region. The 2.4 m high weir was constructed in the 1960's to impound water for power generation (Stanwell). A fish passage options assessment determined that a partial width rock-ramp fishway would be the best remediation option at this site.

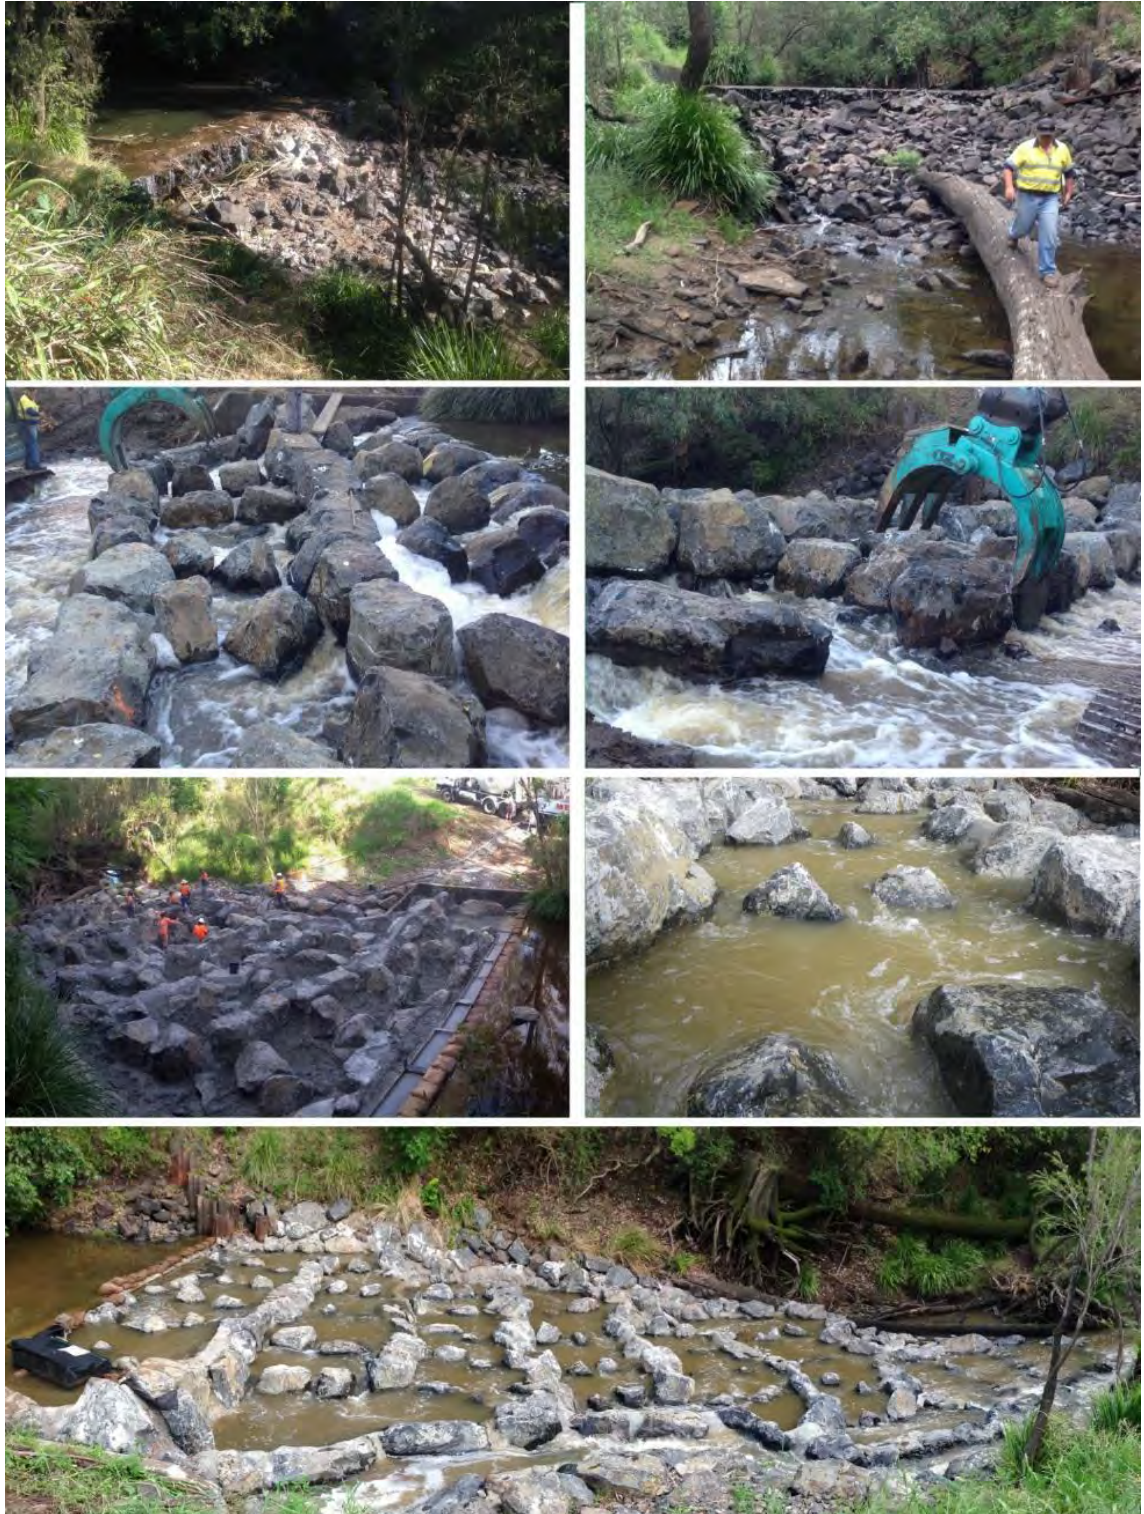
Figure 24. Berrys Weir fishway construction images

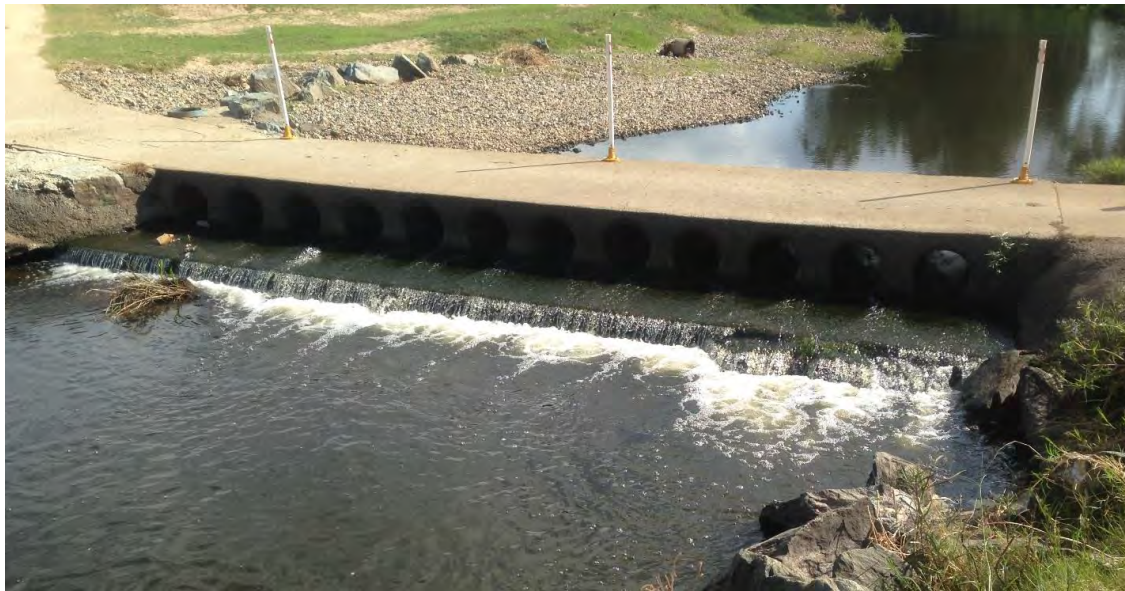
Figure 26. Showing Leitchs Crossing fish barrier prior to fishway construction

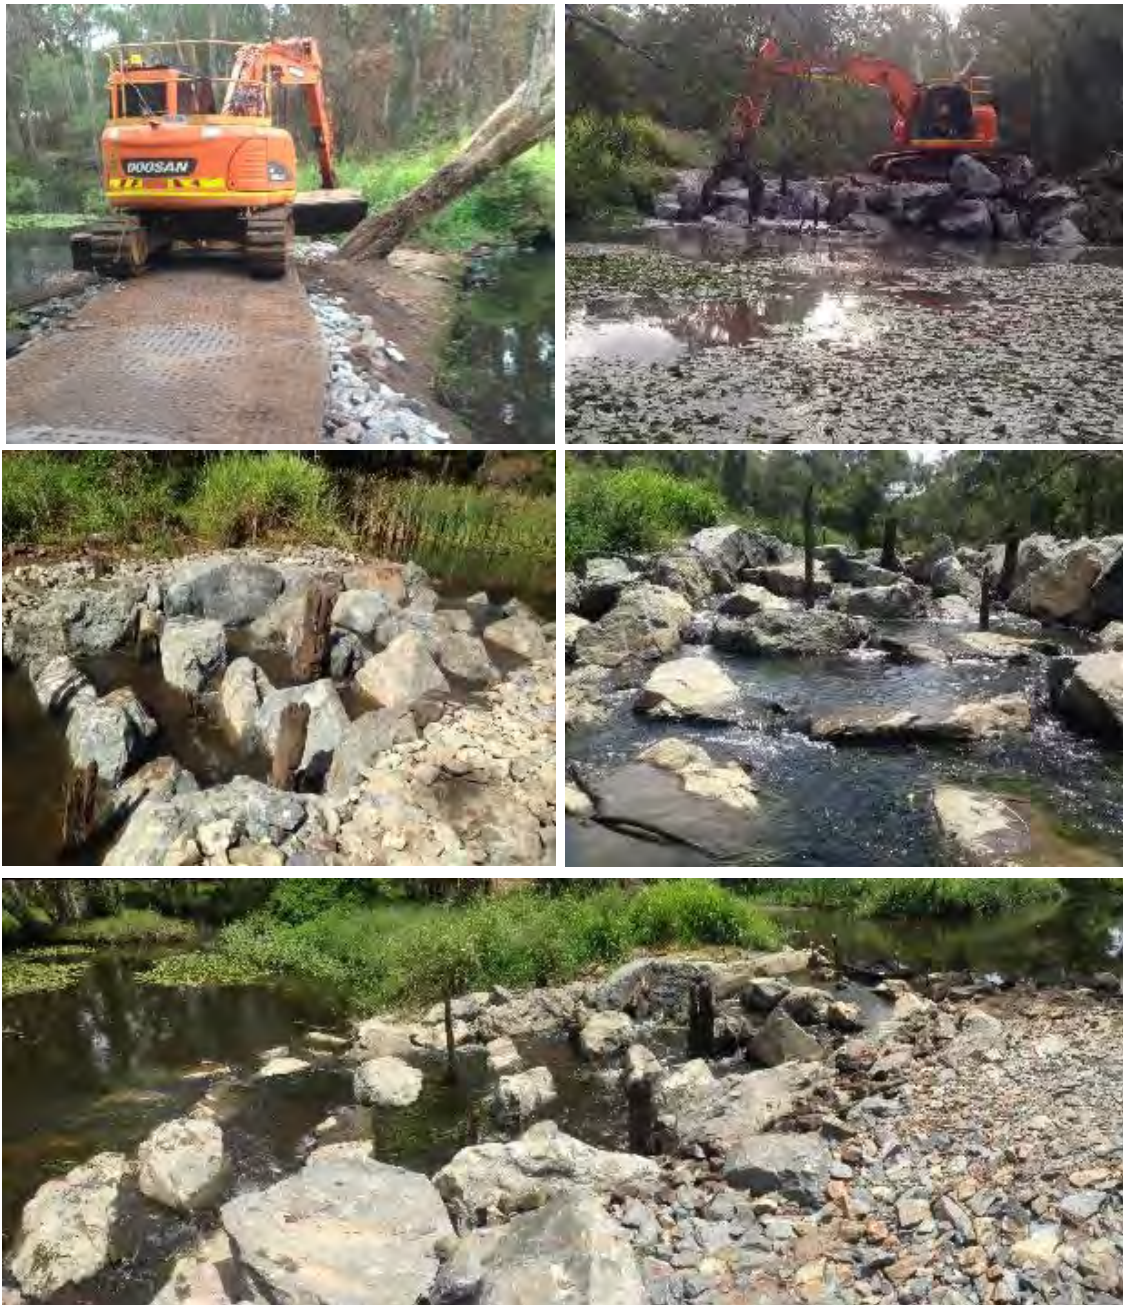
Figure 30. Showing construction images of Hilliards Creek fishway

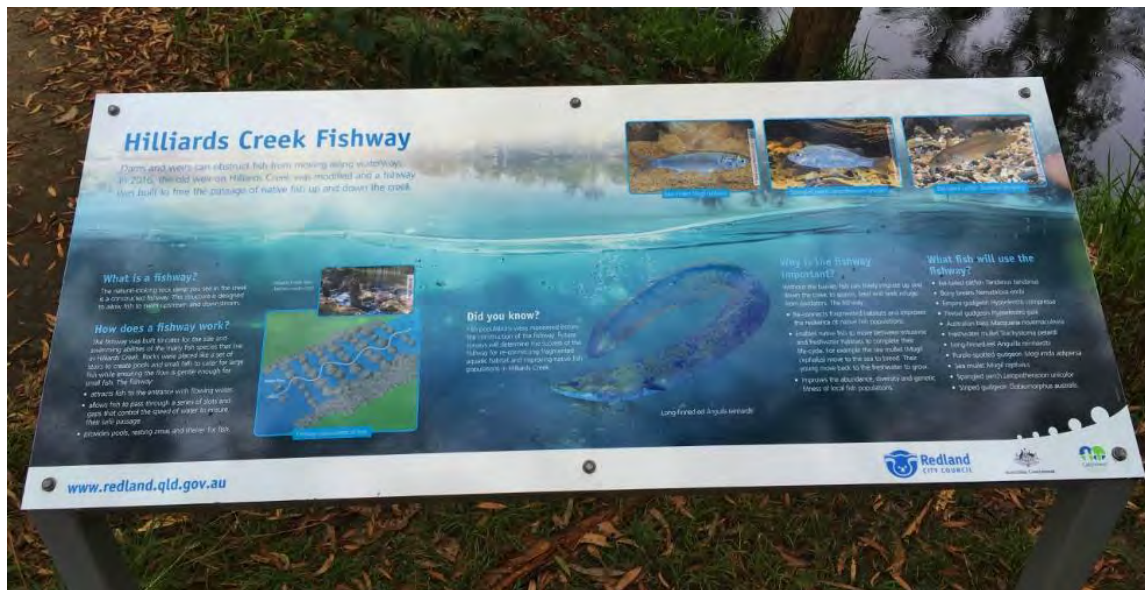
Hilliards Creek Fishway, Redland City Council

Figure 38. Example informative fishway sign which could be installed at a fish passage remediation site to inform the local community regarding the many benefits of improved aquatic connectivity and describe how fishways operate. Fishway Sign designed and installed by Redland City Council.

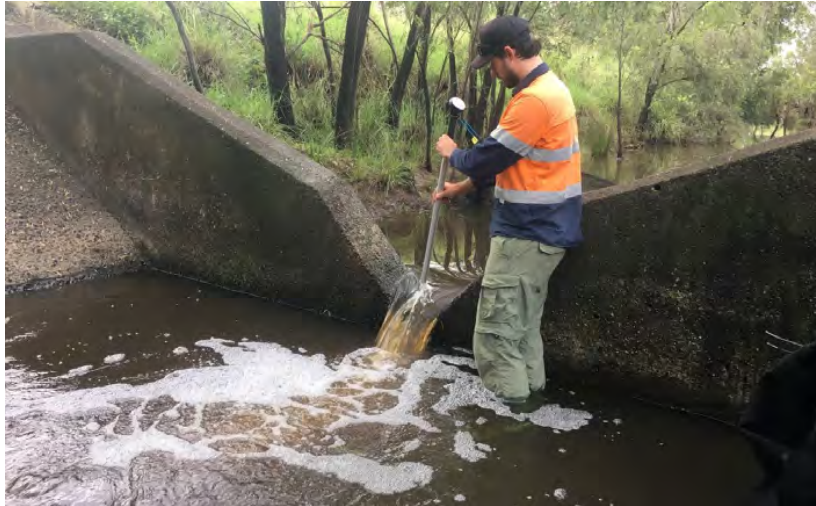
The barrier consists of a vertical concrete wall intersecting the full width of the stream, with a deep V-notch groove formed within the concrete to create a channel of flow for stream height gauging (Figure 4). In total, the estimated head loss from upstream to downstream of the barrier was 300 mm, whilst the estimated drop from the lowest point of the notch to the water surface downstream was 80 mm.

Figure 4. Measuring the velocity through the concrete v-notch gauging station barrier at Walloon in the lower reaches of the Bremer River.

The findings of the current study demonstrate that the Bremer River v-notch gauging weir at Walloon is severely impacting fish passage within the Bremer River catchment. Although eight species were able to ascend the barrier in low abundance (during low flow conditions), five species were not, including economically important eel sp., and bullrout, agassiz's perchlett, dwarf flathead gudgeon and mosquitofish. Furthermore, the catch rate of fish downstream of the weir (35.4 fish/hour) was more than eight times higher than upstream (4.33 fish/hour), further highlighting the impact of this weir on fish passage.

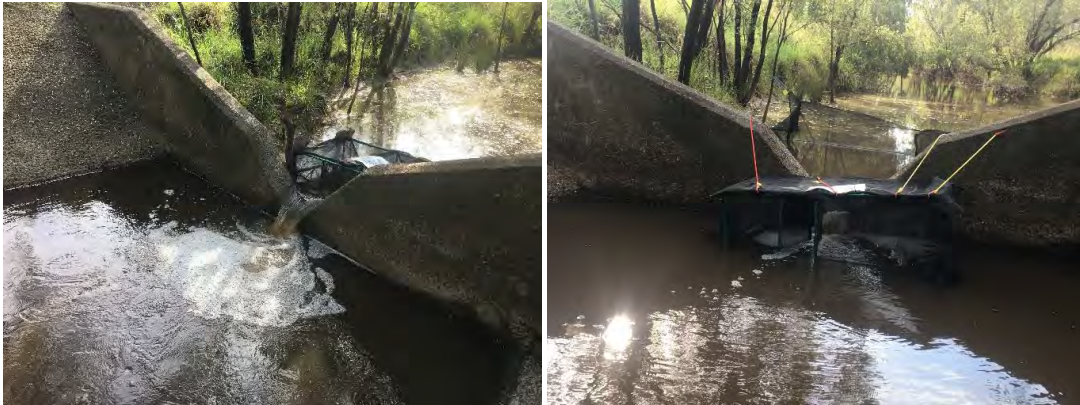
The trap configuration included a single cone entrance. The frame was covered with shade cloth (4.0 mm mesh size). The trap dimensions were 1400 mm x 1000 mm x 1100 mm. Shade cloth wing walls were used to prevent fish from swimming around and underneath the trap, whilst sand bags were used to secure the trap and wing walls in place. The fish trap positioned immediately above the barrier was set for 24.25 hours (Figure 5). Following trapping above the barrier, the trap was set up below the v-notch to sample fish attempting to migrate past the barrier. The entrance to the fish trap was positioned directly in-line with the prevailing stream flow exiting through the v-notch. Fish possess an inherent behavioural response to swim upstream during stream flow events (rheoreaction), attracting fish attempting to migrate upstream into the trap (Wang, 2008). The fish trap was left in place below the barrier for a total of 21.75 hours (Figure 5)

Figure 5. Fish trap set above the V-notch gauging barrier (left), and below the barrier (right)
