Figure 18. Location and overall priority rank of the top 50 barriers to fish passage in the GB region.

Discussion

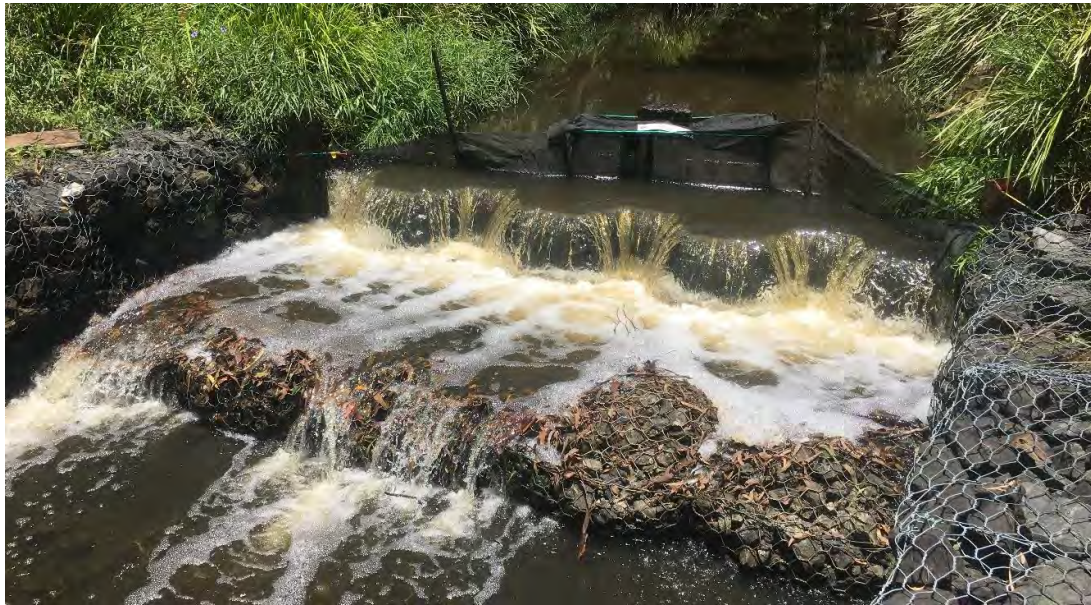
Above the barrier, a fishway trap (Figure 11) was used for sampling. The trap configuration included a single cone entrance. The frame was covered with shade cloth (4.0 mm mesh size). The trap dimensions were 1400 mm x 1000 mm x 1100 mm. Shade cloth wing walls were used to prevent fish from swimming around and underneath the trap, whilst sand bags were used to secure the trap and wing walls in place. The fishway trap was positioned immediately above the barrier was set for a total of 45.25 hours.

Figure 11. Image of fishway trap and wing wall assembly set above the Warrill Creek sheet pile weir

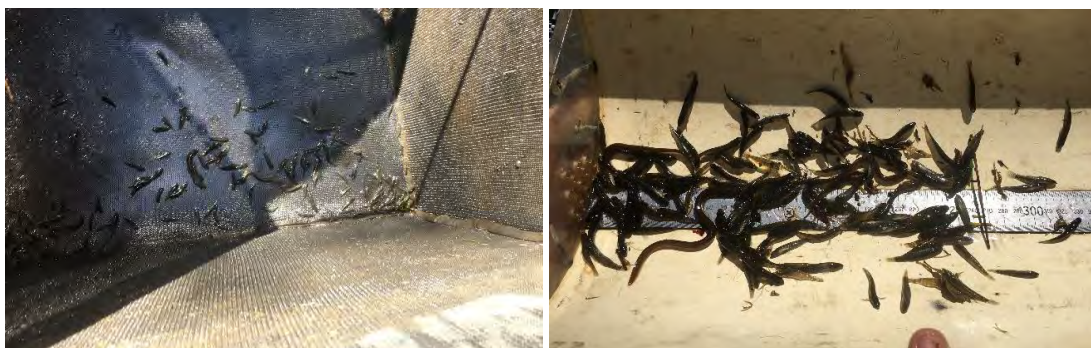
After 45.25 hours of trapping above the Warrill Creek sheet pile barrier, only two species were captured including striped gudgeon (*G. australis*) and eel sp. (*Anguilla species*) at an overall catch rate of 2.8 fish per hour (Figure 13). In total, 116 Striped gudgeon and 3 eel sp. were captured at catch rates of 2.7 and 0.07 fish per hour respectively (Table 3).

Figure 13. Showing juvenile striped gudgeon and eel sp. successful at ‘climbing’ the sheet pile weir.

The findings of the current study demonstrate that the 'Runnymede' sheet pile weir on Warrill Creek is significantly impacting fish passage. Approximately 80% of the fish species sampled directly under the weir were not recorded in the fish trap upstream. Additionally, the two species that were recorded in the upstream trap, striped gudgeon and eel sp., possess a unique ability to climb wet vertical surfaces, allowing them to ascend some barriers. The number of these species captured upstream of the weir was relatively low compared to the number observed downstream. If the fish observed below the weir were attempting to move upstream, this may be an indication that the weir is still impeding passage of striped gudgeon and eel sp. This is supported by concurrent fish trap monitoring at Berrys weir fishway, where striped gudgeon was recorded successfully ascending the fishway at a catch rate 1284 fish per day, compared to just 64 striped gudgeon per day successful at ascending the sheet pile weir, which is located only 10 km further upstream.

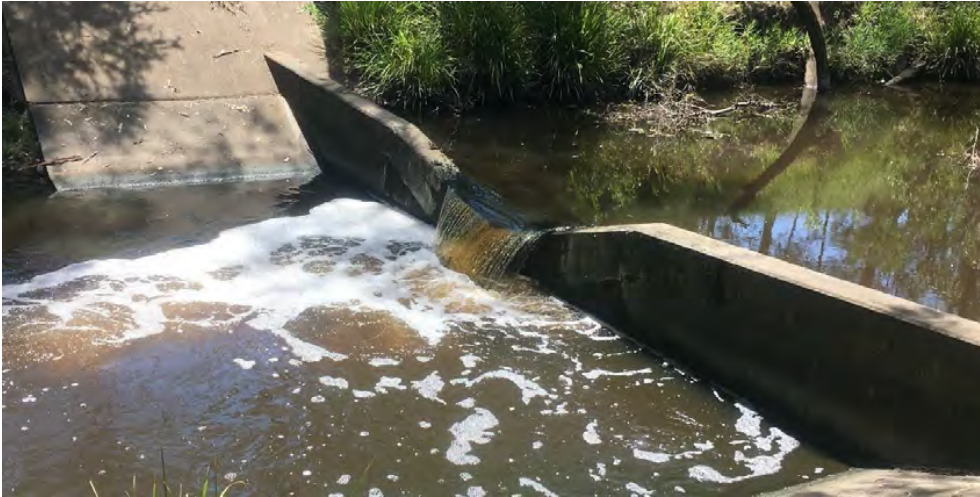
A second barrier was identified in Warrill Creek only 600 m upstream of the sheet pile barrier (Figure 16). This concrete v-notch gauging station weir poses similar threats to the sheet pile barrier

downstream, restricting upstream passage of juvenile and adult native fish. Surveying was intended to take place on this barrier, however site constraints made surveys difficult. The substantial water depth ($\geq 1.5\text{m}$) on the upstream side of the weir meant that a fish trap could not be set up successfully i.e. a trap could not be set up to prevent fish from going under or around the trap. In lieu of this, waterproof cameras were set up at the barrier across two consecutive days for a total of three hours.

Figure 16. V-notch gauging station weir identified approximately 600 m upstream of sheet pile barrier

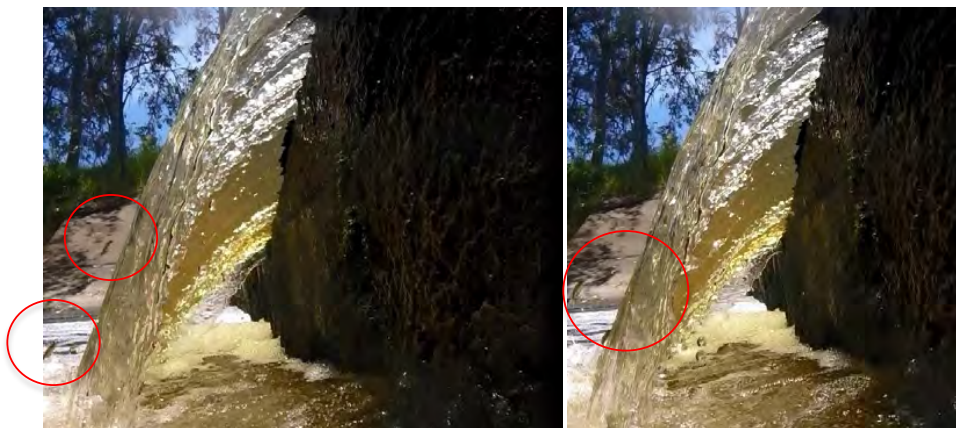
No fish were captured successfully leaping over the weir crest or climbing the weir wall during camera monitoring. At least two (potentially more) Duboulay's rainbowfish were sighted in the footage unsuccessfully attempting to leap past the weir (Figure 17).

Although the monitoring duration was short, no fish were captured in the footage ascending the barrier. Duboulay's rainbowfish were captured attempting to ascend by 'leaping' towards the water flowing through the v-notch (Figure 16). It is possible that some striped gudgeon and eel sp. are able to ascend this weir. However, unlike the sheet pile weir, where potential 'climbing' fish only have to negotiate a short distance of $\sim 10\text{ mm}$ (sheet pile width) with extremely high velocity (as water shoots past the barrier) the width of the gauging weir is approximately 20 times greater. This distance fish has to travel while negotiating high velocities potentially reduces the likelihood of 'climbing' fish ascending this barrier. Along with the sheet pile barrier, the impacts of this gauging station weir warrant further investigation and remediation works to restore connectivity along Warrill Creek

Figure 17. Showing video footage of Duboulay's rainbowfish attempting to 'leap' past the Warrill Creek gauging weir

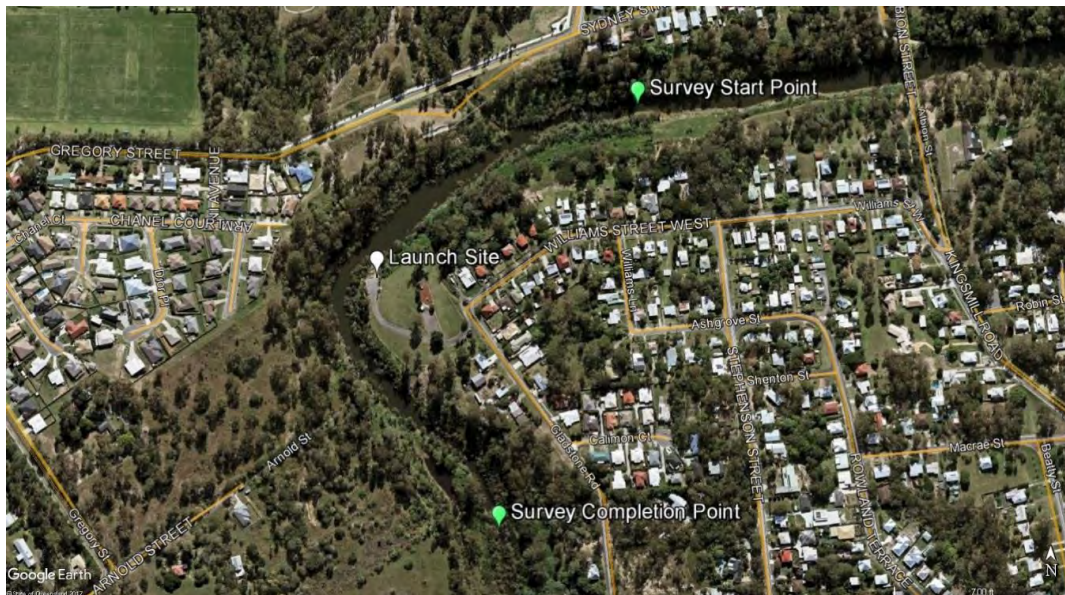
Figure 19. Stretch of river approximately five kilometres downstream of the Berry's weir fishway that electrofishing surveys were conducted, accessed through Shapcott Park (Imagery: Google Earth)

Downstream of the fishway, a suitable stretch of river was identified in the lower reaches of the Bremer River close to the city of Ipswich, approximately five kilometres downstream of the fishway. This reach was accessed through a small boat ramp at Shapcott Park in Ipswich, where an approximate 650 m stretch of river was electrofished (Figure 19). The upper extent of the site was characterised by deeper water with a large number of trees on the streambanks providing cover, and also a large number of log jams within the stream. The lower reaches of the site were dominated by in-stream rock bars and shallower, faster moving water. Overall, habitat condition at this site was excellent.

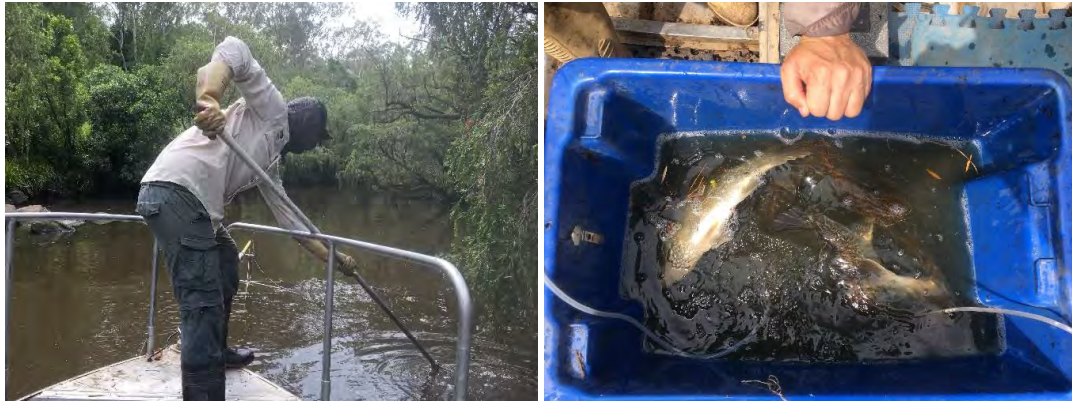
Figure 20. Electrofishing dip- netter extracting stunned fish from the water (left) and an aerated tub of fish on board the vessel after being electrofished (right)

Electrofishing surveys were conducted using a small boat electrofishing unit (Electrolyte). Electrolyte is a 3.7 m vessel which operates a Smith-Root 2.5 GPP electrofisher unit, equipped with a single boom arm, six dropper anode array and hull cathode. An operator and single dip-netter was utilised during electrofishing operations (Figure 20).
