CONSERVATION AND ENVIRONMENT COMMITTEE AGENDA

4. PRIORITISATION AND IDENTIFICATION OF FURTHER FISH BARRIER WORKS

The following Greater Brisbane Fish Barrier Prioritisation (GBFBP) has been developed to assess and rank fish passage barriers having the greatest impacts on freshwater fish communities of the GB region. Low passability barriers located within close proximity to the tidal interface on high ordered waterways have the greatest impact on freshwater fish community condition in coastal Queensland catchments. This is largely due to the ability of these barriers to prevent or impede juvenile diadromous species from undertaking longitudinal life-cycle dependant migrations upstream into important nursery habitats. A single low passability barrier located on the tidal interface has the potential to exclude almost half (44%) of the 50 native freshwater fish species recorded in GB freshwater environments (Rolls et al. 2013; 2014).

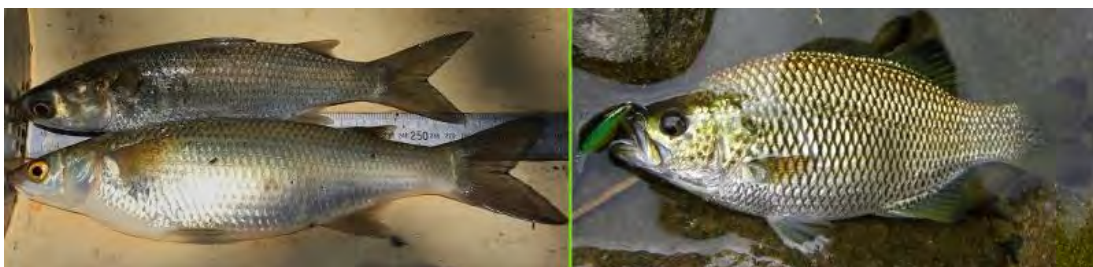
Figure 1. Diadromous fish species impacted by barriers: sea mullet (*M. cephalus*) (top left), freshwater mullet (*T. petardi*) (bottom left) and jungle perch (*K. rupestris*) (right). Sea and freshwater mullet (sampled from the Bremer River) form important recreational, commercial and indigenous fisheries, while jungle perch are a highly prized recreational fishing species.

In addition to their ecosystem service value, diadromous species are also recognised as contributing significant societal values, comprising high value commercial, recreational and Indigenous fisheries. Historically, sea mullet (*Mugil cephalus*) (Figure 1) and long-finned eels (*Anguilla reinhardtii*) have been established as important food sources for indigenous people (Barnett and Ceccarelli, 2007). Today, both sea mullet and long-finned eels form important commercial fisheries, with sea mullet forming the most important commercial inshore net fishery in South-East Queensland (Williams, 2002). Diadromous species are also important recreationally, in particular Australian bass (*Perca latipes*), jungle perch (Figure 1), mangrove jack (*Lutjanus argentimaculatus*), tarpon (*Megalops cyprinoides*) sea mullet and freshwater mullet (*Trachystoma petardi*) (Figure 1). Healthy, sustainable populations of these species have the ability to attract fisherman to local coastal communities, providing valuable social and economic benefits. Ensuring connectivity between habitats is therefore a critical component in managing aquatic environments, and crucial to securing the long-term sustainability of important fisheries that underpin the social fabric of many coastal Queensland communities.

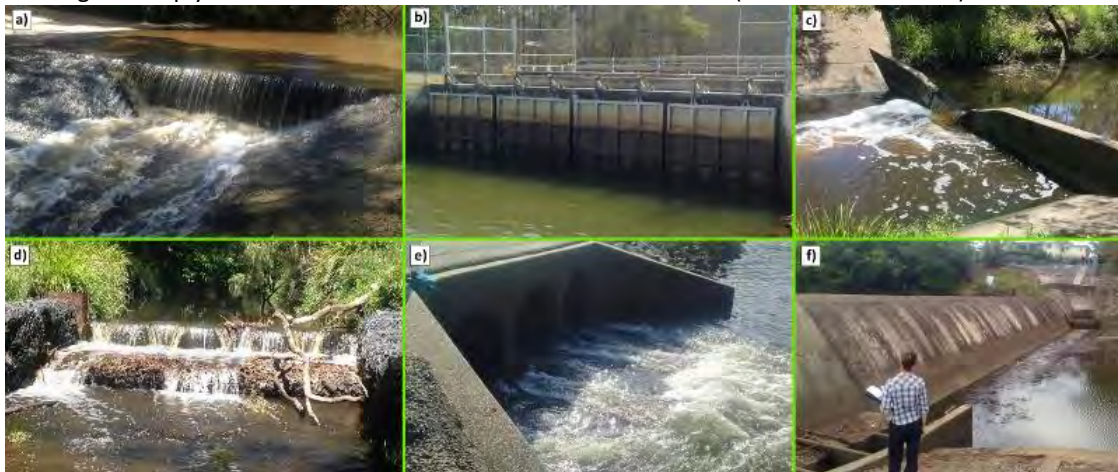
Figure 2. Barrier structures: a) Road causeway & concrete apron (Elimbah Ck), b) tidal floodgates (Behm Ck), c) V-notch stream gauging weir (Warrill Ck), d) Sheet pile and gabion basket weir (Warrill Ck), e) pipe culvert causeway (Albert River) and f) Tidal barrage (Caboolture River).

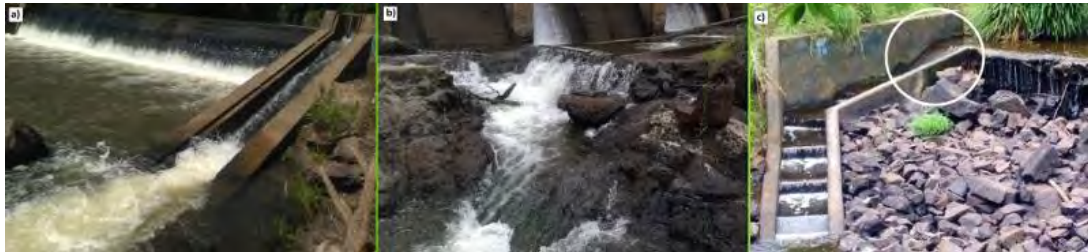
Figure 3. Showing northern hemisphere 'salmonid' style fishway designs exhibiting hydraulic conditions in excess of the swimming abilities of most native freshwater fish species. a) Denil fishway located on Luscombe Weir (Albert River, QLD) showing steep gradient and excessive velocities (note baffles removed). b) Showing the bottom section of the Mt Crosby weir pool and weir fishway (Brisbane River). Note the inadequate fishway entrance with excessive turbulence associated with the large water surface drop and shallow entrance pool and c) Pool and weir fishway located on the Bremer River (Berrys Weir). The exit of this style of fishway has a 600 mm high drop and velocities during base flows of 3.3 m/sec.

(Figure 3), without proper provision of pool depth. Turbulence is most often encountered during medium and high flow conditions.

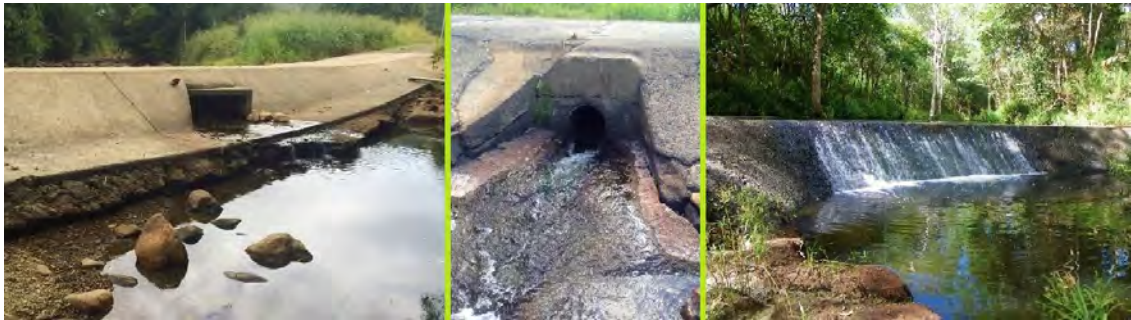
Figure 4. Left to right: Culvert causeway displaying a water surface drop, shallow water surface (through culvert and on apron) and velocity barrier (during medium- high flow conditions) exacerbated due to a culvert diameter <60% of stream width; Pipe causeway displaying velocity and behavioural barriers (dark shadows/insufficient lighting in pipe) and water surface drop barrier.

- Water surface drop – Vertical drop off road crossings, weirs and culvert aprons that are greater than 200 mm in waterways close to the freshwater/estuarine interface and 300 mm in headwater/high gradient streams (Figure 4).
- Turbulence – The motion of water having local velocities and pressures that fluctuate randomly. This is often observed downstream of culvert aprons, weirs, pipes and poorly designed fishways

- Water Depth – Shallow water depth of 5 mm - 100 mm depending on species, size and morphology. Larger bodied demersal species are affected greater. Shallow water is often experienced during low flow conditions across road crossings, through culverts and across culvert aprons (Figure 4).

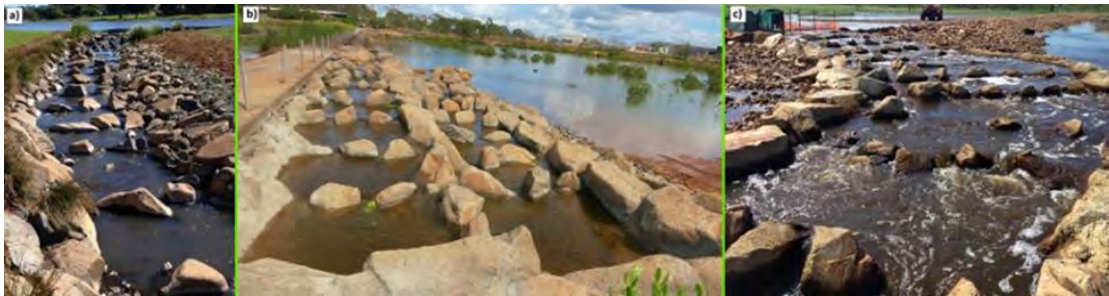
Figure 6. Nature like rock-ramp fishways: a) Full width (Gooseponds Ck, Mackay), b) Dog-leg (Lake Callemondah, Gladstone) c) Partial width (Tedlands Ck, Koumala)

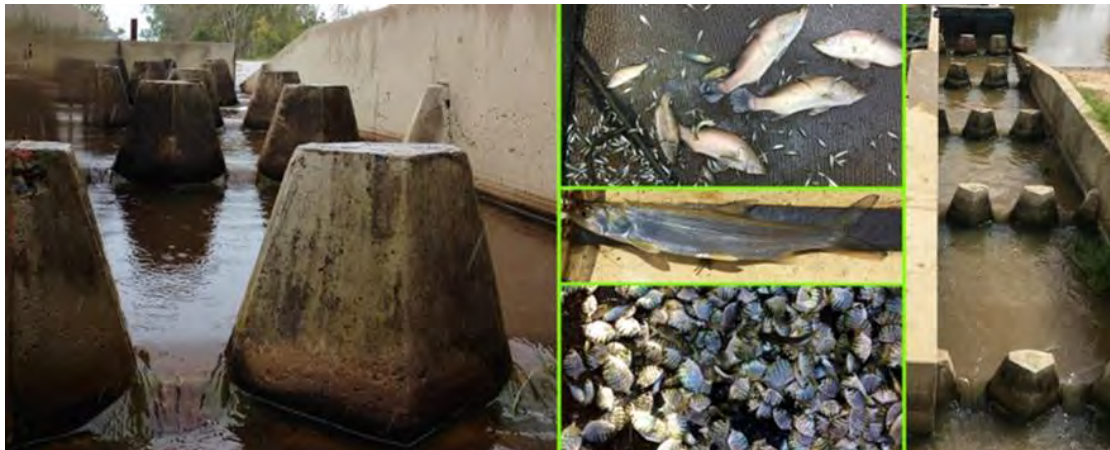
Figure 7. Concrete cone fishway on Boundary Creek, Koumala; showing fish successful at ascending, top to bottom; juvenile barramundi and empire gudgeon, giant herring & over one thousand juvenile banded scats & threadfin - silver biddy.

In an operational sense cone fishways are similar to rock-ramps, comprising of a series of pools interspersed at regular intervals by ridges within a channel on a minimum gradient of approximately 1:20. The main differences between the two fishway types, centers around the prefabrication of materials and unnatural appearance for cone fishways in comparison to the natural appearance of materials used for rock-ramps. Cone fishways have the added advantage of requiring less space than for rock-ramps and can be extremely useful when rock is in short supply e.g. Southern Gulf in northern Australia, as the side walls and cone ridge components can be prefabricated off site (Table 2). The highly engineered structural nature of cone fishways (Figure 7) ensures flow characteristics are also more consistent between ridges when compared to rock-ramps. Conversely, the smooth sided internal walls of cone fishways lack the surface roughness and micro-eddies associated with rock-ramps, which assist the migration of weaker swimming species.

The ridge components of cone fishways can be prefabricated using concrete or HDPE plastic. The pre-cast concrete or plastic cone ridges are inserted into a concrete channel creating a pool upstream and a small drop downstream. Generally, this type of fishway is more expensive to construct due to the cost of the pre-cast components and increased installation time when compared to rock-ramps.

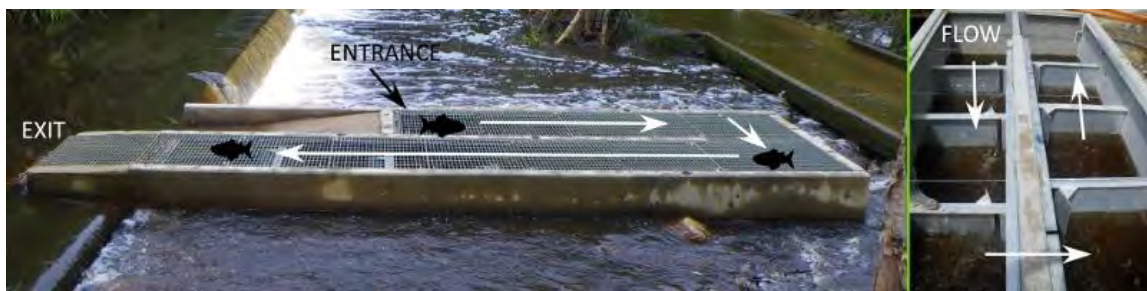
Figure 8. Showing a vertical-slot fishway on Waterpark Creek, Byfield. Note: The partial width nature and small entrance of vertical-slot fishways means it may be difficult for fish to locate the entrance.

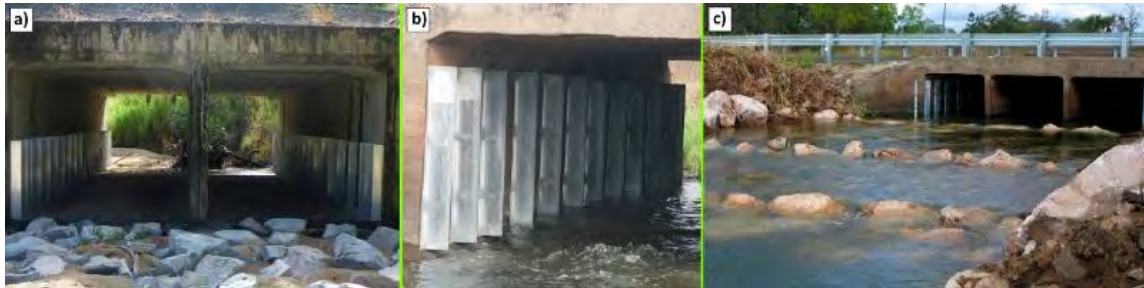
Figure 9. a) Vertical culvert baffles with scour protection (Aims Rd, Townsville) b) Close up view of vertical baffles retrofitted to a culvert c) Vertical baffles in conjunction with a rock-ramp fishway (Sheepstation Creek, Ayr).

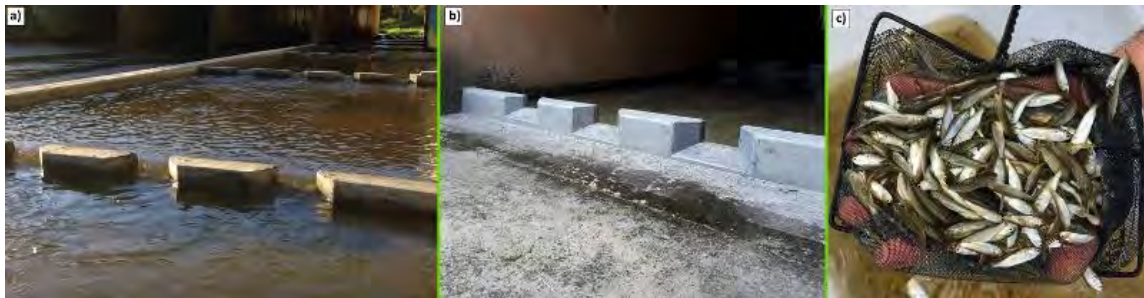
Figure 10. a) Retrofitting horizontal culvert baffles in operation under Paradise Road on Slacks Creek. Note: Nib wall to divert all base attraction flows down the fishway. Prior to remediating this barrier, the flow was spread out across four 2.4 m wide culvert barrels creating a shallow water surface barrier under base flow conditions. b) Horizontal baffles with the boxing recently removed c) Predominantly showing Juvenile sea mullet and striped gudgeon captured successfully ascending through the horizontal culvert baffle fishway at catch rates of 256 and 793 individuals per day respectively.

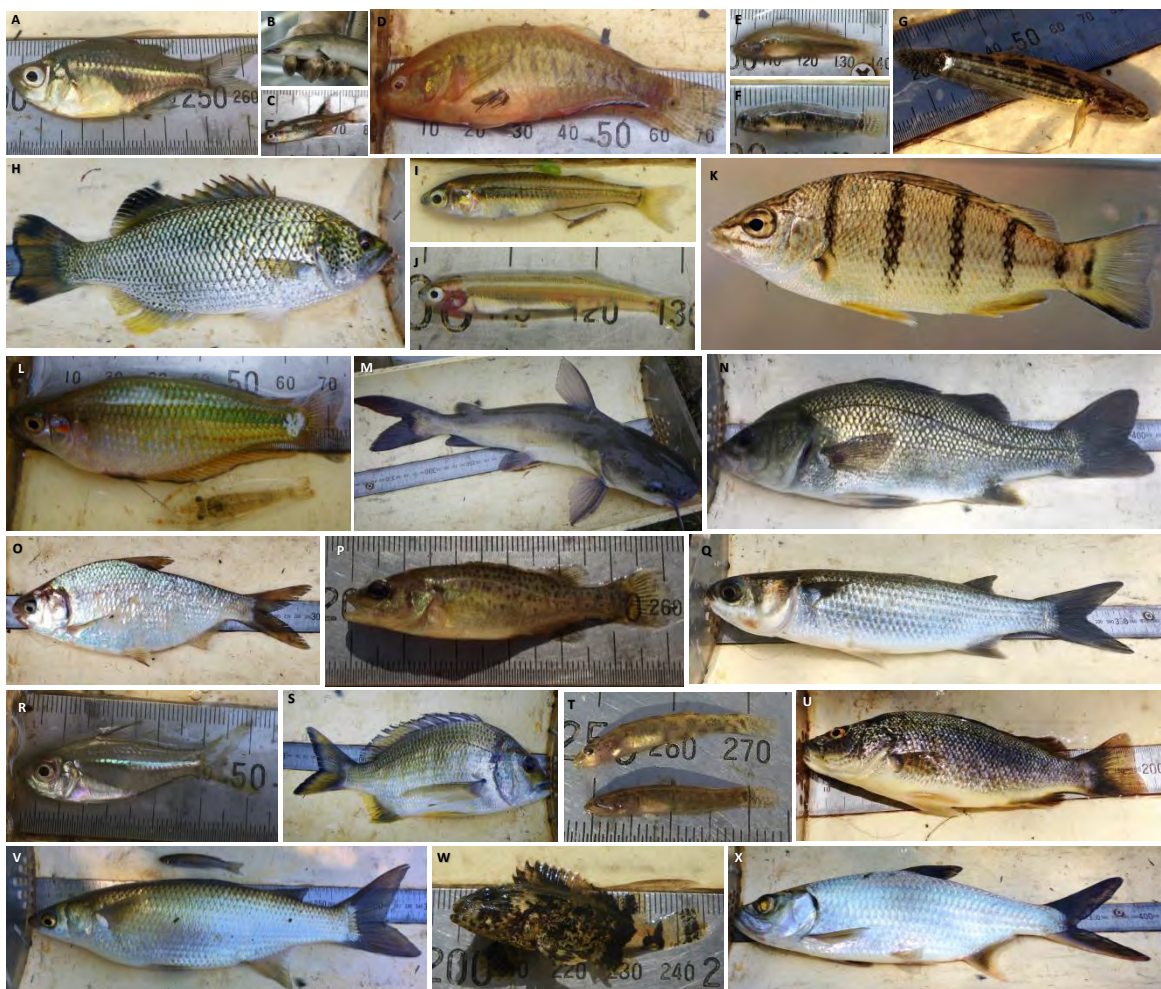
Figure 13. Showing fish species occurring in SEQ waterways. See Table 6 for common and species name.

Table 6. Freshwater fish species recorded in SEQ waterways, including migration class, common name, species name and importance to commercial, recreational, indigenous or aquarium trade fisheries. Note: Letter e.g. (A) after common name refers to species with a fish image in Figure 13 above.

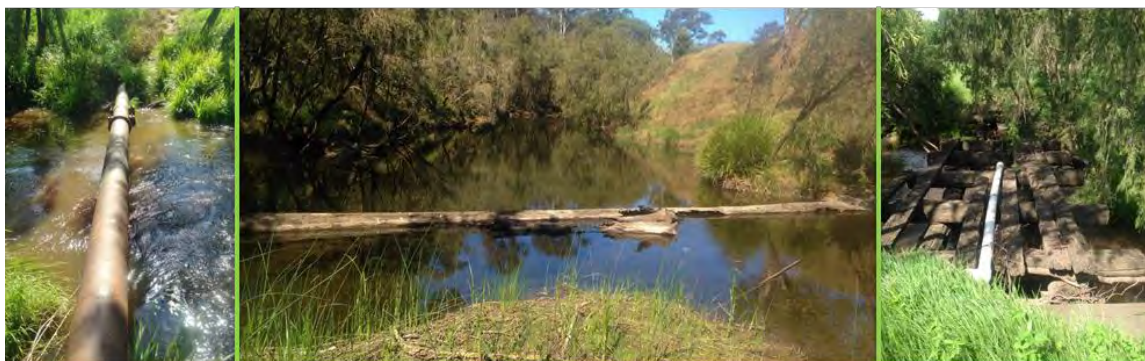
Figure 14. Showing example potential barriers identified via aerial imagery & assessed in the field as not affecting fish passage

A total of 522 potential barriers were assessed in the field during the second stage of the prioritisation. Actual barriers to fish passage accounted for 264 (51%) of the field validated potential barriers (Figure 17), the remaining 258 non-barriers predominantly consisted of bridges, logs (Figure 14), bed control structures and full-width culvert configurations constructed within the stream bed and/ or with a low flow channel and roughening. A further 217 potential barriers were removed via desktop that were identified on local government structure inventories and confirmed by respective council officers as total span bridges. The 264 fish barriers were assessed against site specific ecological criteria set out for stage 2, before advancing to stage 3 of the prioritisation process. The tidal causeway barrier on Elimbah Creek (barrier ID 3728) was the highest scoring barrier in stage 2, scoring 23 out of a maximum 25 points, to bring its combined stage 1 and 2 score to 52 points and an overall rank of 1. Four fish barriers recorded the equal second highest score (22) in stage 2; Luscombe Weir on the Albert River (ID 10352), Caboolture River Barrage (ID 13941), and Pimpama River (ID 13801) and Behm Creek (ID 13800) Tidal Floodgates.

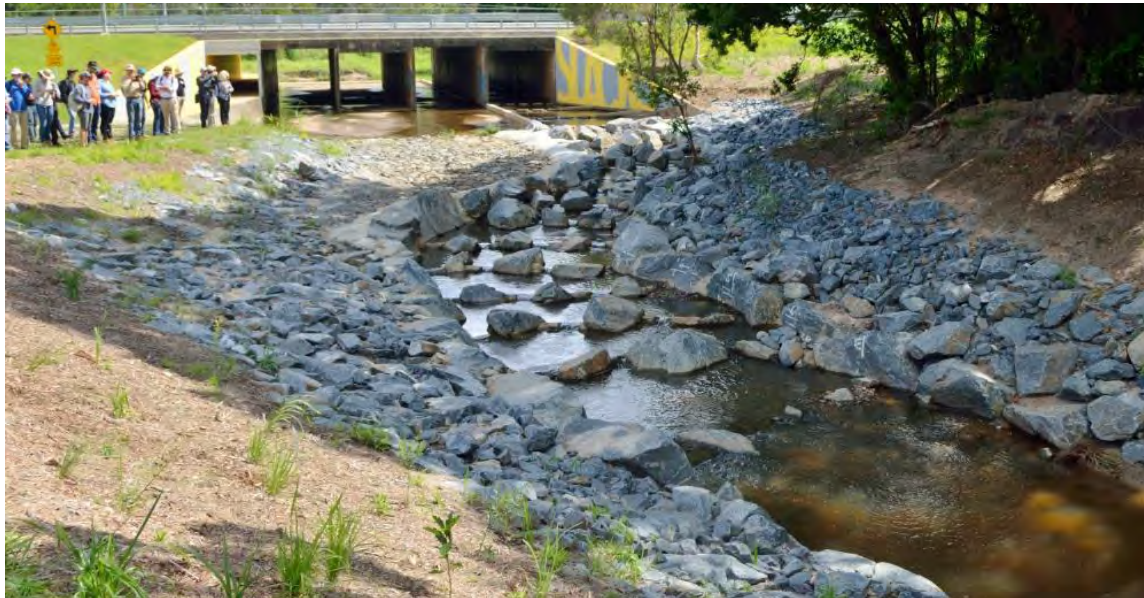
Figure 15. Showing one of the four priority ranked barriers remediated as part of this project; Slacks Creek, (Paradise Road) 17 ridge rock-ramp and horizontal culvert baffle fishway (photo courtesy of Leo Lee).

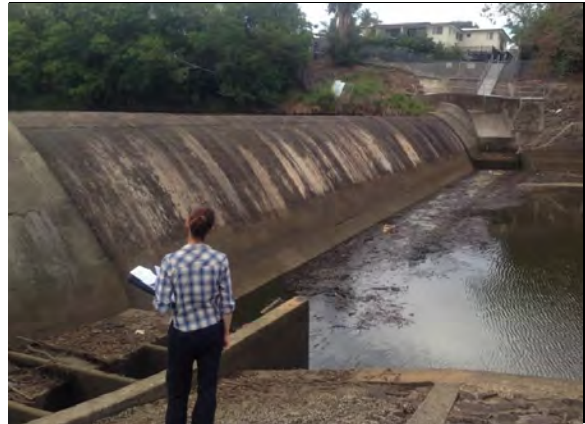
Overall Priority	1	
LGA/LGA Priority	MBRC	1
Barrier ID	13941	
Stream Name	Caboolture River	
Location	-27.086745°	152.957708°
Barrier Type	Redundant Tidal Barrage	
Barrier Name	Caboolture Weir	
Fishway Type Needed	Bypass R.Ramp/Retrofit Cone	
Approx. Cost of Fishway	\$180 - \$250k

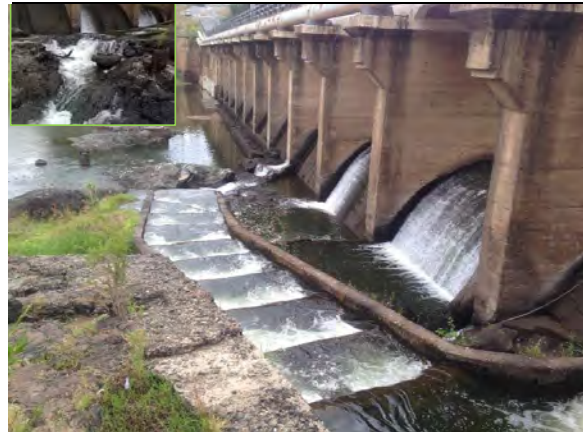
Overall Priority	3	
LGA/LGA Priority	BCC	1
Barrier ID	12850	
Stream Name	Brisbane River	
Location	-27.537293°	152.797935°
Barrier Type	Weir	
Barrier Name	Mt Crosby Weir	
Fishway Type Needed	Concrete Cone	
Approx. Cost of Fishway	\$800 k - \$1 .1 million

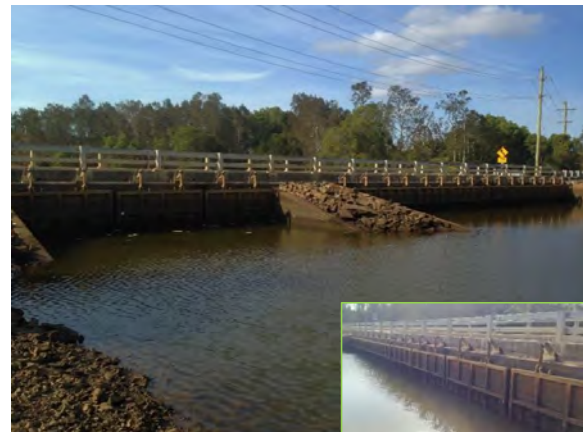
Overall Priority	5	
LGA/LGA Priority	GCCC & LCC	3 & 2
Barrier ID	10351	
Stream Name	Albert River	
Location	-27.775037°	153.186256°
Barrier Type	Tidal Pipe Causeway	
Barrier Name	Stanmore Road	
Fishway Type Needed	Bridge/Culverts	R.Ramp/Cone
Approx. Cost of Fishway	\$100-\$300 k	\$50-\$90 k

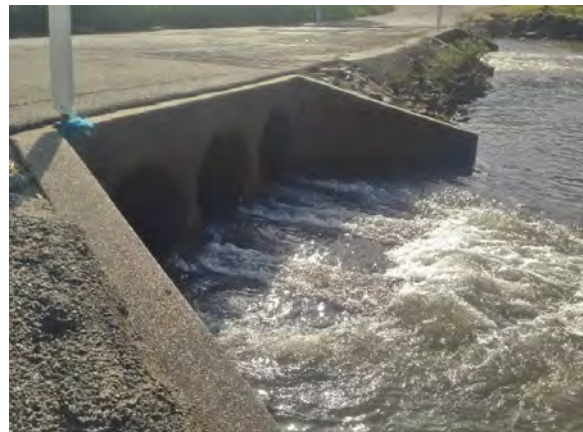
Overall Priority	7	
LGA/LGA Priority	RCC	1
Barrier ID	4374	
Stream Name	Tingalpa Creek	
Location	-27.528354°	153.180559°
Barrier Type	Dam	
Barrier Name	Leslie Harrison Dam	
Fishway Type Needed	Fish Lift/Cone	
Approx. Cost of Fishway	\$1-2 million

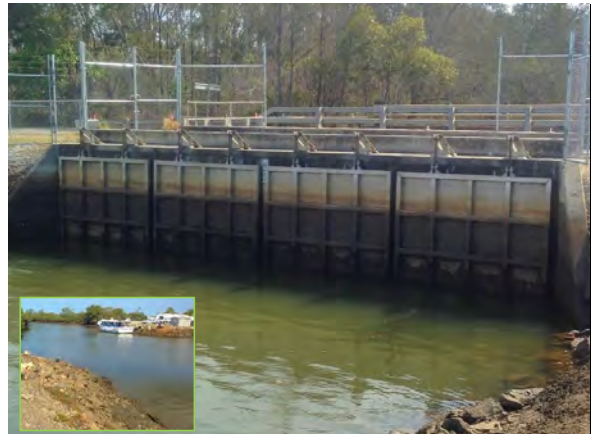
Overall Priority	9	
LGA/LGA Priority	MBRC	3
Barrier ID	218	
Stream Name	South Pine River	
Location	-27.350244°	152.946384°
Barrier Type	Culvert Causeway	
Barrier Name	Bunya Crossing	
Fishway Type Needed	Rock Ramp	
Approx. Cost of Fishway	\$25 - \$40 k

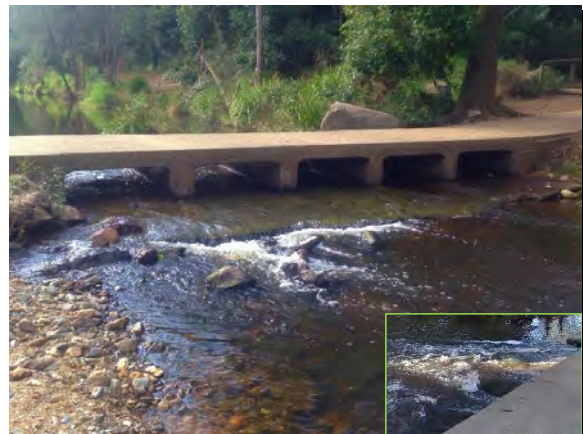
Overall Priority	10	
LGA/LGA Priority	BCC	2
Barrier ID	12199	
Stream Name	Enoggera Creek	
Location	-27.443336°	153.005675°
Barrier Type	Tidal Weir	
Barrier Name	Bancroft Park (Hulme St)	
Fishway Type Needed	Full-width or partial Rock Ramp	
Approx. Cost of Fishway	\$80 - \$100 k

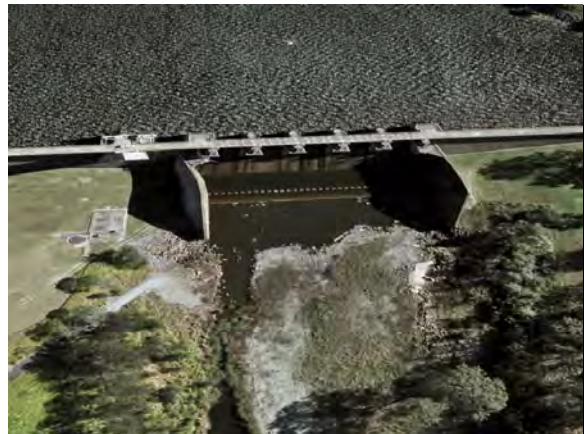
Overall Priority	11	
LGA/LGA Priority	MBRC	4
Barrier ID	2279	
Stream Name	North Pine River	
Location	-27.263543°	152.937002°
Barrier Type	Dam	
Barrier Name	North Pine Dam	
Fishway Type Needed	Fish Lift	
Approx. Cost of Fishway	\$1 - 2 million

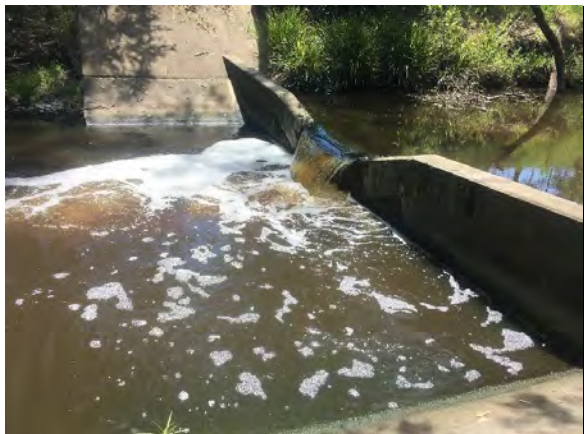
Overall Priority	12	
LGA/LGA Priority	ICC	1
Barrier ID	8231	
Stream Name	Warrill Creek	
Location	-27.659011°	152.698957°
Barrier Type	DNRM V-notch Gauging Weir	
Barrier Name	DNRM Weir	
Fishway Type Needed	Cone (1st ridge) &/or R.Ramp	
Approx. Cost of Fishway	\$70 - \$100 k

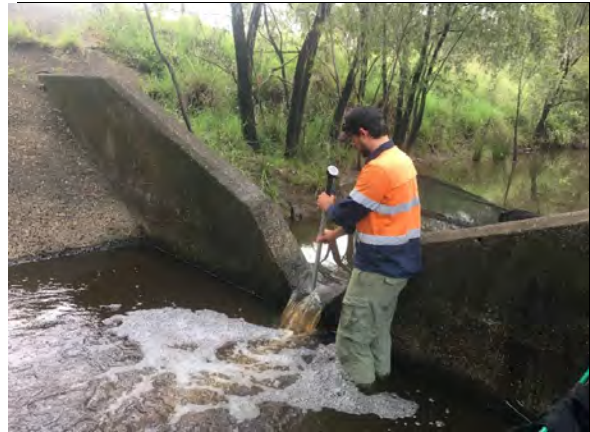
Overall Priority	12	
LGA/LGA Priority	MBRC	5
Barrier ID	2252	
Stream Name	North Pine River	
Location	-27.266964°	152.956523°
Barrier Type	Culvert Causeway	
Barrier Name	Youngs Crossing	
Fishway Type Needed	Rock Ramp + Vertical Baffles	
Approx. Cost of Fishway	\$25 - \$40 k

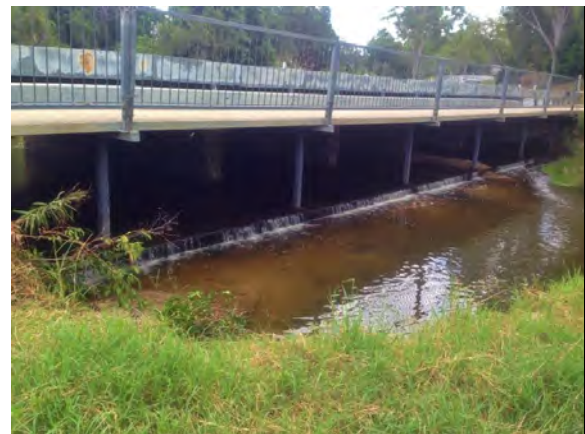
Overall Priority	15	
LGA/LGA Priority	RCC	2
Barrier ID	4876	
Stream Name	Hilliards Creek	
Location	-27.511266°	153.246640°
Barrier Type	Causeway (pedestrian)	
Barrier Name	Fellmonger Park	
Fishway Type Needed	New Culverts + Rock Ramp	
Approx. Cost of Fishway	\$60 - \$100 k

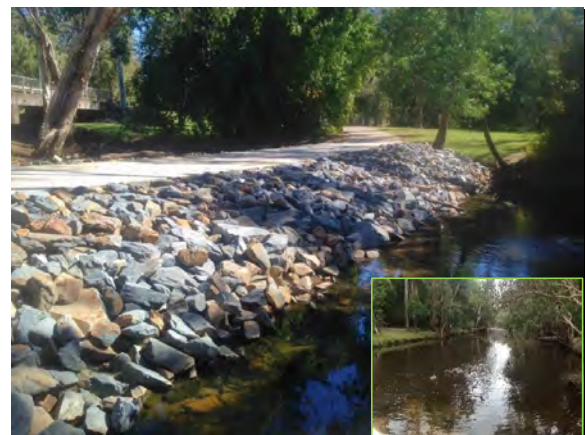
Overall Priority	15	
LGA/LGA Priority	ICC	3
Barrier ID	13807	
Stream Name	Warrill Creek	
Location	-27.602485°	152.695277°
Barrier Type	Weir - Sheet Pile & Gab. Bask.	
Barrier Name	200 m U/S Cunningham Hwy	
Fishway Type Needed	Removal/Full-width R.Ramp	
Approx. Cost of Fishway	\$50 - \$80 k

Overall Priority	Stream Name	Results	Recommendation
Equal 12 th	Warrill Creek	The impact of the barrier is very high. No fish were captured successfully leaping over the weir crest or climbing the weir wall during camera monitoring.	Undertake a design and scope of works for implementation
Equal 12 th	Bremer River (Walloon)	The impact of the barrier is high. 40% of fish species were not able to ascend the barrier, and fish catch rates were a lot higher downstream than upstream.	Undertake a design and scope of works for implementation
Equal 15 th	Warrill Creek (near Runymede trotting stable)	The impact of the barrier is very high. 80% of the fish species sampled at the bottom of the weir were not recorded upstream	Undertake a design and scope of works for implementation

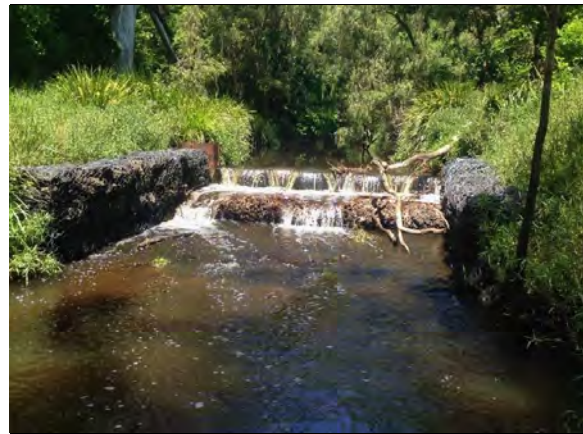
Overall Priority	15	
LGA/LGA Priority	LCC	3
Barrier ID	4170	
Stream Name	Scrubby Creek	
Location	-27.656718°	153.142060°
Barrier Type	Culvert Causeway + Ap. Drop	
Barrier Name	Queens Rd	
Fishway Type Needed	Removal + Bridge	
Approx. Cost of Fishway	\$70 - \$90 k

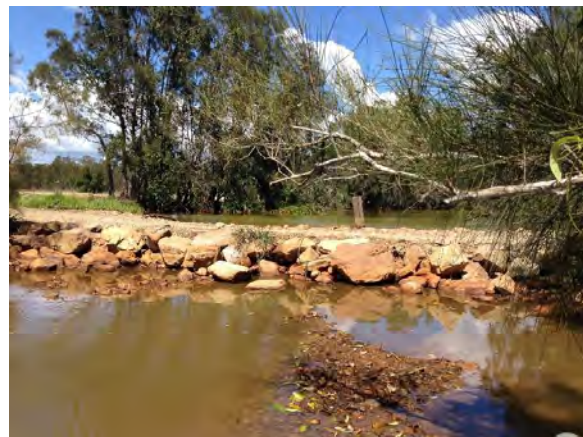
Overall Priority	18	
LGA/LGA Priority	GCCC	5
Barrier ID	13911	
Stream Name	Hotham Creek	
Location	-27.799051°	153.307883°
Barrier Type	Tidal Causeway	
Barrier Name	Sugar Cane Crossing	
Fishway Type Needed	Removal/Rock Ramp	
Approx. Cost of Fishway	\$30 - \$40 k

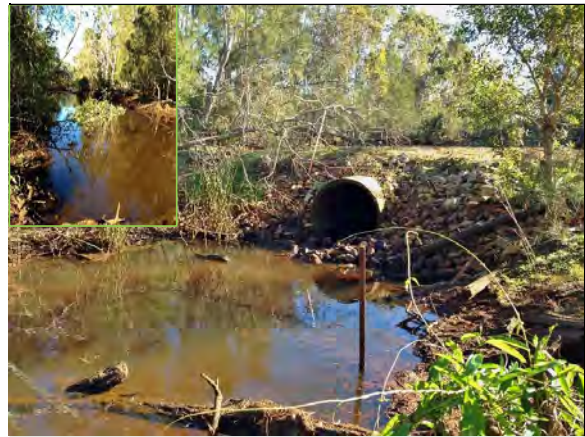
Overall Priority	18	
LGA/LGA Priority	MBRC	6
Barrier ID	10719	
Stream Name	King John Creek	
Location	-27.093888°	153.028851°
Barrier Type	Pipe Causeway	
Barrier Name	Estuary diverted	
Fishway Type Needed	Bed Level Xing &/or R.Ramp	
Approx. Cost of Fishway	\$15 - \$25 k

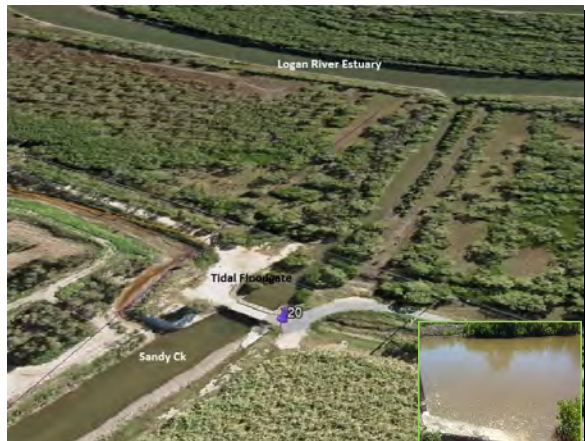
Overall Priority	20	
LGA/LGA Priority	GCCC	6
Barrier ID	5810	
Stream Name	Sandy Creek	
Location	-27.716465°	153.302614°
Barrier Type	New Tidal Floodgate	
Barrier Name	Loves Rd (main west arm)	
Fishway Type Needed	Fish Friendly Auto Tidal Gate	
Approx. Cost of Fishway	*\$25 - \$75 k

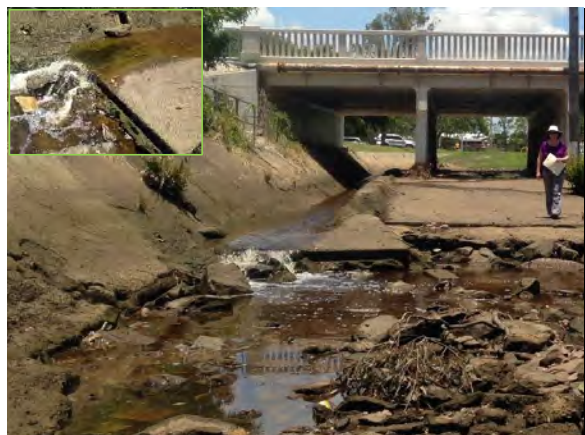
Overall Priority	20	
LGA/LGA Priority	BCC	3
Barrier ID	11864	
Stream Name	Norman Creek	
Location	-27.497907°	153.043011°
Barrier Type	Tidal Culvert Apron Drop ~300mm	
Barrier Name	Logan Road - Hanlon Park	
Fishway Type Needed	R.Ramp/Cone + horizontal baffles	
Approx. Cost of Fishway	\$20 - \$40 k

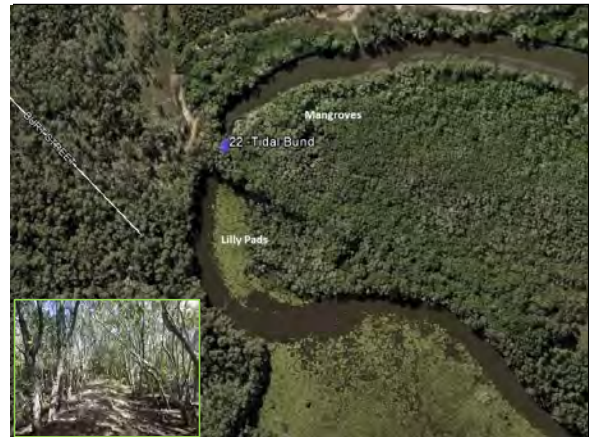
Overall Priority	22	
LGA/LGA Priority	MBRC	7
Barrier ID	2107	
Stream Name	Freshwater Creek	
Location	-27.252072°	153.043054°
Barrier Type	Tidal Bund	
Barrier Name	Hays Inlet FHA	
Fishway Type Needed	Removal/Rock Ramp	
Approx. Cost of Fishway	\$5 - \$30 k

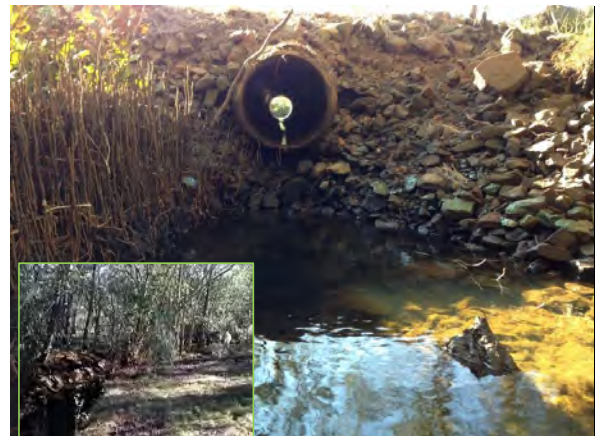
Overall Priority	22	
LGA/LGA Priority	MBRC	7
Barrier ID	13992	
Stream Name	King John Creek	
Location	-27.104366°	153.025763°
Barrier Type	Tidal Pipe Causeway	
Barrier Name	Tidal causeway adj FHA	
Fishway Type Needed	Removal/Bed level Crossing	
Approx. Cost of Fishway	\$5 - \$25 k

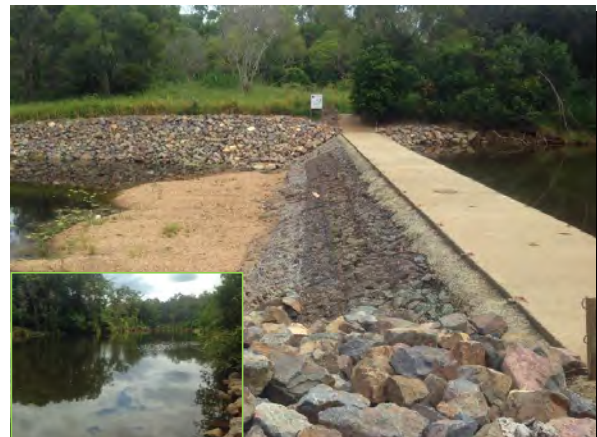
Overall Priority	22	
LGA/LGA Priority	MBRC	7
Barrier ID	2278	
Stream Name	North Pine River	
Location	-27.259740°	152.950767°
Barrier Type	Weir ~2.5 m high	
Barrier Name	Seqwater @ Petrie Town	
Fishway Type Needed	Rock Ramp	
Approx. Cost of Fishway	\$60 - \$90 k

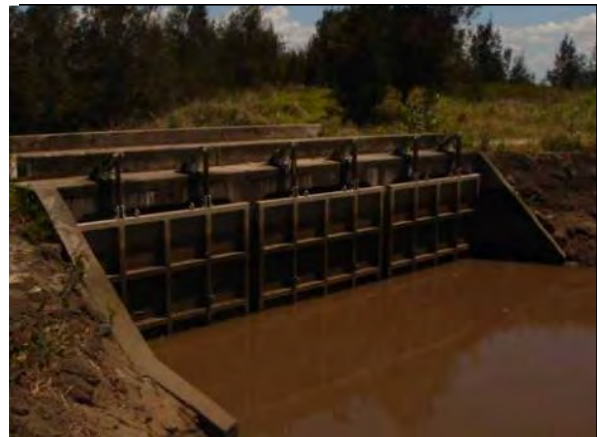
Overall Priority	22	
LGA/LGA Priority	GCCC	7
Barrier ID	5807	
Stream Name	Sandy Creek East	
Location	-27.719208°	153.309700°
Barrier Type	Tidal Floodgate	
Barrier Name	School Rd	
Fishway Type Needed	Fish Friendly Auto Tidal Gate	
Approx. Cost of Fishway	*\$25 - \$75 k

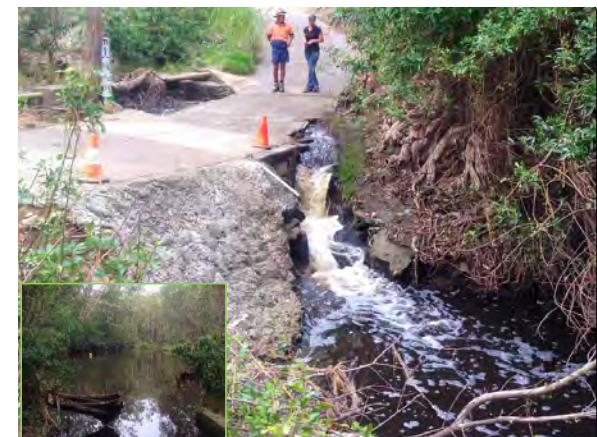
Overall Priority	26	
LGA/LGA Priority	RCC	3
Barrier ID	4890	
Stream Name	Hilliards Creek	
Location	-27.525889°	153.246758°
Barrier Type	Box Culvert Causeway	
Barrier Name	QLD Gov.(DAF) Research Stn.	
Fishway Type Needed	Rock Ramp + Culverts	
Approx. Cost of Fishway	\$60 - \$90 k

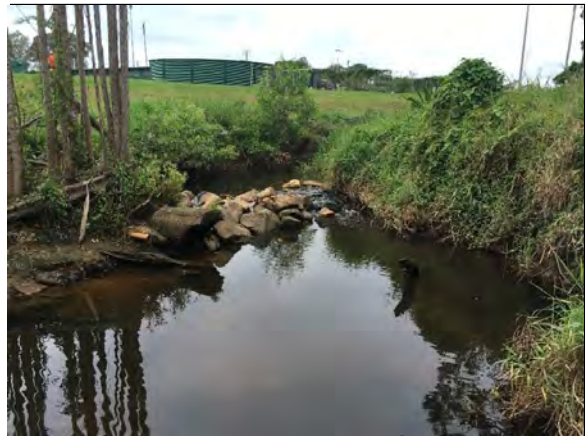
Overall Priority	26	
LGA/LGA Priority	BCC	4
Barrier ID	13996	
Stream Name	Cabbage Tree Creek	
Location	-27.334655°	153.043116°
Barrier Type	Rock Weir	
Barrier Name	Lemke Rd - adj AFL Club	
Fishway Type Needed	Removal/Rock Ramp	
Approx. Cost of Fishway	\$5 - \$10 k

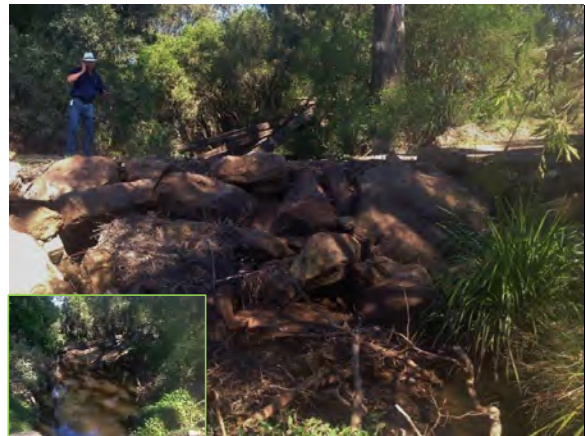
Overall Priority	26	
LGA/LGA Priority	LCC	4
Barrier ID	7083	
Stream Name	Quinze Creek	
Location	-27.755147°	153.115479°
Barrier Type	Causeway	
Barrier Name	D/S Waterford-Tamborine Rd	
Fishway Type Needed	Removal + Bd Level Xing/R.Ramp	
Approx. Cost of Fishway	\$25 - \$60 k

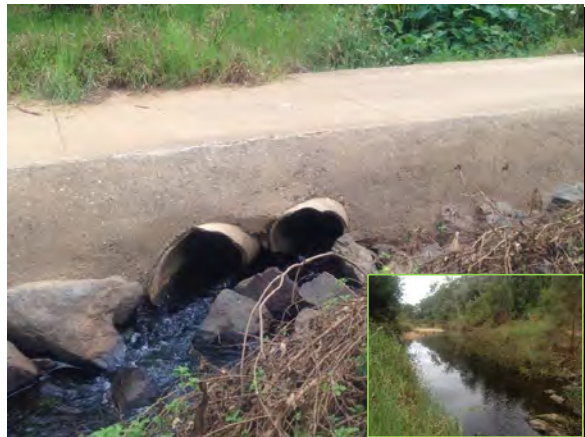
Overall Priority	26	
LGA/LGA Priority	MBRC	10
Barrier ID	13992	
Stream Name	North Pine River	
Location	-27.263190°	152.951383°
Barrier Type	Pipe Culvert Causeway	
Barrier Name	Opposite Old Petrie Town	
Fishway Type Needed	Bed Level Xing/New Culverts	
Approx. Cost of Fishway	\$20 - \$50 k

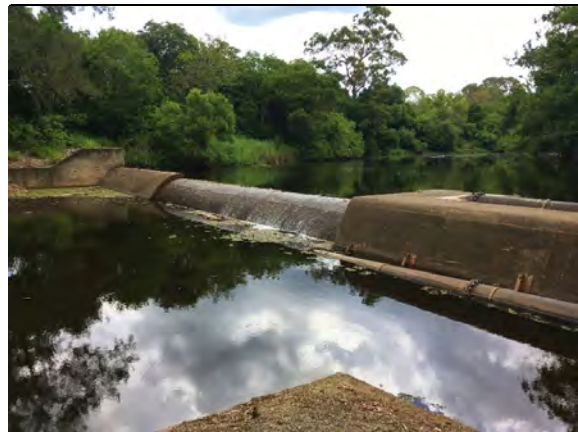
Overall Priority	26	
LGA/LGA Priority	MBRC	10
Barrier ID	13942	
Stream Name	Waraba Creek	
Location	-27.086080°	152.935456°
Barrier Type	Weir	
Barrier Name	Waraba Weir - Caboolture	
Fishway Type Needed	Cone/V-Slot/Bypass R.Ramp	
Approx. Cost of Fishway	\$80 - \$200 k

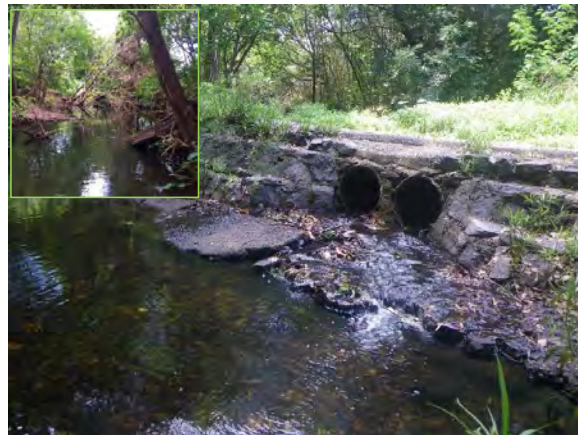
Overall Priority	32	
LGA/LGA Priority	BCC	6
Barrier ID	12435	
Stream Name	Moggill Creek	
Location	-27.513516°	152.927873°
Barrier Type	Pipe Culvert Causeway	
Barrier Name	Kilkivan Avenue	
Fishway Type Needed	Low Flow & High Flow Rock Ramp	
Approx. Cost of Fishway	\$20 - \$80 k

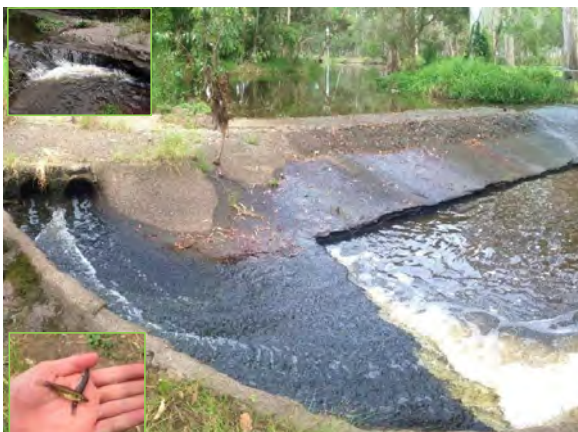
Overall Priority	32	
LGA/LGA Priority	LCC	5
Barrier ID	6387	
Stream Name	Scrubby Creek	
Location	-27.662613°	153.123738°
Barrier Type	Pipe Culvert Causeway	
Barrier Name	Gould Adams Prk - Kingston Rd	
Fishway Type Needed	Full-width Rock Ramp	
Approx. Cost of Fishway	\$60- \$100 k

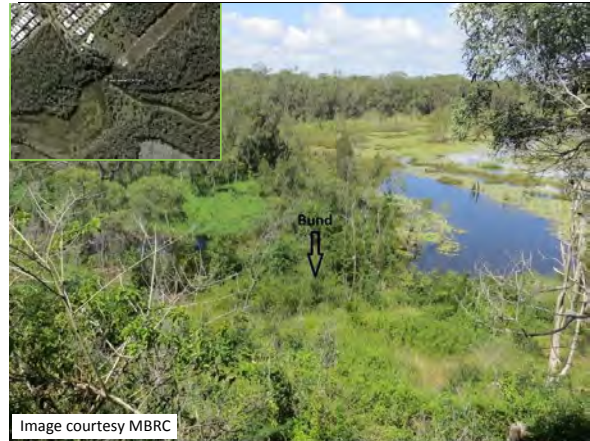
Overall Priority	32	
LGA/LGA Priority	MBRC	12
Barrier ID	2106	
Stream Name	Freshwater Creek	
Location	-27.668090°	153.119794°
Barrier Type	Earthen Bund	
Barrier Name	Upstream Hays Inlet FHA	
Fishway Type Needed	Removal/Rock Ramp	
Approx. Cost of Fishway	\$5 - \$30 k

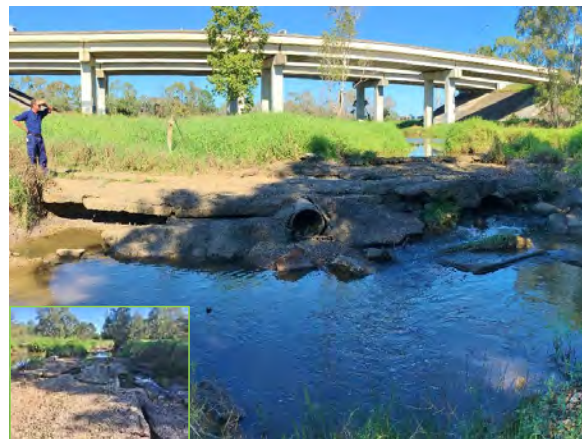
Overall Priority	32	
LGA/LGA Priority	ICC	4
Barrier ID	9649	
Stream Name	Bundamba Creek	
Location	-27.635605°	152.790513°
Barrier Type	Rock Weir	
Barrier Name	Worley Park	
Fishway Type Needed	Rock Ramp	
Approx. Cost of Fishway	\$5 - \$8 k

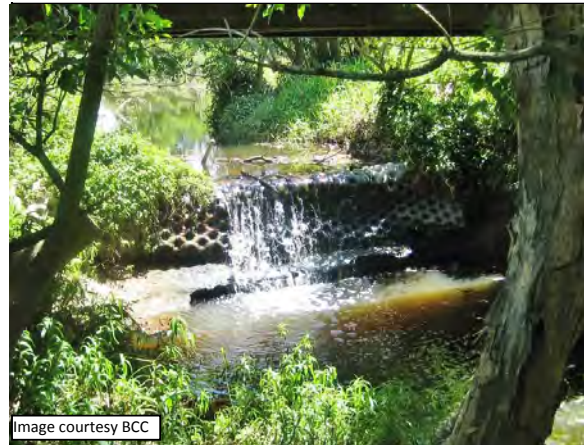
Overall Priority	37	
LGA/LGA Priority	ICC	8
Barrier ID	9748	
Stream Name	Bundamba Creek	
Location	-27.644044°	152.800083°
Barrier Type	Pipe Causeway	
Barrier Name	East Owen Street	
Fishway Type Needed	New Box Culverts &/or Rock Ramp	
Approx. Cost of Fishway	\$20 - \$90 k

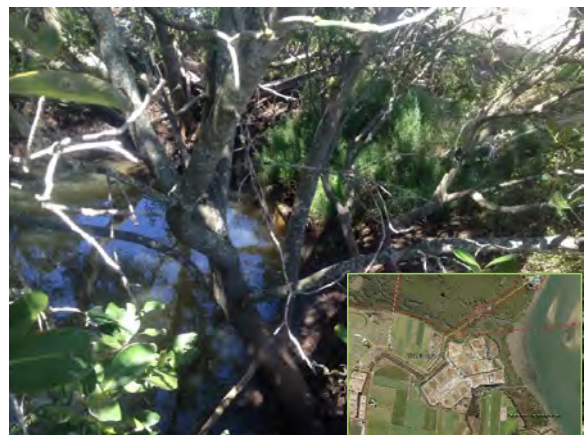
Overall Priority	37	
LGA/LGA Priority	GCCC	8
Barrier ID	5525	
Stream Name	Cabbage Tree Point Creek	
Location	-27.722999°	153.344490°
Barrier Type	Tidal Floodgate - Pipe	
Barrier Name	Cabbage Tree Point	
Fishway Type Needed	Fish Friendly Auto-tidal Gates	
Approx. Cost of Fishway	\$10 - \$15 k

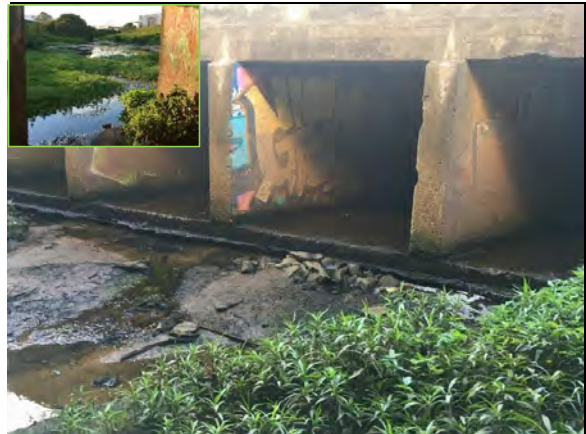
Overall Priority	40	
LGA/LGA Priority	BCC	8
Barrier ID	343	
Stream Name	Zillmere Waterholes	
Location	-27.364832°	153.061926°
Barrier Type	Culvert Causeway	
Barrier Name	Sandgate Road	
Fishway Type Needed	Rock Ramp + Nib wall & Baffles	
Approx. Cost of Fishway	\$30 - \$50 k

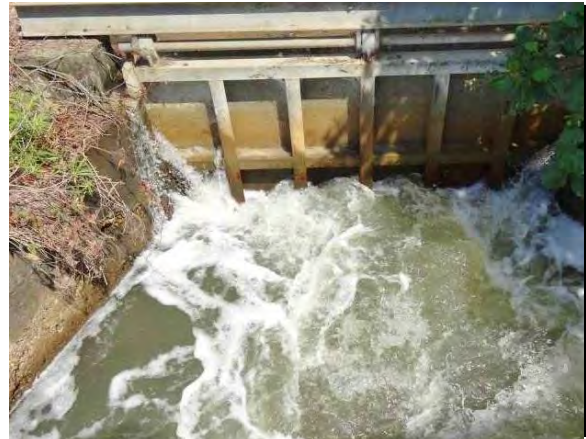
Overall Priority	40	
LGA/LGA Priority	BCC	8
Barrier ID	13828	
Stream Name	Hemmant Creek	
Location	-27.451713°	153.125205°
Barrier Type	Tidal Floodgate	
Barrier Name	Hemmant Tingalpa Rd	
Fishway Type Needed	Fish Friendly Auto-tidal Gates	
Approx. Cost of Fishway	\$25 - \$35

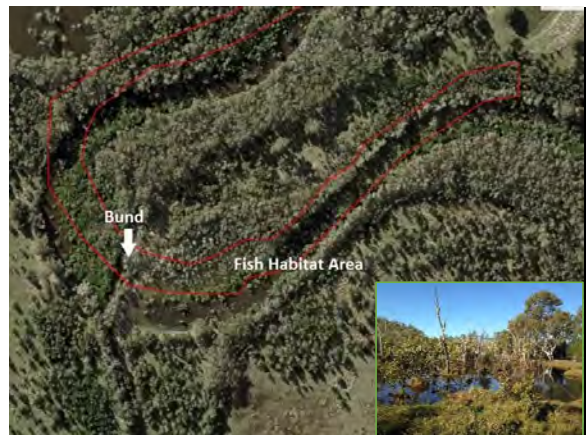
Overall Priority	40	
LGA/LGA Priority	MBRC	13
Barrier ID	13940	
Stream Name	King John Creek	
Location	-27.102760°	153.025381°
Barrier Type	Earthen Bund	
Barrier Name	Deception Bay FHA	
Fishway Type Needed	Removal/Bed Level Crossing	
Approx. Cost of Fishway	\$5 - \$15 k

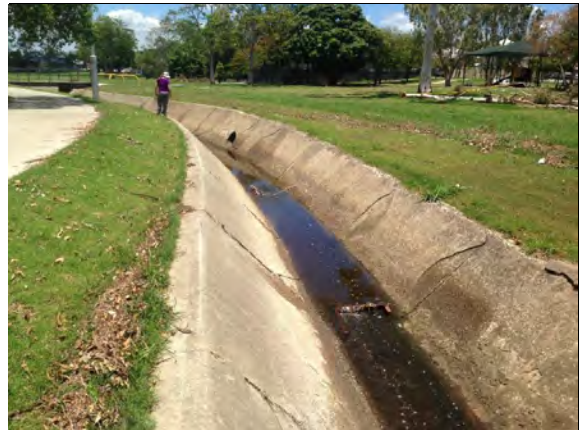
Overall Priority	40	
LGA/LGA Priority	BCC	8
Barrier ID	11865	
Stream Name	Norman Creek	
Location	-27.499142°	153.042516°
Barrier Type	Concrete lined drain	
Barrier Name	Hanlon Park	
Fishway Type Needed	Horizontal Culvert Baffles	
Approx. Cost of Fishway	\$40 - \$90 k

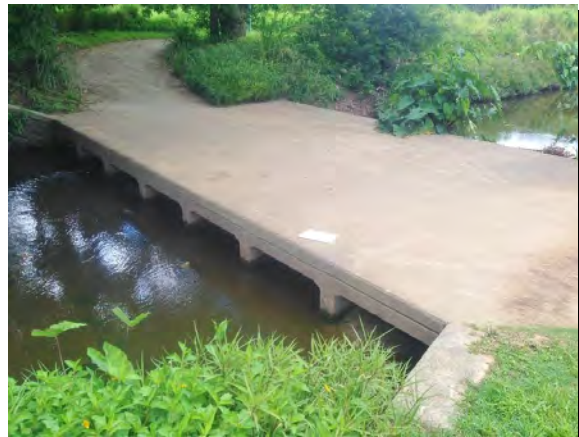
Overall Priority	44	
LGA/LGA Priority	BCC	11
Barrier ID	11647	
Stream Name	Bulimba Creek	
Location	-27.502643°	153.105451°
Barrier Type	Culvert Causeway	
Barrier Name	Opposite Carindale Shop. Cntr	
Fishway Type Needed	Rock Ramp	
Approx. Cost of Fishway	\$15 - \$25

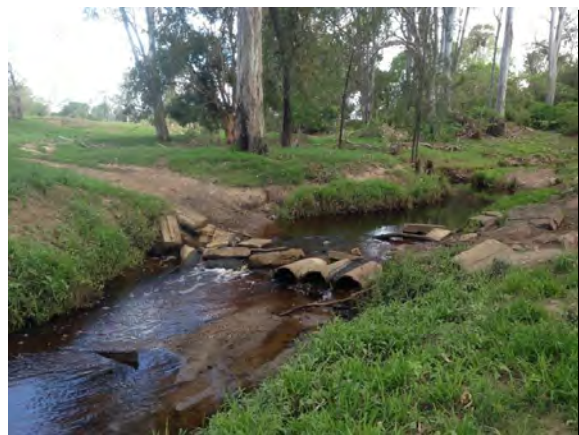
Overall Priority	44	
LGA/LGA Priority	BCC	11
Barrier ID	13943	
Stream Name	Blunder Creek	
Location	-27.571258°	152.987956°
Barrier Type	Causeway	
Barrier Name	Oxley Creek Junction	
Fishway Type Needed	Removal/Bed Level Xing	
Approx. Cost of Fishway	\$3 - \$5 k

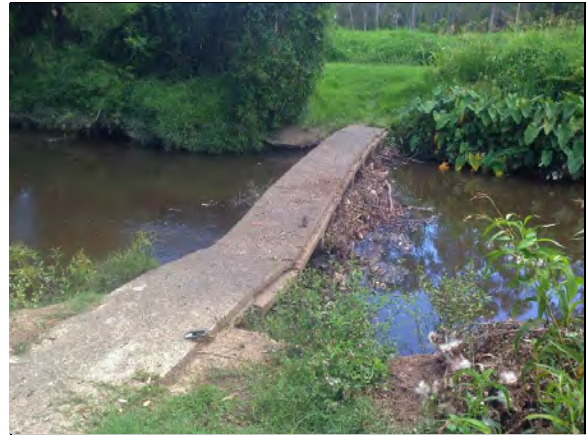
Overall Priority	44	
LGA/LGA Priority	BCC	11
Barrier ID	11648	
Stream Name	Bulimba Creek	
Location	-27.504079°	153.105604°
Barrier Type	Culvert Causeway	
Barrier Name	Opposite Carindale Shop. Cntr	
Fishway Type Needed	Removal	
Approx. Cost of Fishway	\$3 - \$5 k

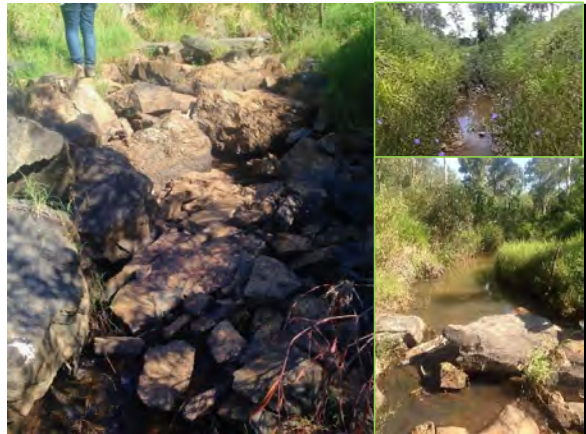
Overall Priority	47	
LGA/LGA Priority	ICC	9
Barrier ID	12970	
Stream Name	Woogaroo Creek	
Location	-27.622268°	152.908130°
Barrier Type	Rock Weir	
Barrier Name	Newman St Easement	
Fishway Type Needed	Rock Ramp	
Approx. Cost of Fishway	\$30 - \$50 k

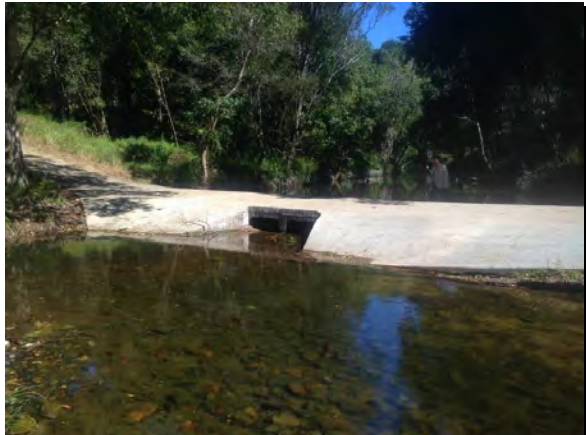
Overall Priority	47	
LGA/LGA Priority	MBRC	14
Barrier ID	1523	
Stream Name	South Pine River	
Location	-27.365176°	152.877745°
Barrier Type	Culvert Causeway	
Barrier Name	Cannington Crt - Samford	
Fishway Type Needed	Rock Ramp + Baffles/Culverts	
Approx. Cost of Fishway	\$40 k - \$80 k

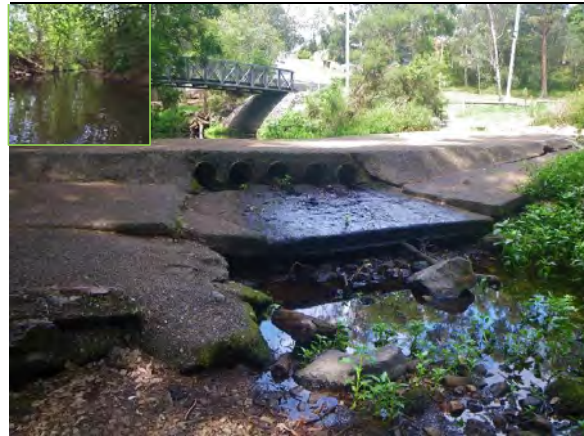
Overall Priority	47	
LGA/LGA Priority	BCC	14
Barrier ID	12461	
Stream Name	Moggill Creek	
Location	-27.504555°	152.930528°
Barrier Type	Pipe Causeway	
Barrier Name	Branton Street	
Fishway Type Needed	Removal/Rock Ramp	
Approx. Cost of Fishway	\$20 k - \$80 k

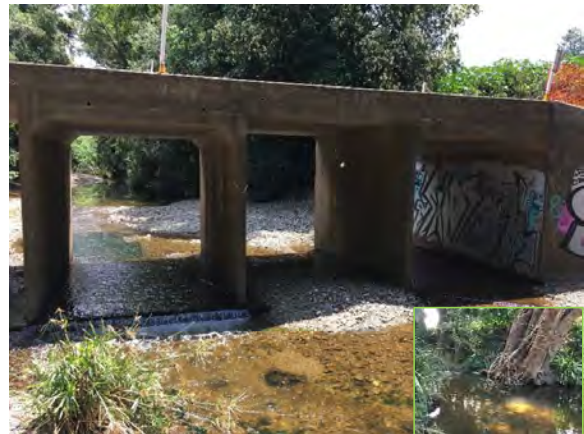
Overall Priority	47	
LGA/LGA Priority	MBRC	15
Barrier ID	11071	
Stream Name	Caboolture River	
Location	-27.109714°	152.885927°
Barrier Type	Culvert Causeway	
Barrier Name	Litherland Road	
Fishway Type Needed	Rock Ramp + Baffles	
Approx. Cost of Fishway	\$30 - \$50 k

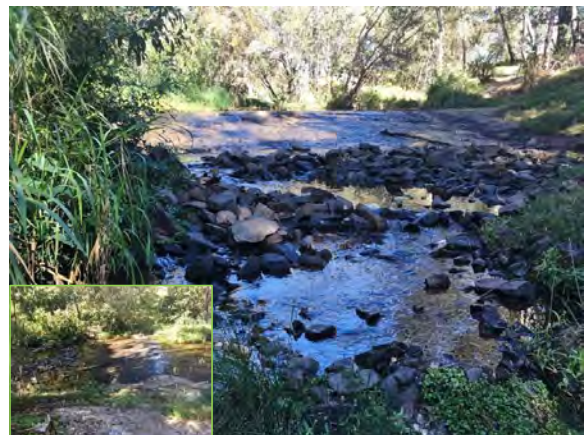
Overall Priority	47	
LGA/LGA Priority	LCC	14
Barrier ID	13407	
Stream Name	Scrubby Creek	
Location	-27.664953°	153.087981°
Barrier Type	Weir	
Barrier Name	Demeio Park	
Fishway Type Needed	Full-width Rock Ramp	
Approx. Cost of Fishway	\$50 k - \$80 k
