CONSERVATION AND ENVIRONMENT COMMITTEE AGENDA

4. PRIORITISATION AND IDENTIFICATION OF FURTHER FISH BARRIER WORKS

The following Greater Brisbane Fish Barrier Prioritisation (GBFBP) has been developed to assess and rank fish passage barriers having the greatest impacts on freshwater fish communities of the GB region. Low passability barriers located within close proximity to the tidal interface on high ordered waterways have the greatest impact on freshwater fish community condition in coastal Queensland catchments. This is largely due to the ability of these barriers to prevent or impede juvenile diadromous species from undertaking longitudinal life-cycle dependant migrations upstream into important nursery habitats. A single low passability barrier located on the tidal interface has the potential to exclude almost half (44%) of the 50 native freshwater fish species recorded in GB freshwater environments (Rolls et al. 2013; 2014).

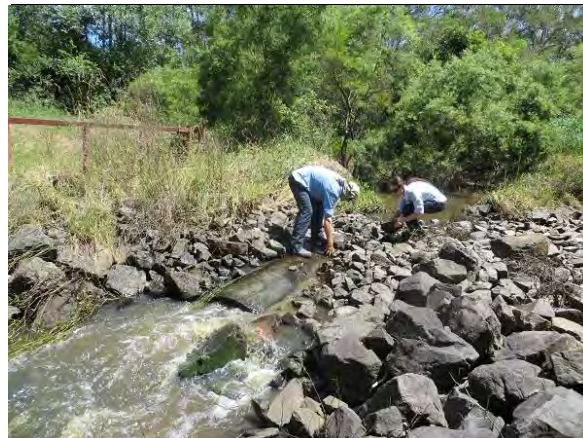
Overall Priority	47	
LGA/LGA Priority	MBRC	14
Barrier ID	3953	
Stream Name	Six Mile (Elimbah) Creek	
Location	-26.997845°	152.918202°
Barrier Type	Relic Causeway	
Barrier Name	Beerburum West State Forest	
Fishway Type Needed	Removal	
Approx. Cost of Fishway	\$4 - 8 k

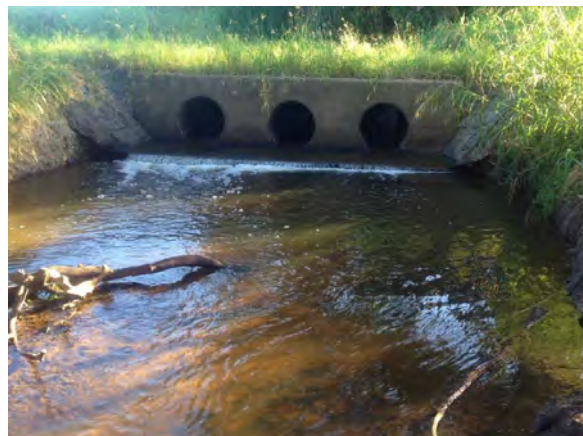
Overall Priority	47	
LGA/LGA Priority	GCCC	9
Barrier ID	7749	
Stream Name	Pimpama River	
Location	-27.790614°	153.269688°
Barrier Type	Pipe Causeway	
Barrier Name	Relic barrier in GC train corridor	
Fishway Type Needed	Removal	
Approx. Cost of Fishway	\$5 - \$15 k

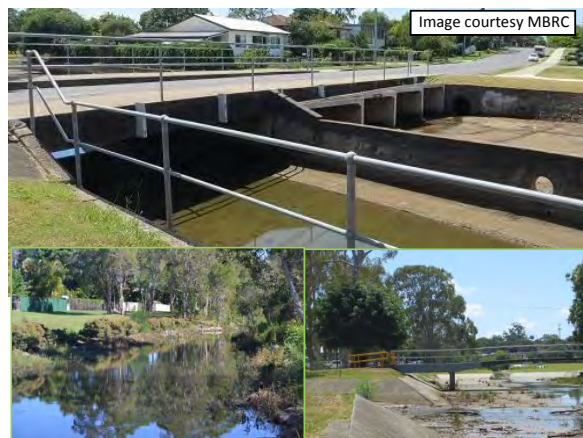
Overall Priority	47	
LGA/LGA Priority	MBRC	14
Barrier ID	2417	
Stream Name	Bells Creek	
Location	-27.252733°	153.092914°
Barrier Type	Culverts + Concrete lined drain	
Barrier Name	Bells Paddock Reserve	
Fishway Type Needed	Horizontal & Vertical Baffles	
Approx. Cost of Fishway	\$15 - \$50 k

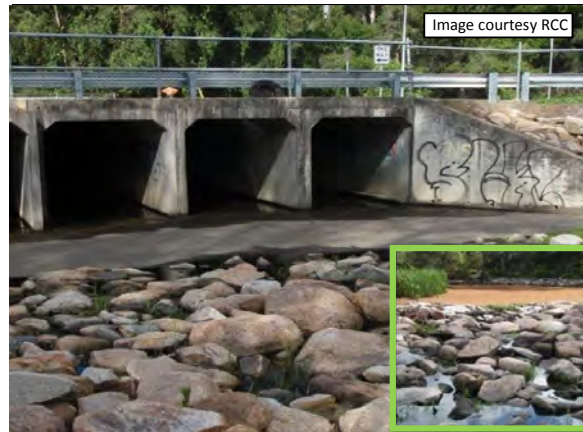
Overall Priority	47	
LGA/LGA Priority	RCC	4
Barrier ID	5071	
Stream Name	Eprapah Creek	
Location	-27.583315°	153.281349°
Barrier Type	Culvert Causeway	
Barrier Name	Redland Bay Road	
Fishway Type Needed	Culvert Baffles	
Approx. Cost of Fishway	\$15 - \$40 k

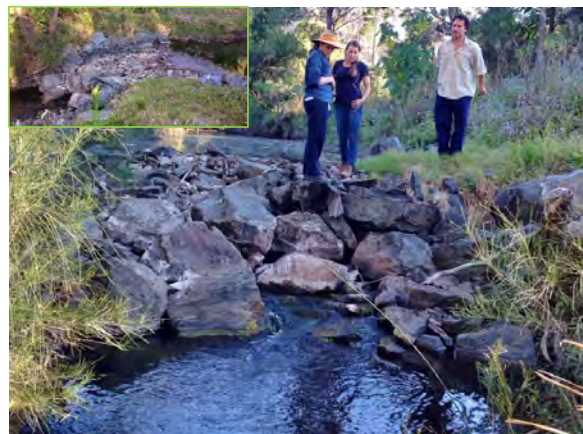
Overall Priority	56	
LGA/LGA Priority	ICC	10
Barrier ID	3953	
Stream Name	Six Mile Creek	
Location	-27.606753°	152.859900°
Barrier Type	Rock Weir	
Barrier Name	Urban Utilities Pipeline barrier	
Fishway Type Needed	Removal/Rock Ramp	
Approx. Cost of Fishway	\$10 - \$40 k

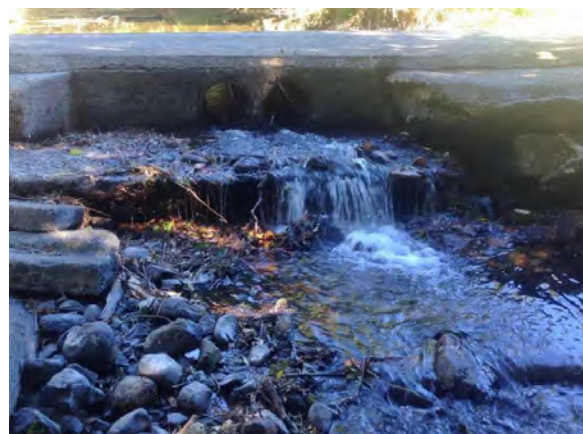
Overall Priority	56	
LGA/LGA Priority	MBRC	18
Barrier ID	1264	
Stream Name	Cedar Creek	
Location	-27.338880°	152.882218°
Barrier Type	Perched Culvert Causeway	
Barrier Name	Hanson Road	
Fishway Type Needed	New culverts/ Rock Ramp	
Approx. Cost of Fishway	\$40 - \$80 k

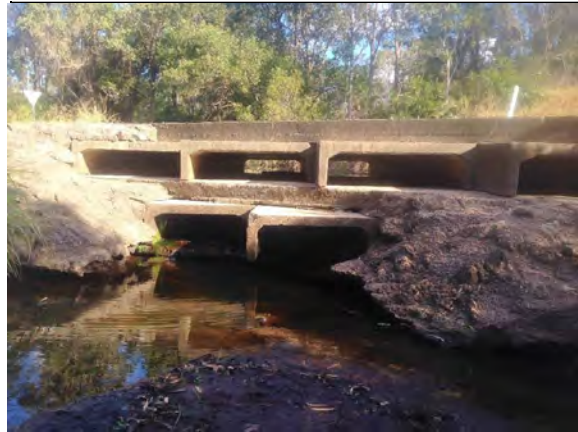
Overall Priority	56	
LGA/LGA Priority	LCC	15
Barrier ID	10540	
Stream Name	Oxley Creek	
Location	-27.728289°	152.948461°
Barrier Type	Perched Culvert Causeway	
Barrier Name	Roberts Road	
Fishway Type Needed	New culverts/Rock Ramp	
Approx. Cost of Fishway	\$40 - \$80 k

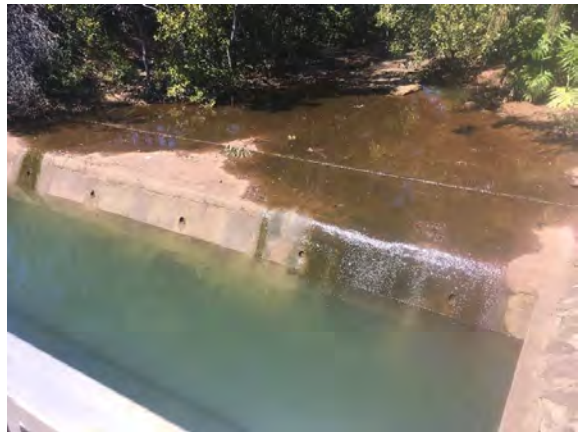
Overall Priority	56	
LGA/LGA Priority	RCC	5
Barrier ID	4850	
Stream Name	Tarradarrapin Creek	
Location	-27.490879°	153.220676°
Barrier Type	Culvert Apron Drop	
Barrier Name	Dorsal Drive	
Fishway Type Needed	Retro-fit Cone/Rock Ramp	
Approx. Cost of Fishway	\$50 - \$80 k

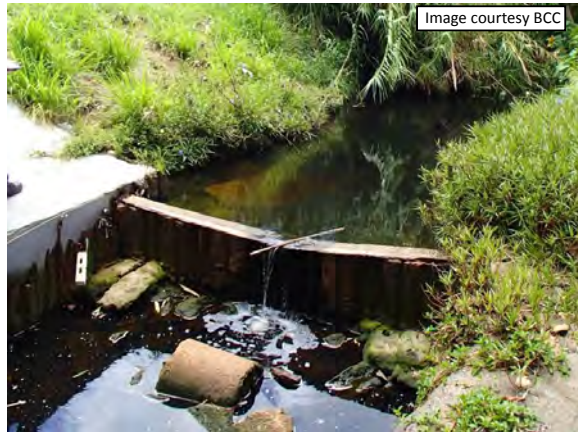
Overall Priority	56	
LGA/LGA Priority	BCC	15
Barrier ID	4256	
Stream Name	Wynnum Creek	
Location	-27.440850°	153.169327°
Barrier Type	Tidal Weir	
Barrier Name	Adjacent Tingal Rd	
Fishway Type Needed	Removal/Rock Ramp	
Approx. Cost of Fishway	\$4 - \$30 k

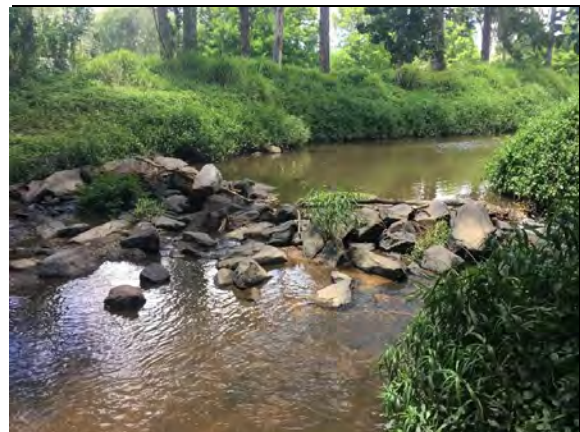
Overall Priority	56	
LGA/LGA Priority	BCC	15
Barrier ID	13995	
Stream Name	Bulimba Creek	
Location	-27.514289°	153.108399°
Barrier Type	Rock Weir	
Barrier Name	Pacific Golf Course	
Fishway Type Needed	Removal	
Approx. Cost of Fishway	\$2 - \$5 k

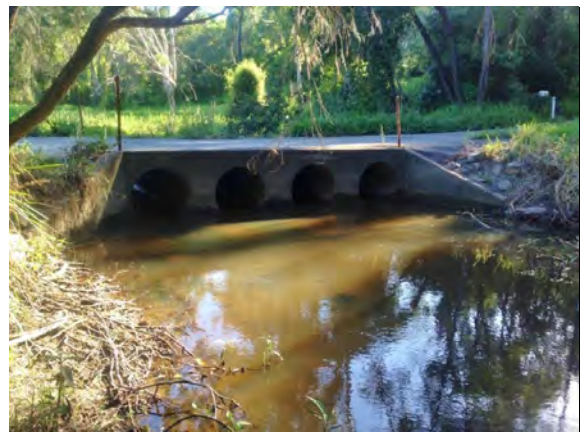
Overall Priority	56	
LGA/LGA Priority	GCCC	10
Barrier ID	7811	
Stream Name	Pimpama River	
Location	-27.787995°	153.268460°
Barrier Type	Culvert Causeway	
Barrier Name	Stewarts Road	
Fishway Type Needed	Rock Ramp + Baffles/Box Culverts	
Approx. Cost of Fishway	\$30 - \$70 k

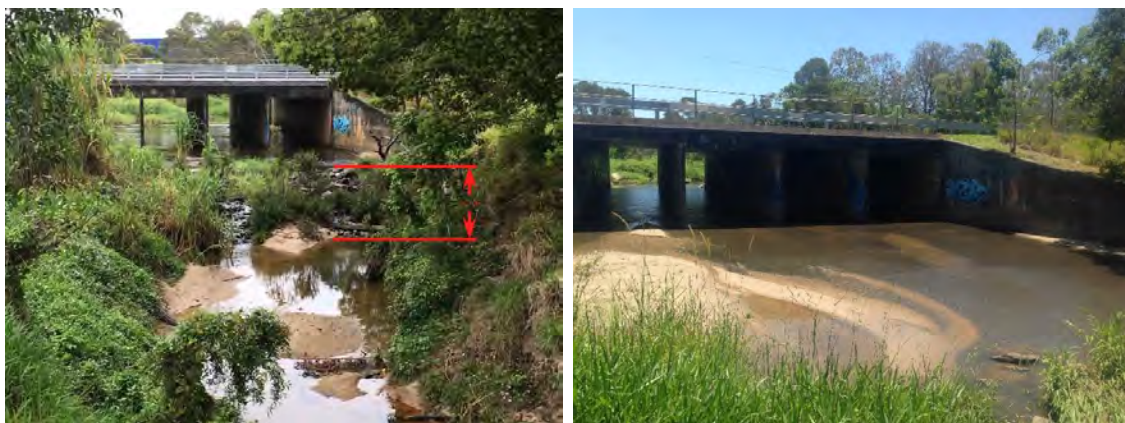
Figure 20. Left; showing the 1.3 m surface drop barrier off the downstream face of the culvert apron. Right; showing stream flow spread out across all four box culverts creating a shallow water surface barrier along the entire 50 m length of the structure. During stream flow events the culverts also created a flow velocity barrier.

The remediation of the Paradise Road overpass barrier in Slacks Creek was undertaken in partnership between Logan City Council and Catchment Solutions. The Paradise Road overpass was ranked the 36th highest priority barrier in the GB region. A fish passage options assessment was undertaken to determine the most appropriate fish passage solution at this site. The investigation determined that a combination of two fishway designs would provide suitable fish passage; rock-ramp fishway to assist fish ascending the concrete culvert apron drop, and a series of horizontal concrete baffles retrofitted to the base of the culverts to assist fish passage through the 50 m long culverts (500 mm head loss).

Barrier Ranking	36 th in the Greater Brisbane region
Barrier Type(s)	Surface drop, water depth and flow velocity
Total Surface Drop (head loss)	1.8 m, consisting of 0.5 m through culverts and 1.3 m off culvert apron
Best Remediation Method	Combination of nature-like partial-width rock-ramp and horizontal culvert baffle fishways
Length of Fishway	91 m
Number of Ridges	17 ridges in rock-ramp, 10 horizontal culvert baffle ridges
Drops Between Pools	80 mm for rock-ramp & 50 mm for the horizontal baffles
Slots (number & type)	4 slots, consisting 2 x high flow and 2 x low flow
Total Construction Time	3 weeks
Total Rock Used	783 t – predominantly consisting of large rock: 1.2 - 3 m (up to 11 t)
Total Overall Cost	\$ 124 000

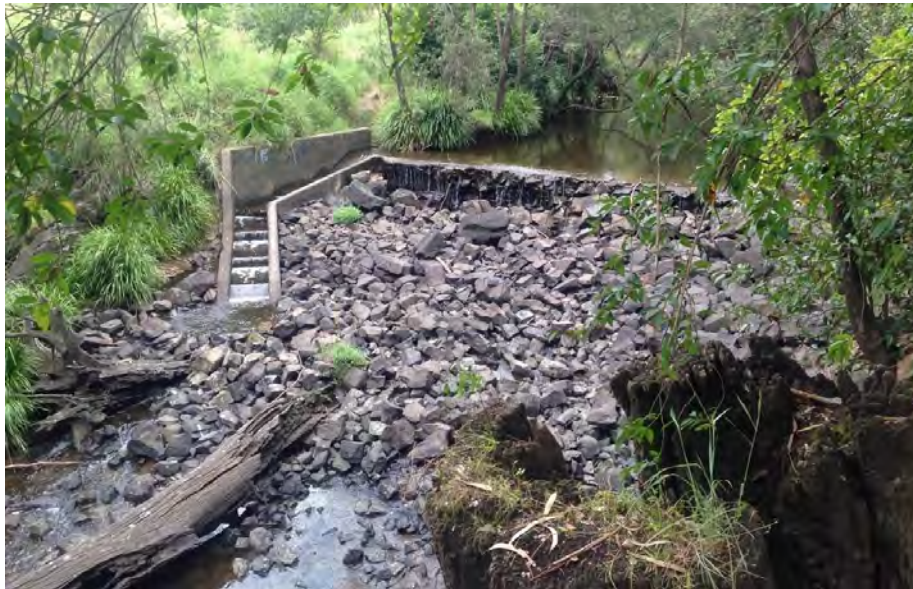
Figure 23. Berrys Weir fish barrier before remediation works, with relic north- American style fish ladder visible down left side of weir

The remediation of Berrys Weir with rock-ramp fishway on the Bremer River was undertaken in partnership between Ipswich City Council and Catchment Solutions in 2016. Berrys Weir was the 7th highest priority ranked fish barrier in the Greater Brisbane region. The 2.4 m high weir was constructed in the 1960's to impound water for power generation (Stanwell). A fish passage options assessment determined that a partial width rock-ramp fishway would be the best remediation option at this site.

Barrier Ranking	7 th in Greater Brisbane region
Barrier Type(s)	Surface drop
Total Surface Drop	2.4 m
Best Remediation Method	1:33 Partial- width rock-ramp fishway + 1:15 full width
Length of Fishway	90 m
Number of Ridges	33
Drops Between Pools	75 mm
Total Construction Time	3 weeks
Total Rock Used	480 t
Total Overall Cost	\$ 96 000

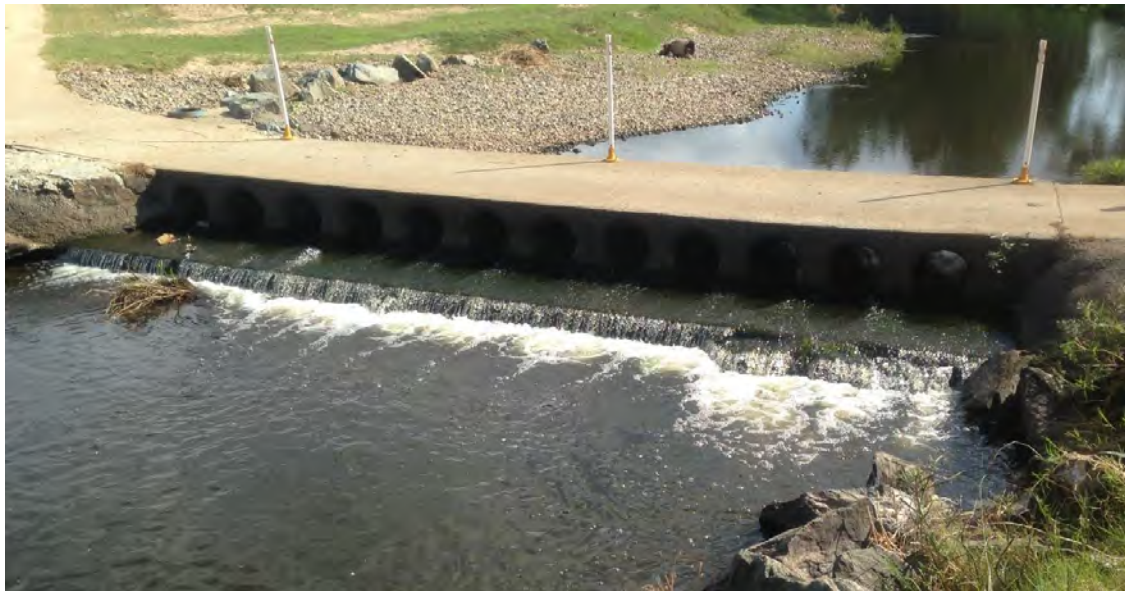
Figure 26. Showing Leitchs Crossing fish barrier prior to fishway construction

The remediation of Leitchs Crossing with a nature-like rock-ramp fishway was undertaken in partnership between Moreton Bay Regional Council and Catchment Solutions. Leitchs Crossing is located in the lower reaches of the South Pine River and was ranked the 11th highest priority fish barrier in the Greater Brisbane region. A fish passage options assessment determined that a full width rock-ramp fishway was the best fish passage remediation option for this barrier type in assisting fish to ascend past the barrier.

Barrier Ranking	11 th in Greater Brisbane region
Barrier Type(s)	Surface drop barrier, water depth barrier and flow velocity barrier
Total Surface Drop (head loss)	0.5 m
Best Remediation Method	Full width rock-ramp fishway
Length of Fishway	15
Number of Ridges	7
Drops Between Pools	75 mm
Total Construction Time	4 days
Total Rock Used	192 t
Total Overall Cost	\$60 000

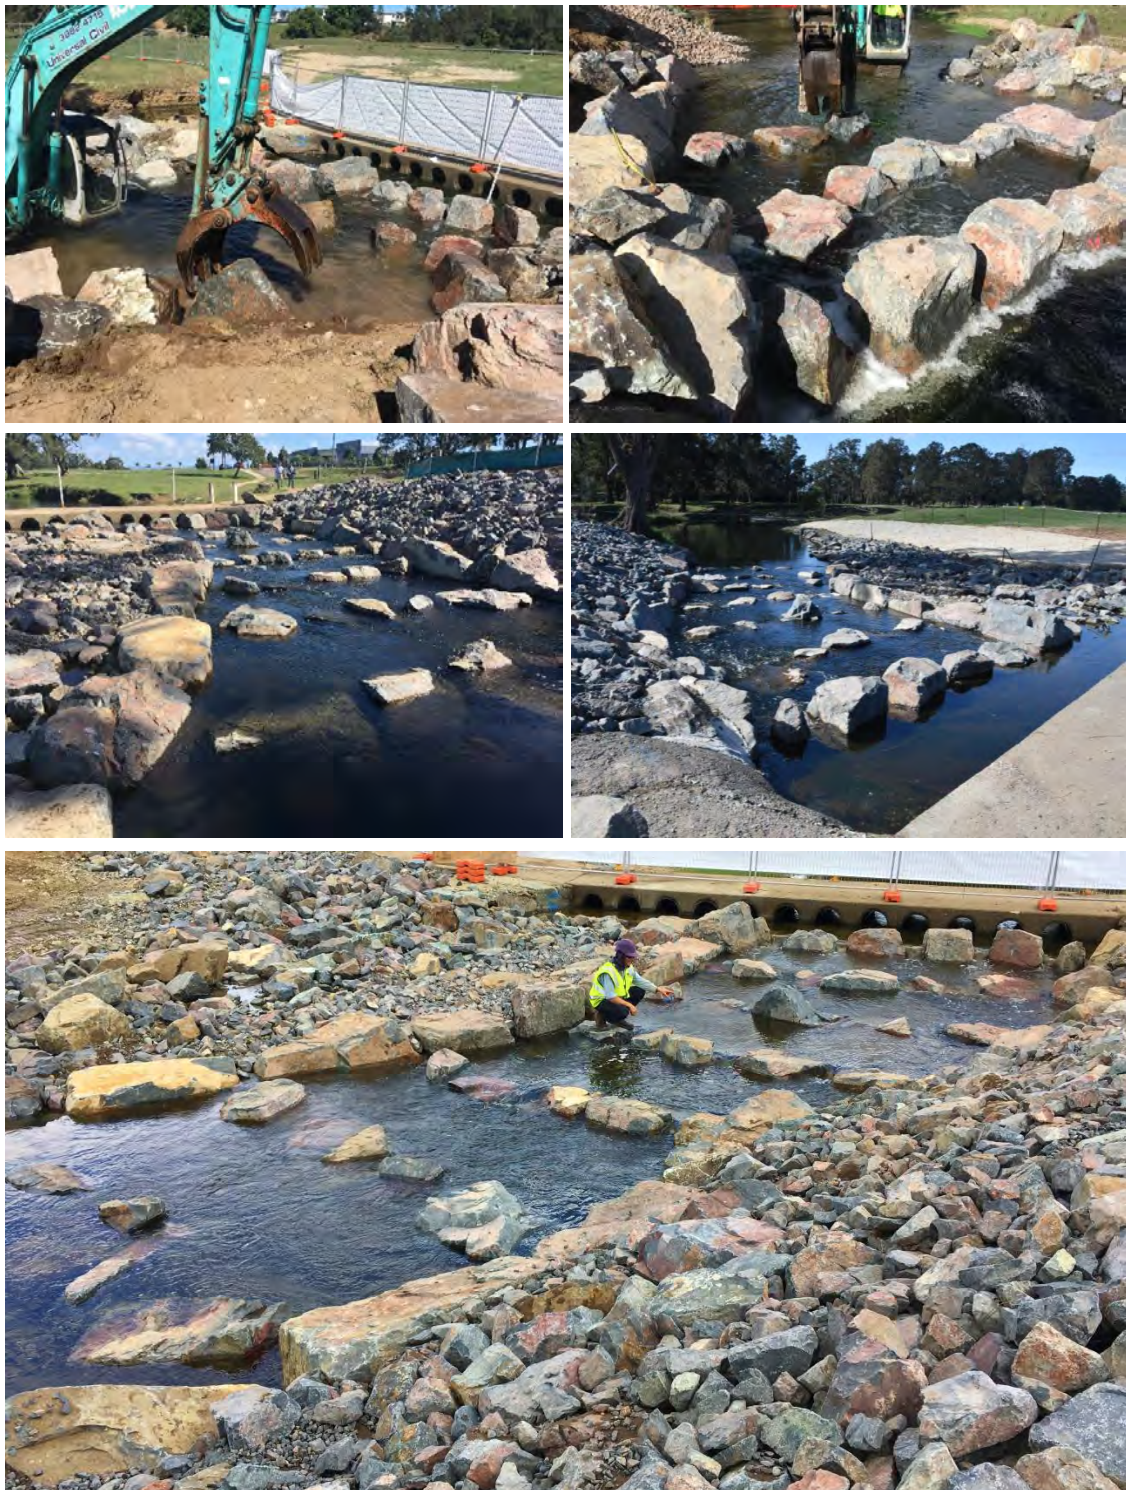
Figure 27. Showing during and post construction of Leitchs Crossing fishway

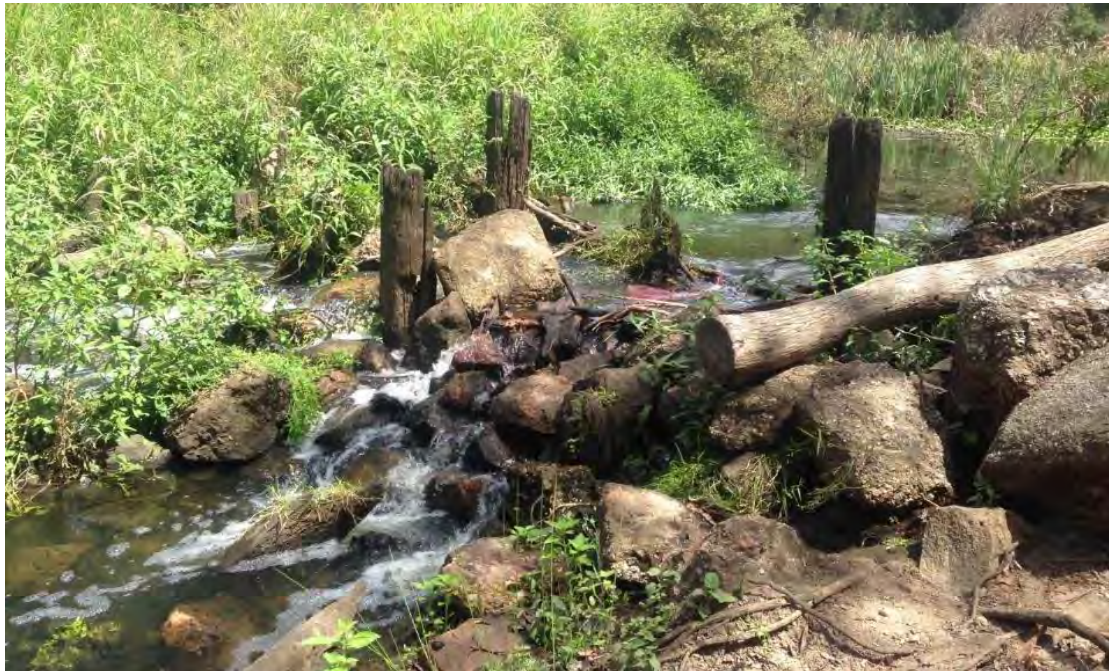
Figure 29. Showing the Hilliards Creek weir prior to fishway construction.

The remediation of Hilliards Creek Weir with a rock-ramp fishway was undertaken in partnership between Redland City Council and Catchment Solutions. The relic weir on Hilliards Creek was ranked the 36th highest priority fish barrier in Greater Brisbane region. A fish passage options assessment determined that a full width rock-ramp fishway was the best fish passage remediation option for this barrier type in assisting fish to ascend past the barrier.

Barrier Ranking	36 th in Greater Brisbane region
Barrier Type(s)	Surface drop barrier
Total Surface Drop	0.75 m
Best Remediation Method	Full width rock-ramp fishway
Length of Fishway	18 m
Number of Ridges	9
Drops Between Pools	80 mm
Total Construction Time	4 days
Total Rock Used	205 t
Total Overall Cost	\$ 42 000

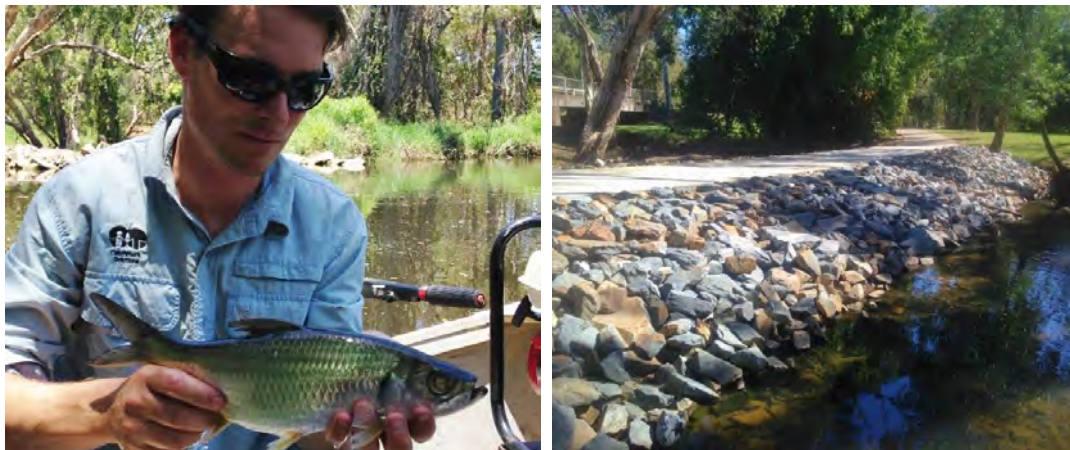
Figure 31. Left; showing an adult tarpon captured immediately upstream of the barrier site post fishway construction. tarpon are a highly prized recreational fishing species, which breed in estuarine waters before migrating upstream into freshwater as juveniles. Barriers significantly impact the distribution and population of this species. Right; Fellmonger Park pedestrian causeway fish barrier. A Hilliards Creek fish community study found this barrier to be significantly impacting fish populations within Hilliards Creek , particular diadromous species.

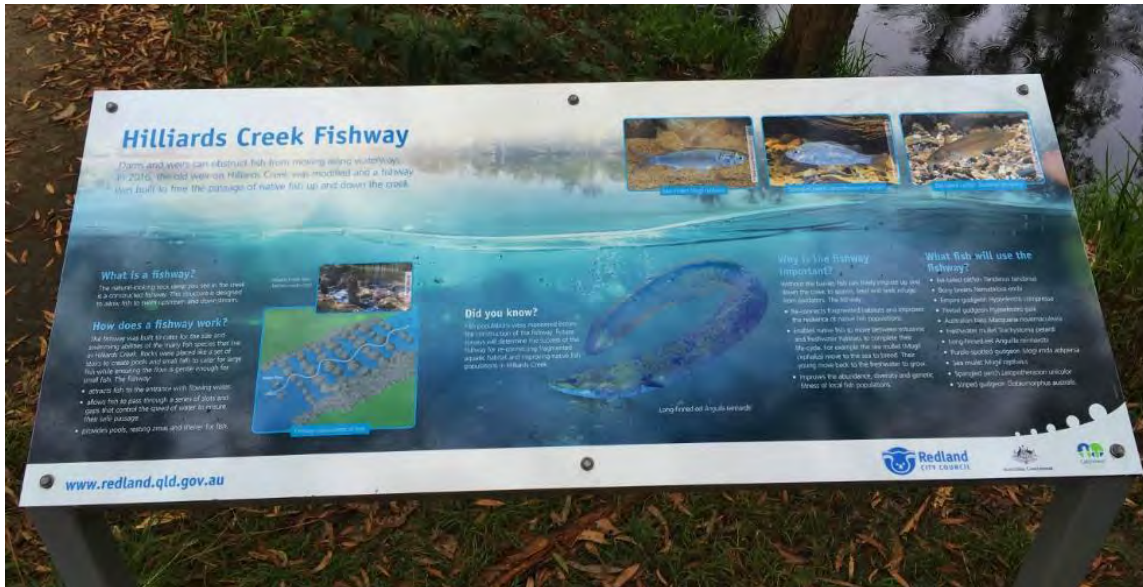
Hilliards Creek Fishway, Redland City Council

Figure 38. Example informative fishway sign which could be installed at a fish passage remediation site to inform the local community regarding the many benefits of improved aquatic connectivity and describe how fishways operate. Fishway Sign designed and installed by Redland City Council.

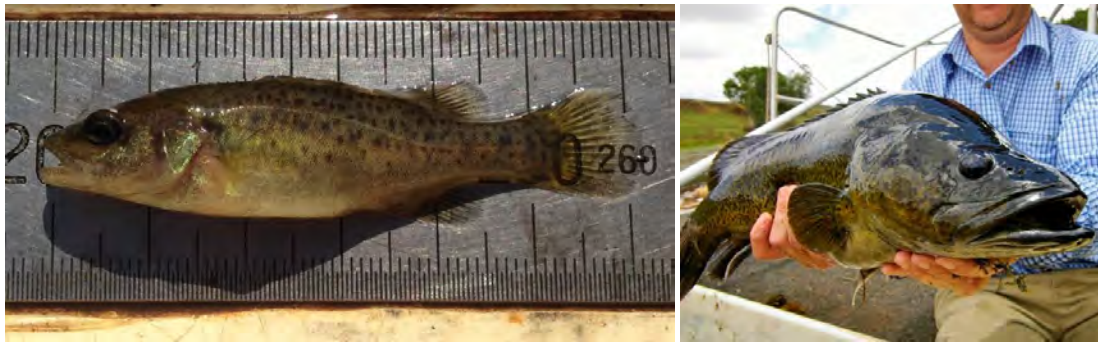
Figure 1. Left; Juvenile MRC released downstream of Berrys Weir fishway as part of a research trial and captured during monitoring having successfully ascended the fishway. Right; Showing an adult MRC captured in the Mary River catchment during research monitoring.

To test whether MRC are able to negotiate Berrys Weir fishway, a small number (n=20) of juvenile MRC were released at the bottom of the fishway during the first round of fishway monitoring in December 2016. During the subsequent 4 days of fishway monitoring, one 62 mm long MRC was recorded successfully ascending the fishway (Figure 1). While this capture only represents 5% of the fish that were released, the result did provide an indication that juveniles of this species can pass the fishway.

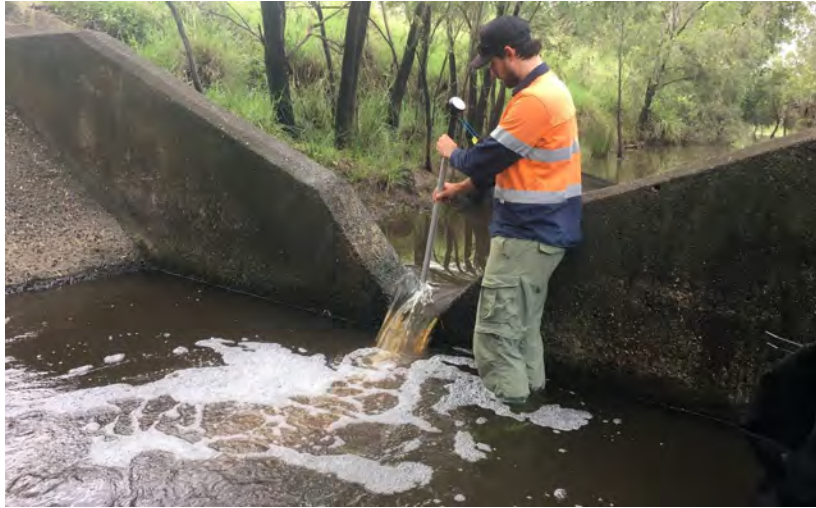
The barrier consists of a vertical concrete wall intersecting the full width of the stream, with a deep V-notch groove formed within the concrete to create a channel of flow for stream height gauging (Figure 4). In total, the estimated head loss from upstream to downstream of the barrier was 300 mm, whilst the estimated drop from the lowest point of the notch to the water surface downstream was 80 mm.

Figure 4. Measuring the velocity through the concrete v-notch gauging station barrier at Walloon in the lower reaches of the Bremer River.

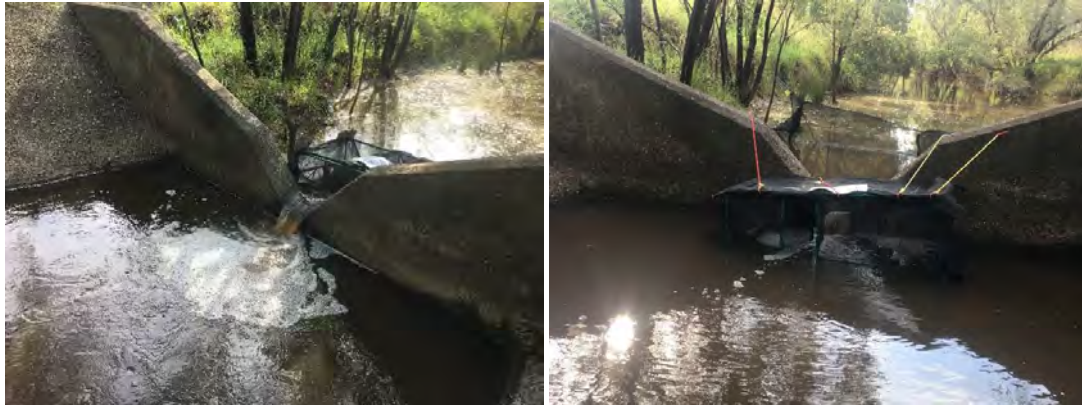
The trap configuration included a single cone entrance. The frame was covered with shade cloth (4.0 mm mesh size). The trap dimensions were 1400 mm x 1000 mm x 1100 mm. Shade cloth wing walls were used to prevent fish from swimming around and underneath the trap, whilst sand bags were used to secure the trap and wing walls in place. The fish trap positioned immediately above the barrier was set for 24.25 hours (Figure 5). Following trapping above the barrier, the trap was set up below the v-notch to sample fish attempting to migrate past the barrier. The entrance to the fish trap was positioned directly in-line with the prevailing stream flow exiting through the v-notch. Fish possess an inherent behavioural response to swim upstream during stream flow events (rheoreaction), attracting fish attempting to migrate upstream into the trap (Wang, 2008). The fish trap was left in place below the barrier for a total of 21.75 hours (Figure 5)

Figure 5. Fish trap set above the V-notch gauging barrier (left), and below the barrier (right)

Fish trapping surveys were undertaken upstream and downstream of the Walloon v-notch gauging weir (Figure 5). Sampling was undertaken to identify differences in fish communities successful at ascending the barrier compared to those that were accumulated below the weir (attempting to ascend past).

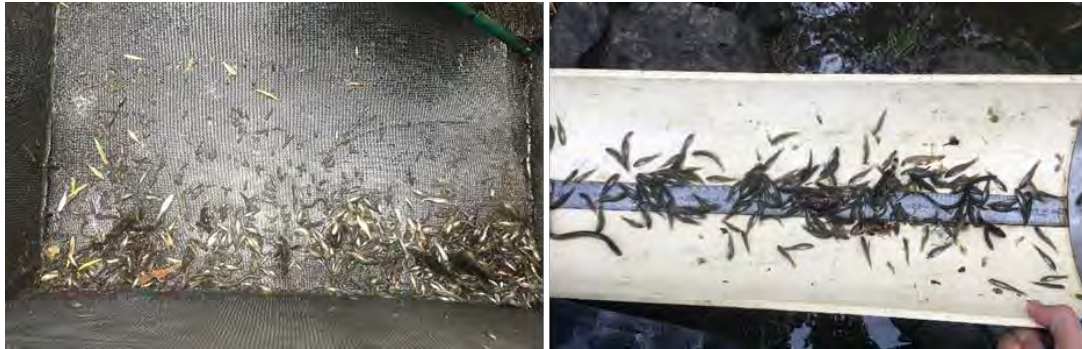
Figure 7. Fish captured whilst trapping below barrier (left), and showing fish captured on measuring board, including bullrout (*N. robusta*), long-finned eel (*A. reinhardtii*) and firetail gudgeon (*H. galii*) (right).

After 21.75 hours of trapping below the Bremer River v-notch gauging weir, a total of 12 species were captured, comprising 11 native species and 1 pest fish (mosquitofish) (Table 1). Native fish included four diadromous species and seven potamodromous species. In total, 770 individual fish were caught at a rate of 35.4 fish per hour, with the most abundant species being firetail gudgeon (*H. galii*) at a rate of 27.77 per hour, followed by Australian smelt (*R. semoni*), Bullrout (*N. robusta*) and mosquitofish at catch rates of 3.72, 0.74 and 0.64 fish per hour respectively. Photos of some fish captured below the weir are provided in Figures 6 & 7.

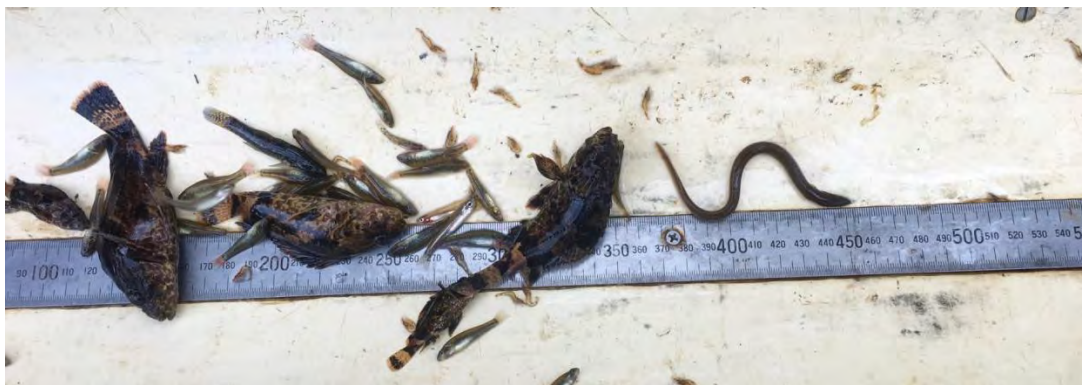
Figure 8. Showing juvenile bullrout, eel sp. smelt, unspecked hardyhead, dwarf flathead gudgeon and firetail gudgeon captured downstream of the Walloon v-notch gauging weir. Note: bullrout, eel sp. and dwarf flathead gudgeon were not captured upstream of the weir, indicating that the weir is potentially blocking upstream passage for these species.

A total of 16 juvenile bullrout (Figure 8) were captured downstream of the weir and none upstream. Bullrout are a sedentary bottom dwelling diadromous fish species, which undertake upstream migrations as juveniles from estuarine environments (Pusey *et al.*, 2004). Barriers that block upstream passage, such as the Walloon v-notch gauging weir have the potential to significantly reduce upstream populations of bullrout. The configuration of the v-notch weir crest combined with tailwater pool water level being approximately 80 mm lower than the control of the crest, results in the creation of an air pocket or void as stream flow passes over the crest prior to entering the tailwater pool. It's likely that for fish to successfully ascend they would either need to climb the vertical surface (e.g. eels) or leap over the void (e.g. rainbow fish). Sedentary species such as bullrout may not be able to leap over

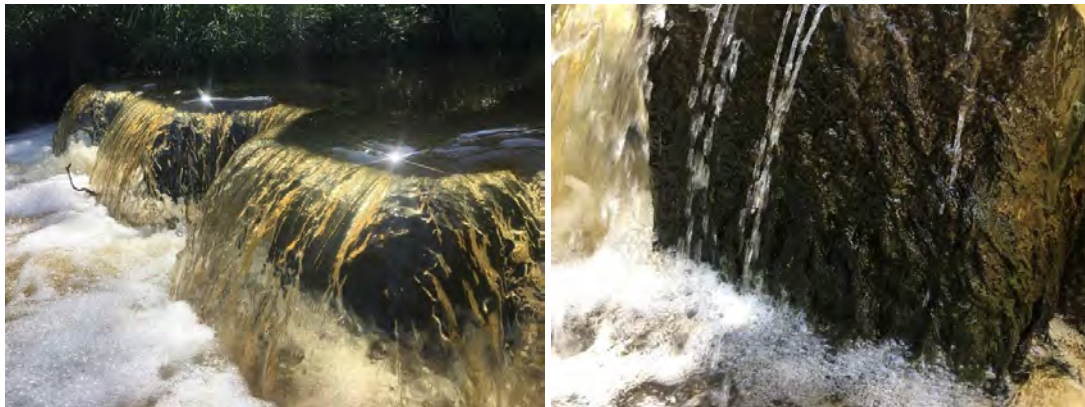
The barrier consists of a shallow rock gabion basket with a step-up of approximately 400 mm where the rock gabion basket continued for approximately 2 m before reaching the base of the sheet pile. The sheet pile, which extended across the full width of the stream, then rises approximately 350 mm to the head of the upstream water body (Figure 10). In total, the combined sheet pile and rock gabion basket barrier poses a 750 mm (approx.) surface drop barrier.

Figure 10. Close up image of the Warrill Creek sheet pile fish barrier (left), and close up of sheet pile surface showing roughness and algae used by striped gudgeon and eel sp. to climb this barrier (right).

Only two (22%) of the nine species monitored directly under the sheet pile weir were captured upstream (striped gudgeon and eel sp.), clearly demonstrating that the headloss (750 mm) of the sheet pile weir is significantly impacting fish passage. Two diadromous species were successful at ascending the sheet pile weir, with striped gudgeon dominating the catch representing 97%. All fish captured were juveniles and sub-adults. Both striped gudgeon and eel sp. undertake migrations as juveniles from downstream estuarine environments to upstream freshwater habitats, with eel sp. in particular known to penetrate to the very upper headwater reaches of waterways. Furthermore, both of these species are noted 'climbers', and have the ability to crawl up rough, wet surfaces to ascend small barriers such as waterfalls. It is postulated that all individual eels and striped gudgeon captured upstream of the barrier had climbed the wet, algae-coated surface of the sheet pile weir to ascend the barrier and move upstream (Figure 10).

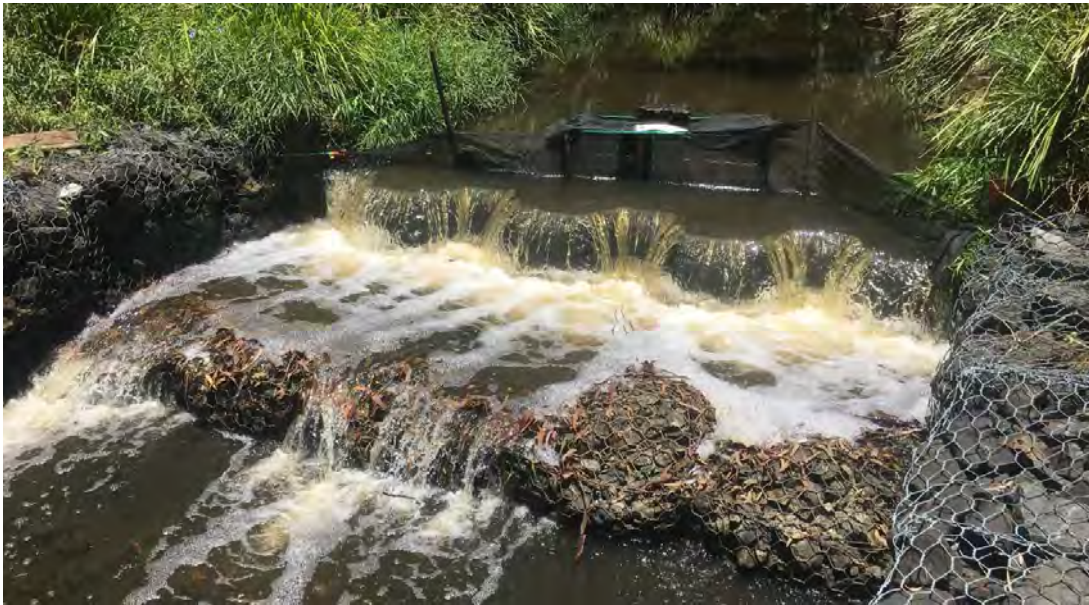
Above the barrier, a fishway trap (Figure 11) was used for sampling. The trap configuration included a single cone entrance. The frame was covered with shade cloth (4.0 mm mesh size). The trap dimensions were 1400 mm x 1000 mm x 1100 mm. Shade cloth wing walls were used to prevent fish from swimming around and underneath the trap, whilst sand bags were used to secure the trap and wing walls in place. The fishway trap was positioned immediately above the barrier was set for a total of 45.25 hours.

Figure 11. Image of fishway trap and wing wall assembly set above the Warrill Creek sheet pile weir

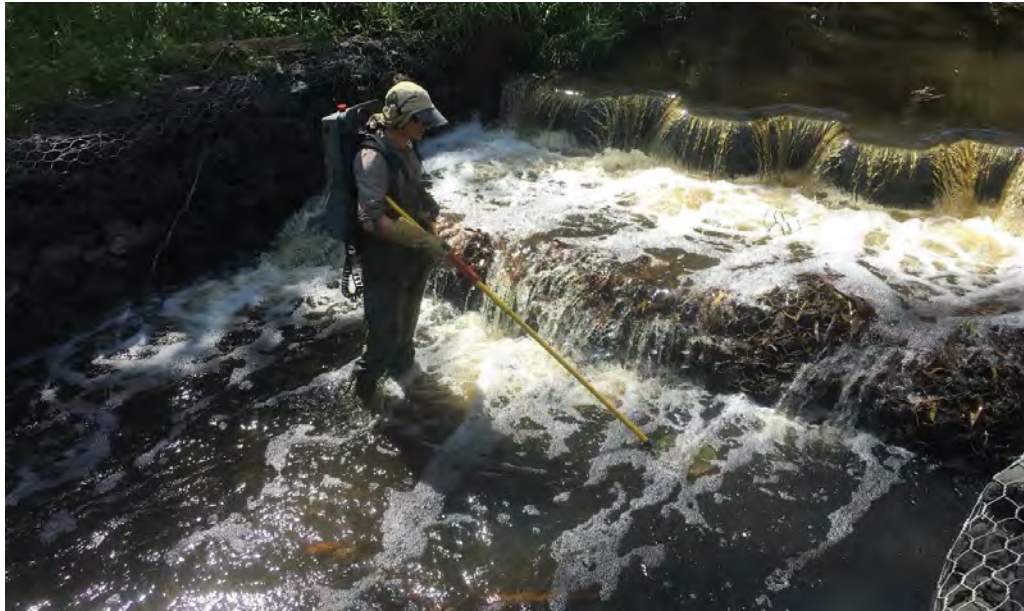
Below the barrier, sampling was performed using a backpack electrofisher unit. The backpack unit utilised was a Smith-Root Model-LR24 backpack electrofisher operating a 300-500 volt pulsed-DC current and a standard pulse setting (1ms). An operator and single dip-netter were employed during all backpacking operations. Sampling protocol involved a series of 'shots' that consisted of altering power-on and power-off periods encompassing all instream habitat types present within the site. Power-on time was recorded to standardize results by Catch Per Unit Effort (CPUE). An operator used a sweeping motion as they moved through the pool and riffle below the barrier while a netter followed behind collecting stunned fish (Figure 12). During electrofishing operations, the observation of uncaptured, positively identified fish were also recorded and included in abundance records.

Figure 12. Image of backpack electrofisher operator conducting fish community surveys below barrier

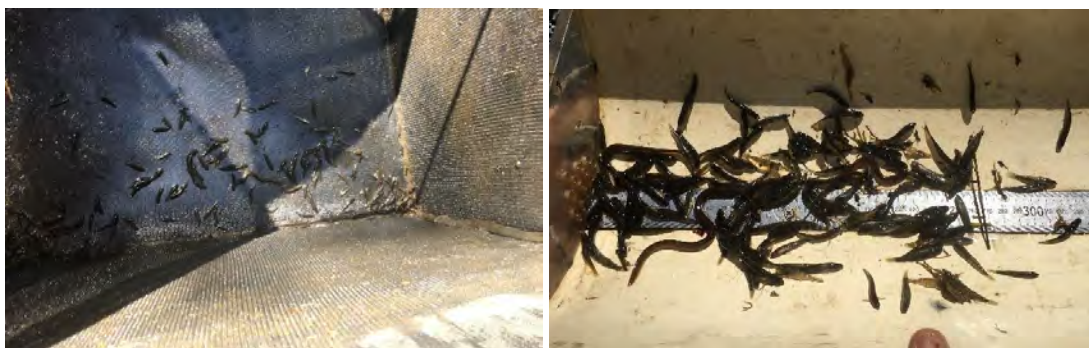
After 45.25 hours of trapping above the Warrill Creek sheet pile barrier, only two species were captured including striped gudgeon (*G. australis*) and eel sp. (*Anguilla species*) at an overall catch rate of 2.8 fish per hour (Figure 13). In total, 116 Striped gudgeon and 3 eel sp. were captured at catch rates of 2.7 and 0.07 fish per hour respectively (Table 3).

Figure 13. Showing juvenile striped gudgeon and eel sp. successful at ‘climbing’ the sheet pile weir.

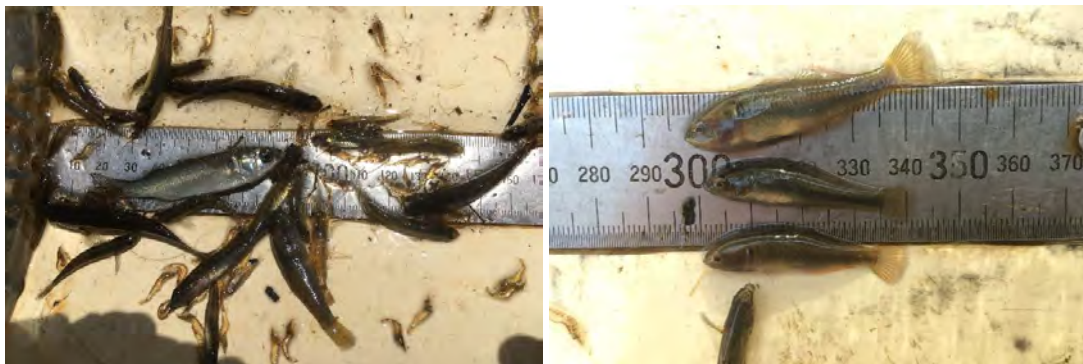
Figure 14. Showing fish captured below the sheet pile weir, Left: juvenile sea mullet (*M. cephalus*), striped gudgeon (*G. australis*) and empire gudgeon (*H. compressa*). Right: firetail gudgeon (*H. galii*).

Striped gudgeon (*G. australis*) were caught in the highest abundance comprising 328 individuals at a catch rate of 57 fish per minute, followed by 138 empire gudgeon (*H. compressa*), 14 firetail gudgeon (*H. galii*) and 9 eel sp. at catch rates of 24, 2.43 and 1.57 fish per minute respectively. Overall, the combined total catch per unit of all species was 87.13 fish per minute. Diadromous migratory species dominated the catch comprising 95% of the total catch below the barrier (Figure 8).

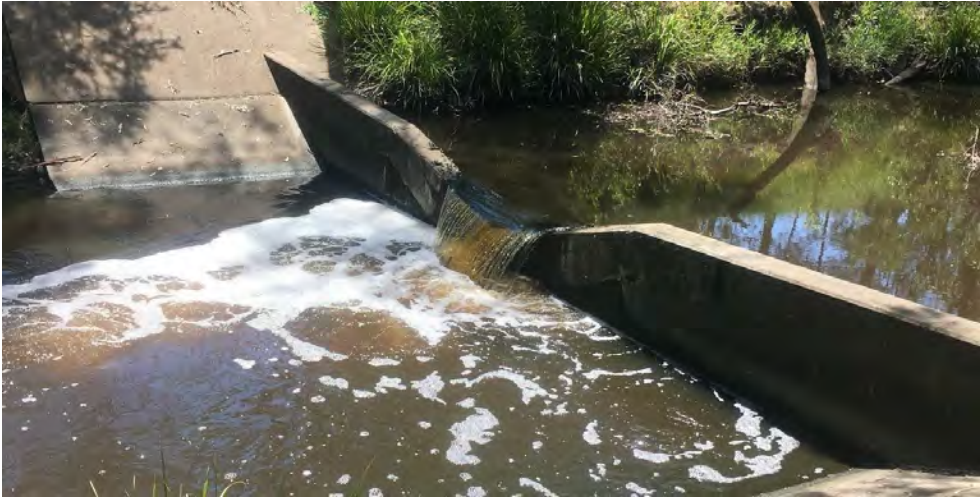
A second barrier was identified in Warrill Creek only 600 m upstream of the sheet pile barrier (Figure 16). This concrete v-notch gauging station weir poses similar threats to the sheet pile barrier

downstream, restricting upstream passage of juvenile and adult native fish. Surveying was intended to take place on this barrier, however site constraints made surveys difficult. The substantial water depth ($\geq 1.5\text{m}$) on the upstream side of the weir meant that a fish trap could not be set up successfully i.e. a trap could not be set up to prevent fish from going under or around the trap. In lieu of this, waterproof cameras were set up at the barrier across two consecutive days for a total of three hours.

Figure 16. V-notch gauging station weir identified approximately 600 m upstream of sheet pile barrier

Although the monitoring duration was short, no fish were captured in the footage ascending the barrier. Duboulay's rainbowfish were captured attempting to ascend by 'leaping' towards the water flowing through the v-notch (Figure 16). It is possible that some striped gudgeon and eel sp. are able to ascend this weir. However, unlike the sheet pile weir, where potential 'climbing' fish only have to negotiate a short distance of $\sim 10\text{ mm}$ (sheet pile width) with extremely high velocity (as water shoots past the barrier) the width of the gauging weir is approximately 20 times greater. This distance fish has to travel while negotiating high velocities potentially reduces the likelihood of 'climbing' fish ascending this barrier. Along with the sheet pile barrier, the impacts of this gauging station weir warrant further investigation and remediation works to restore connectivity along Warrill Creek

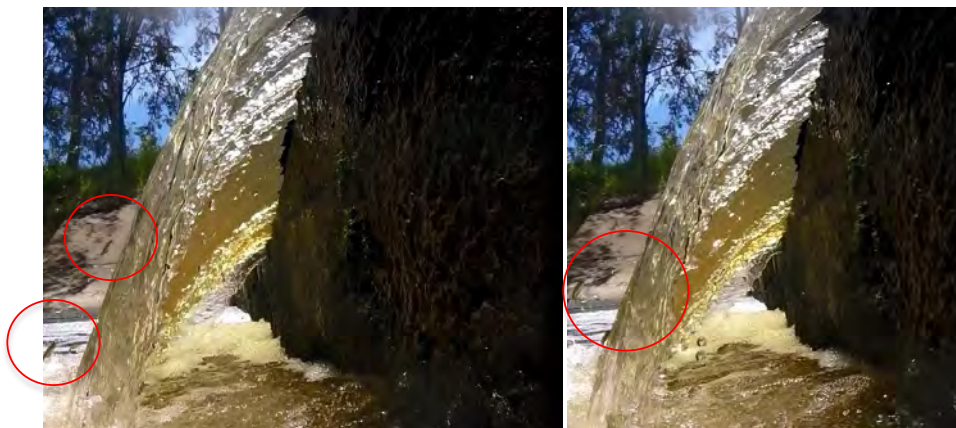
Figure 17. Showing video footage of Duboulay's rainbowfish attempting to 'leap' past the Warrill Creek gauging weir

No fish were captured successfully leaping over the weir crest or climbing the weir wall during camera monitoring. At least two (potentially more) Duboulay's rainbowfish were sighted in the footage unsuccessfully attempting to leap past the weir (Figure 17).

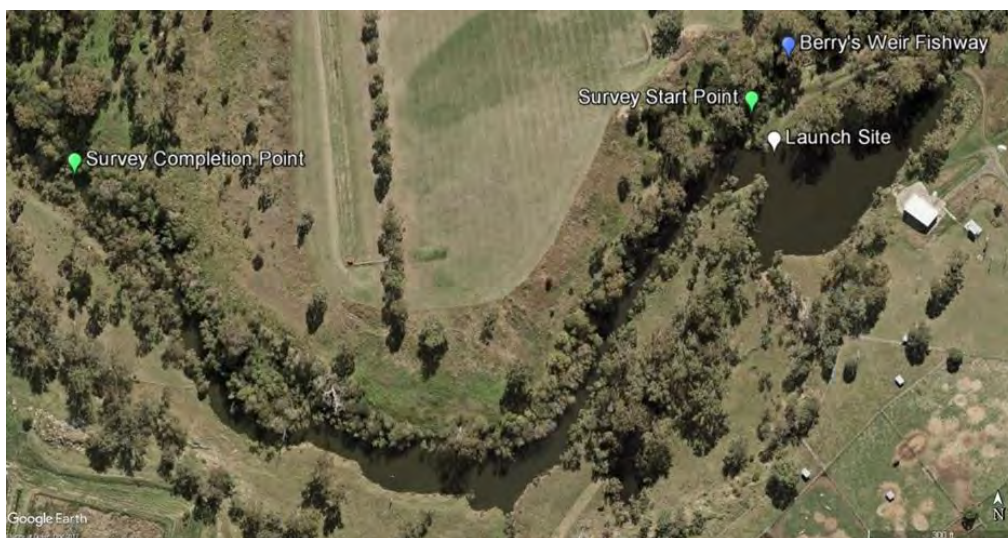
Figure 18. Stretch of river upstream of the Berry's weir fishway that electrofishing surveys were conducted (Imagery: Google Earth)

Upstream of the fishway, the electrofishing boat was launched into a small off-stream pool where good access was available to launch the boat into the river. Electrofishing surveys were then conducted from the reaches immediately upstream of the fishway, to the survey completion point, where log jams prevented further access upstream. In total, approximately 750 m of river was surveyed. The habitat at the upstream site was characteristic of weir pool environments, dominated by deep reaches of stream with relatively low flow. In-stream habitat comprised of fallen trees and log jams, with large sections of open water (weir pool) devoid of habitat complexity (Figure 18)

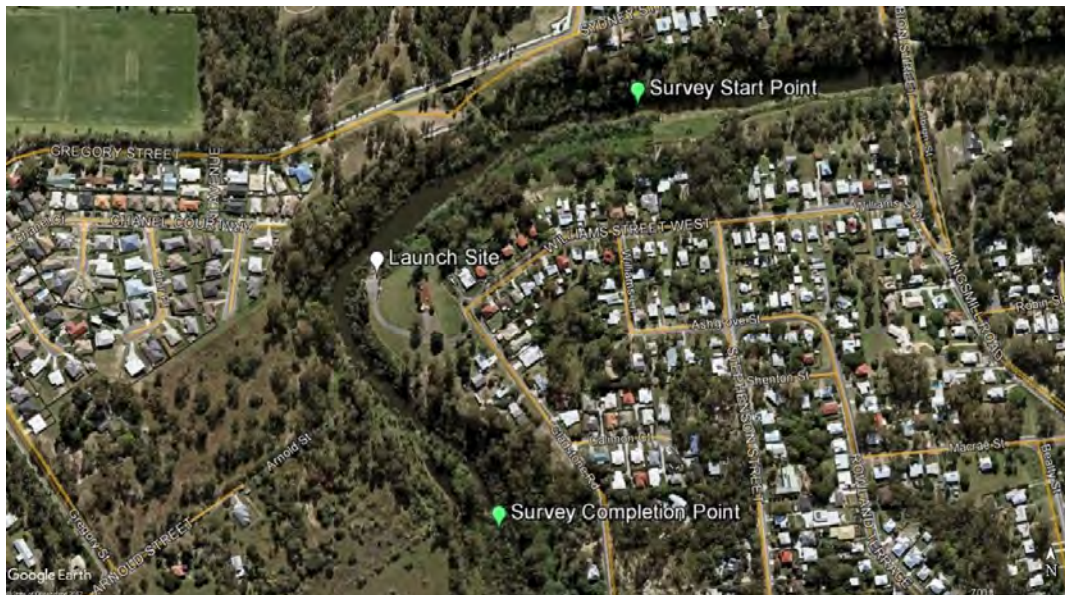
Figure 19. Stretch of river approximately five kilometres downstream of the Berry's weir fishway that electrofishing surveys were conducted, accessed through Shapcott Park (Imagery: Google Earth)

Downstream of the fishway, a suitable stretch of river was identified in the lower reaches of the Bremer River close to the city of Ipswich, approximately five kilometres downstream of the fishway. This reach was accessed through a small boat ramp at Shapcott Park in Ipswich, where an approximate 650 m stretch of river was electrofished (Figure 19). The upper extent of the site was characterised by deeper water with a large number of trees on the streambanks providing cover, and also a large number of log jams within the stream. The lower reaches of the site were dominated by in-stream rock bars and shallower, faster moving water. Overall, habitat condition at this site was excellent.

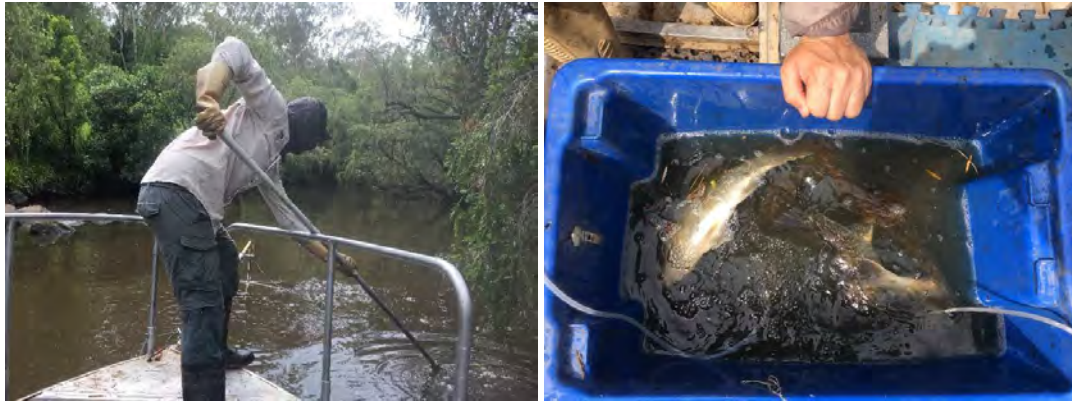
Figure 20. Electrofishing dip- netter extracting stunned fish from the water (left) and an aerated tub of fish on board the vessel after being electrofished (right)

Electrofishing surveys were conducted using a small boat electrofishing unit (Electrolyte). Electrolyte is a 3.7 m vessel which operates a Smith-Root 2.5 GPP electrofisher unit, equipped with a single boom arm, six dropper anode array and hull cathode. An operator and single dip-netter was utilised during electrofishing operations (Figure 20).
