# City of Ipswich **Platypus Recovery Plan**

2020

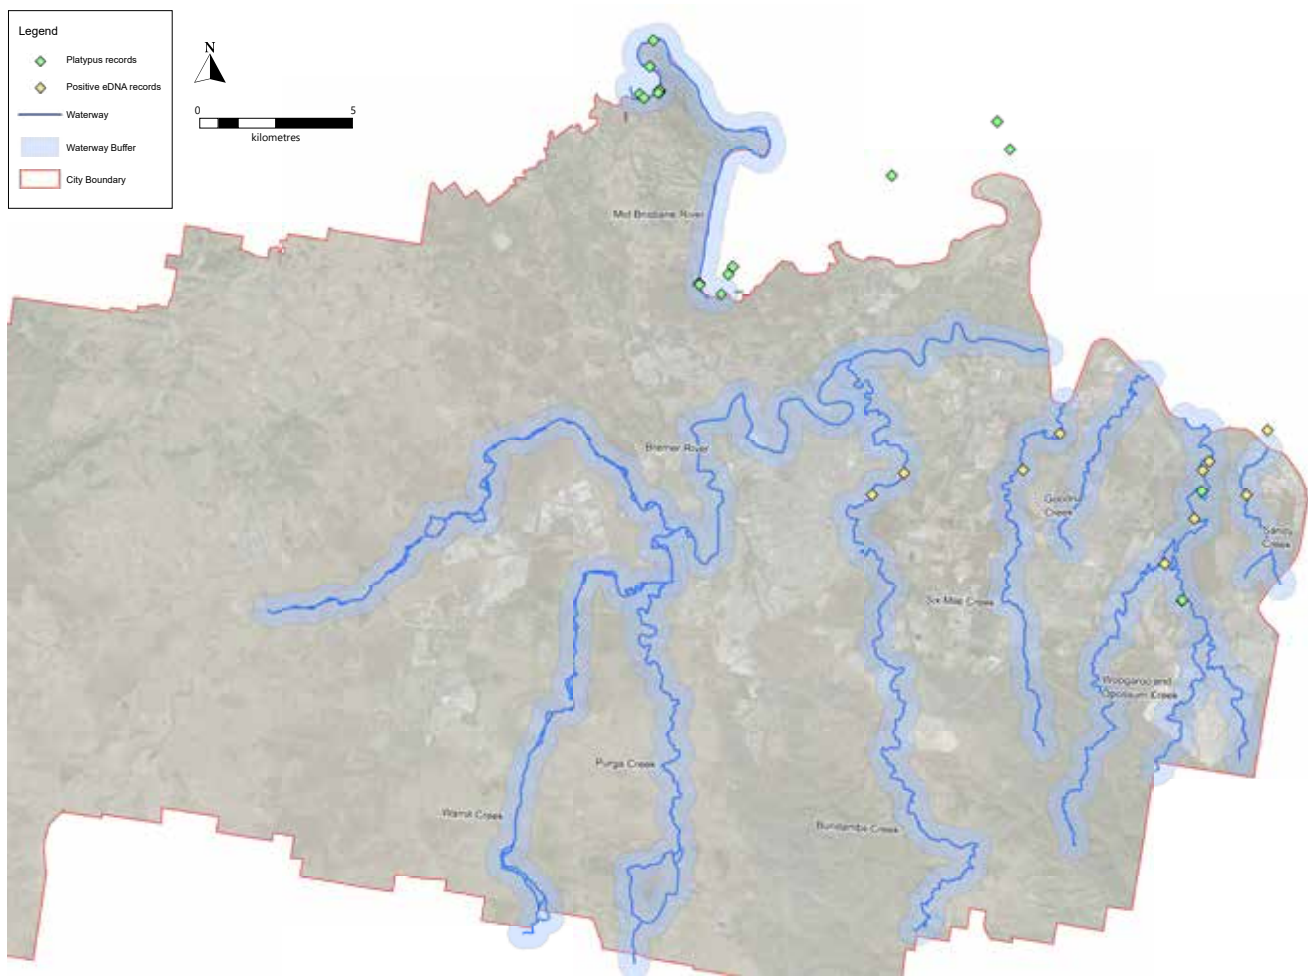
Figure 1: Map of all catchments relevant to this recovery plan. Includes records of known platypus sightings in addition to positive eDNA records.
