Franklin Vale Catchment

Condition Assessment

Australian Rivers Institute, Griffith University, Brisbane

Ipswich City Council to inform the Franklin Vale Creek Catchment Initiative

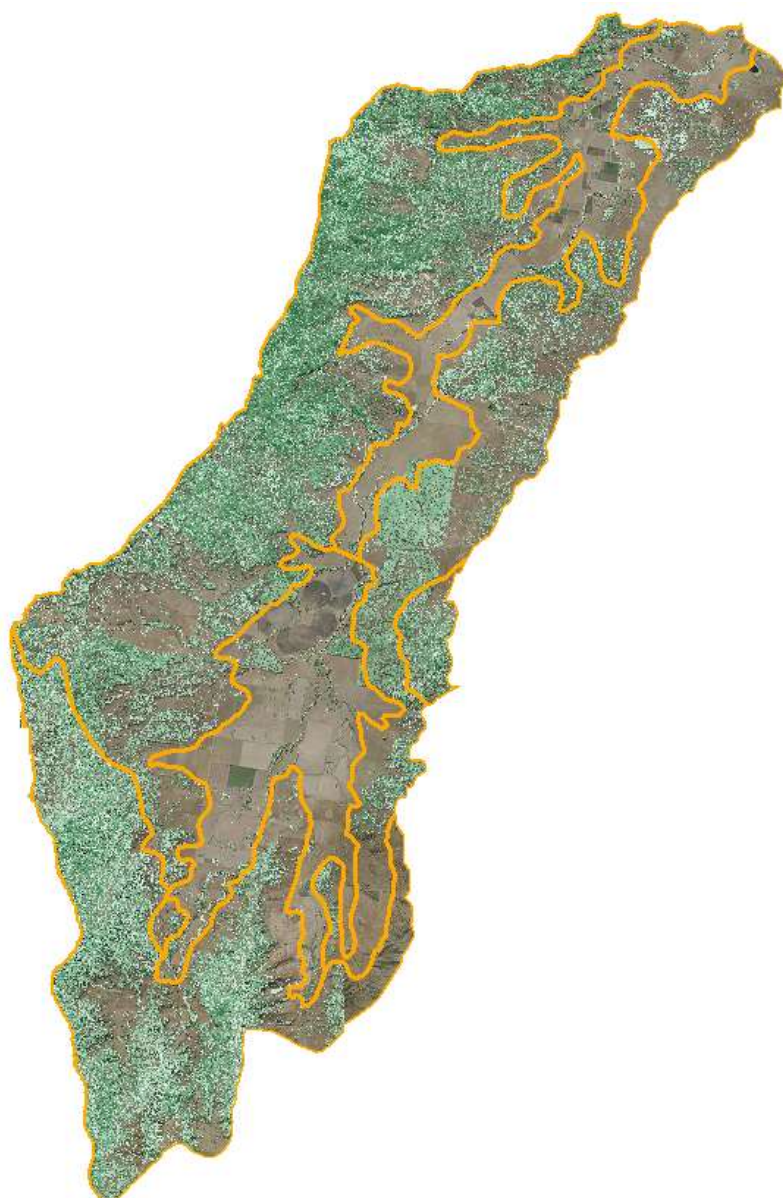
A substantial amount of vegetation is present in the catchment which does not meet the Queensland Herbarium definition of remnant vegetation (Figure 14). It is highly probable, however, that this other vegetation would still provide significant benefits for water quality and other ecological functions. When considering all vegetation within riparian buffers adjacent to waterways in the catchment (Figure 4, Table 11), it is apparent that the canopy cover of vegetation between 1 and 5 m height is generally low (i.e., < 10%; Figure 15). However without ground truthing the LiDAR data, this cannot be confirmed and may be an artefact of the limitations of the LiDAR data capture. In contrast, the percent canopy cover of vegetation of vegetation greater than 5 m in height is relatively high. For vegetation within this height category, average canopy cover is around 30 % for first and second order streams with some very high values (> 95%) also apparent. For the fourth order main stem of Franklin Vale Creek, average canopy cover of vegetation > 5 m is approximately 45% (Table 11; Figure 16).

Figure 14. All vegetation cover (green shading) in the Franklin Vale catchment as derived from the 2014 LiDAR data. Orange borders represent geomorphic process zones.

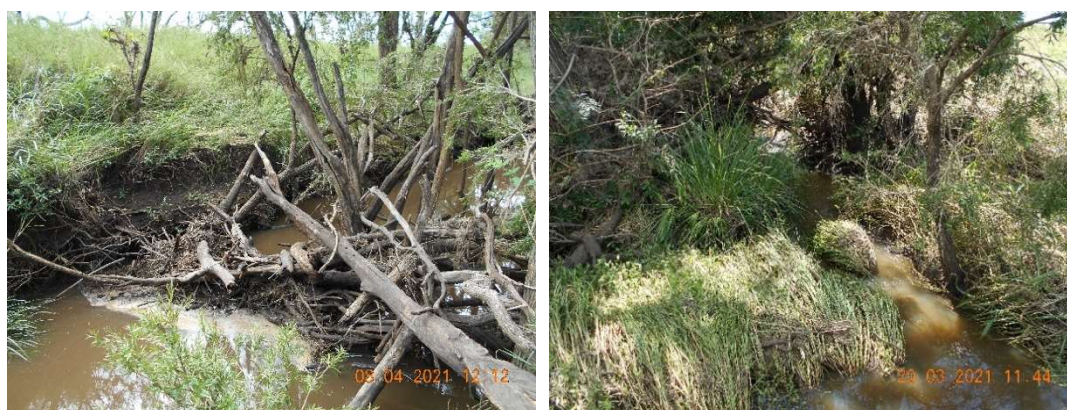
The field assessment identified at least one aquatic habitat feature recorded in 63% of sites (examples in figure 18). Where aquatic habitat features were not observed, significant bank and stream bed modification had occurred to maintain road crossing stability. Visible log jams were more common in lower order streams of the headwaters. Aquatic vegetation was low throughout the catchment (only recorded at 7 sites) which was generally submerged grasses that likely grew during dry periods.

Figure 18. Examples of instream aquatic habitat observed during field assessment of Franklin Vale Creek catchment condition. Left: log jam. Right: instream emergent vegetation. Images: R. Grieger

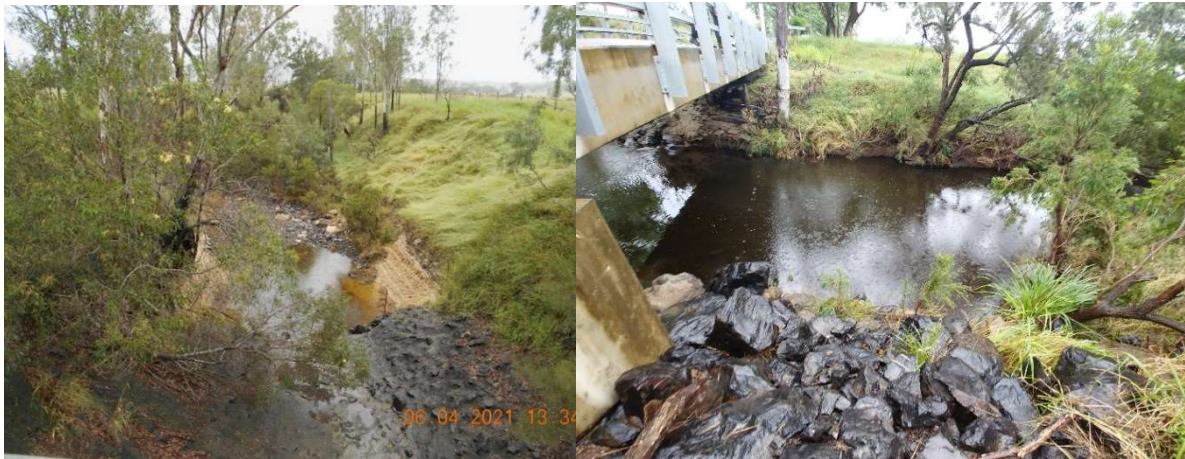
Field assessment of catchment condition revealed that significant modifications to channel form and complexity are evident at all creek crossing sites. These represent challenges both

in terms of erosion potential and in terms of habitat quality and complexity for aquatic fauna. Many sites had significant bankside works around bridges, which included rocks and concrete (Figure 21).

Figure 21. Banks around large bridges (left: Schmidt's Bridge – Grandchester-Mt Mort Rd, right: Franklyn vale Rd) reinforced with large rocks and concrete. Images: R. Grieger

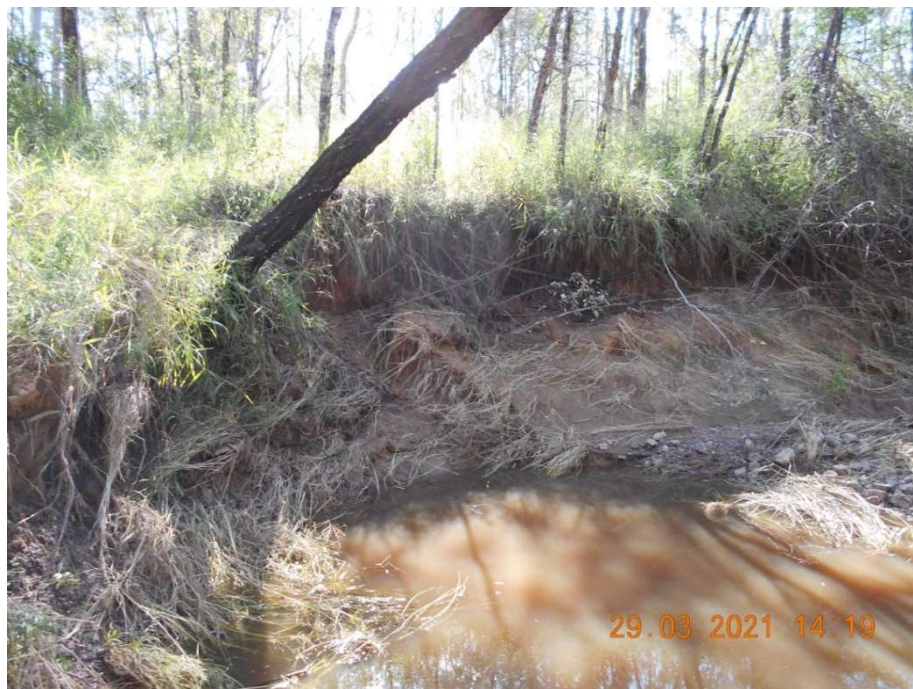
In addition, across the surveyed sites, a wide range of culvert types and sizes was observed – some were as small as being 30 cm in diameter, others were greater than 3m in diameter. One of the smaller culverts was blocked at the time of the survey and there was evidence of significant downstream erosion (Figure 20). Although a detailed analysis of culverts throughout the entire catchment was not conducted, there are certainly concerns around the degree to which this infrastructure may be a threat to the condition of the catchment and the water quality exiting the catchment.

Figure 20. Erosion following a small blocked culvert at one creek crossing. Image: R. Grieger

- Road crossings were variable in structure and condition. Smaller culverts blocked with debris have resulted in significant downstream erosion.
- Franklin Vale catchment has a diverse but cohesive community. Community activities conducted during this project indicate that there is a wealth of knowledge regarding the catchment and a strong interest in engaging and supporting catchment restoration and management.
