Franklin Vale Catchment

Restoration Plan 2021-2026

Australian Rivers Institute, Griffith University, Brisbane

Ipswich City Council to inform the Franklin Vale Creek Catchment Initiative

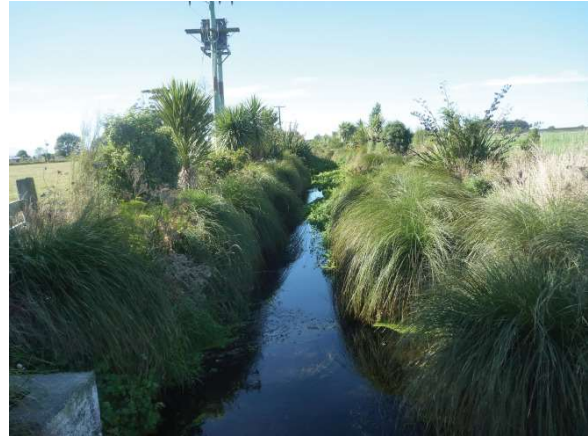
Figure 1. Planted riparian buffer at Birdlings Brook site, typical of restored areas in the Lake Ellesmere catchment (from Collins, 2011).

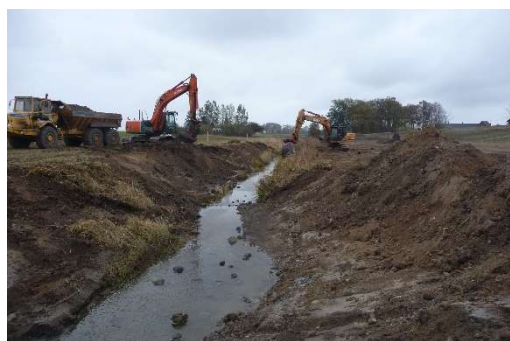
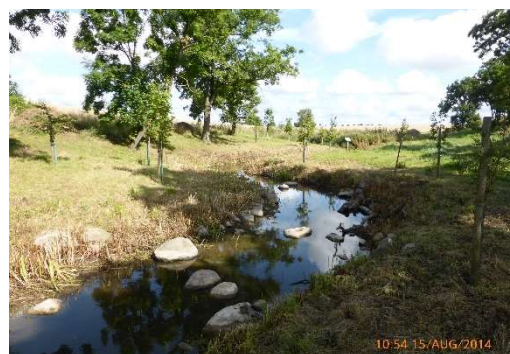
Figure 2. Part of Tullstorp Stream during and after restoration works (from The Tullstorp Stream Project, 2020).

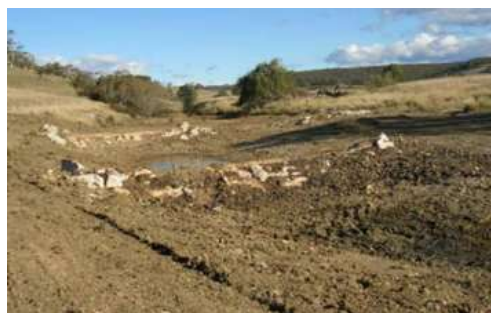
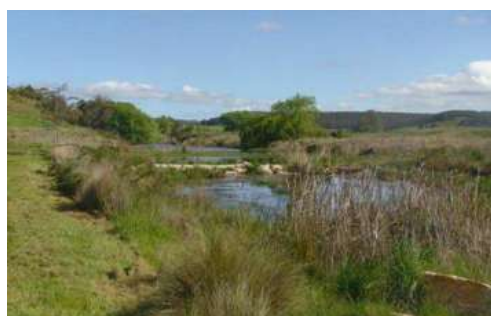
Figure 3. Part of Mulloon Creek before and after restoration works (from Southern Rivers Catchment Management Authority (2011))
