EARLY COLONIAL/VICTORIAN 1850-1880

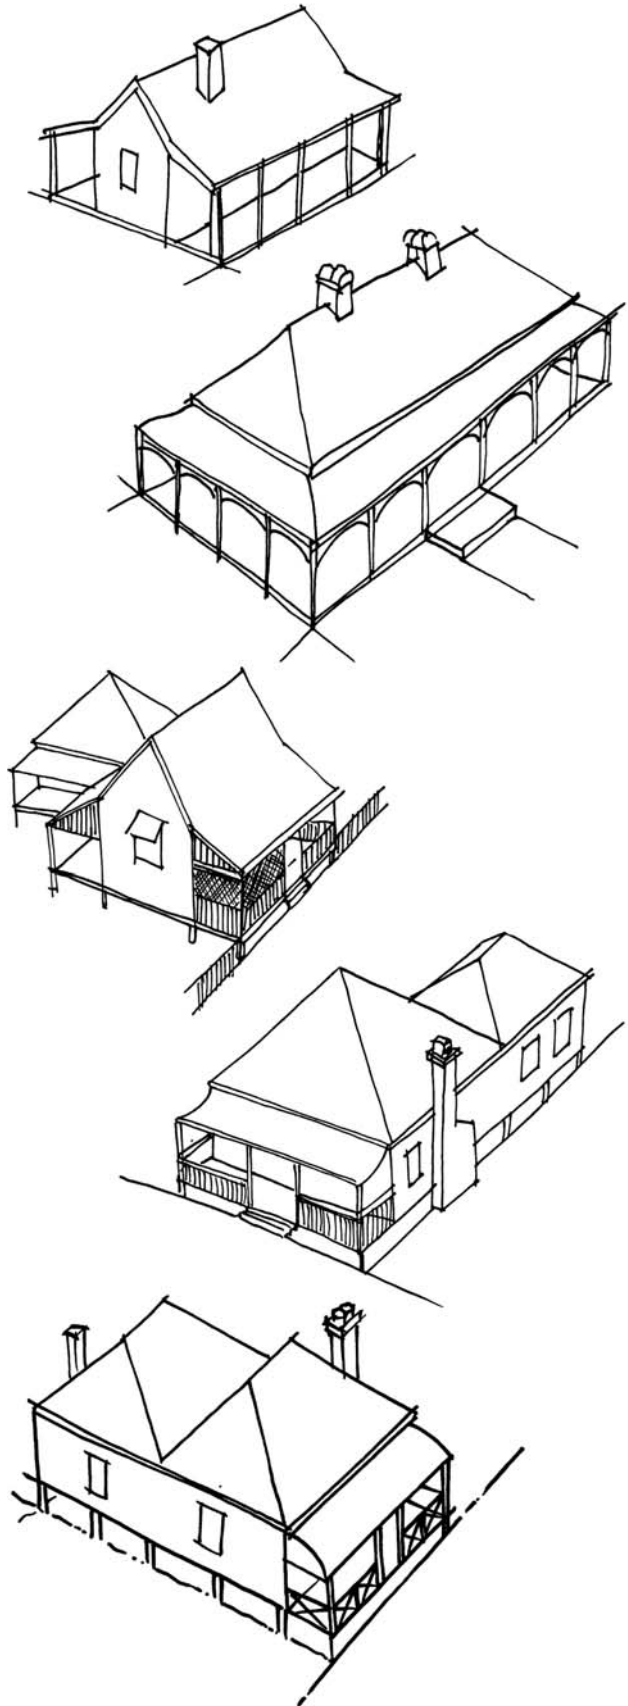
Single storey, often with no setback from the street alignment. The plan form often featured detached or semi-detached kitchens at the rear. Roof forms were either pitched or hipped with simple skillion roofed verandahs. Variants include reverse curve iron to verandahs. Chimneys were prevalent. Generally the earliest examples are derivatives of the late colonial Georgian style with a gradual transition to Queensland vernacular.

Earliest examples are often of brickwork with stone footings. External walls may be rendered and decorated with ruled joints to simulate large blocks of stone. Other examples have wide horizontal pine chamferboards on stud timber frame. Floors were generally of hoop pine tongue and groove on a timber frame. Roof materials on earliest examples were slate, shingle or galvanised iron, generally replaced by the turn of the century with corrugated galvanised iron custom orb profile. Windows were usually double hung sash or colonial sash type with six panes of glass to each sash. Windows and french doors sometimes had outward opening timber shutters.

Many of these buildings pre-date the era of cast iron lace. Low set verandahs often had no balustrading while others had simple vertical square balusters or pickets. Often the original detail no longer exists or has been altered to a later form. Columns were either of rectangular or square section with simple capital moulds.
